Fire Risk Assessment

Nelson House

**1 – 34 Nelson House,
Upper Church Lane,
Tipton,
DY4 9PW.**

Date Completed: 01/10/2025

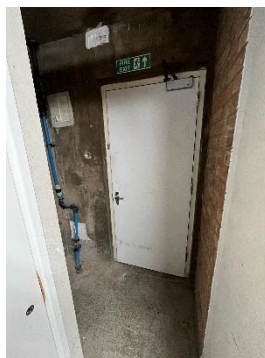
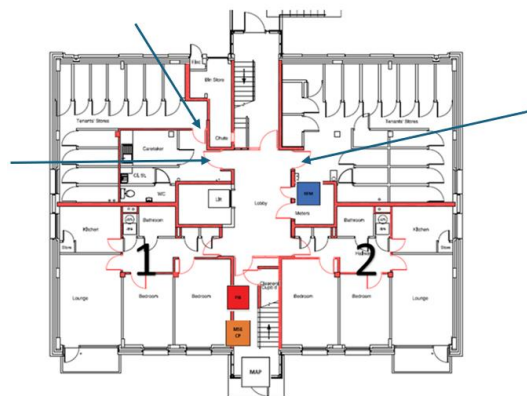
- 9) **The fire exit doors from the two residents' storage shed areas require the internal key locks to be replaced with thumb twist locks. This will prevent the chance of persons becoming accidentally locked in these corridors in the event of an emergency. A total of three locks require changing, two in the righthand side and one in the lefthand side. See Action 7/9**

Question/ Ref No	Required Action	Supporting photograph	Priority	Timescale and Person Responsible	Date Completed
7/9	The fire exit doors from the two residents' storage shed areas required the internal key locks to be replaced with thumb twist locks (on the inside). A total of three locks require changing, two in the righthand side and one in the lefthand side.

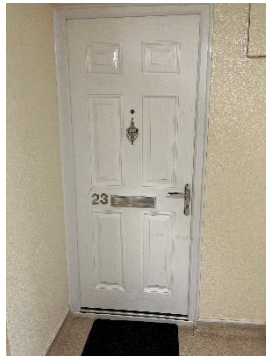
a) Flat 23 - Door is correct.

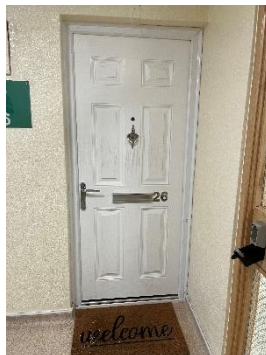
b) Flat 26 - Door is correct.

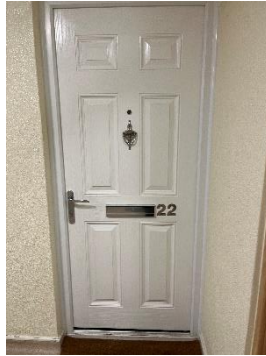
c) Flat 22 - Door is correct.

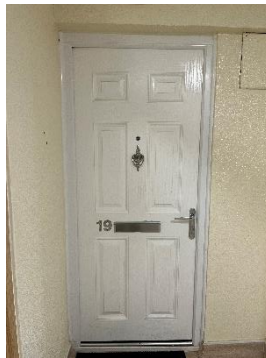
d) Flat 19 - Door is correct.

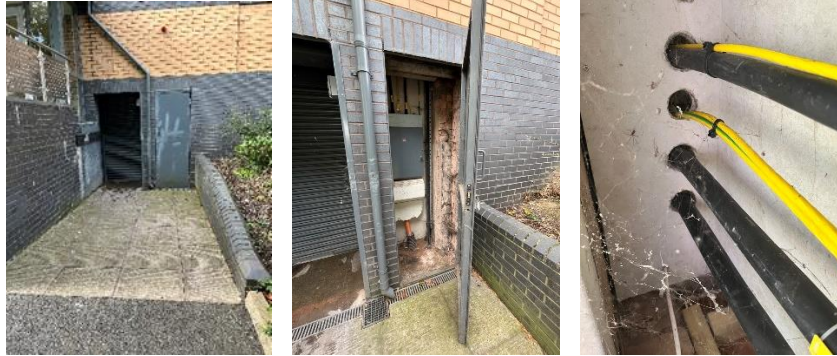
- 4) The electrical intake cupboard, accessed from the rear of the block, requires fire stopping to be installed around cable penetrations. It was not possible to view these cable penetrations from the above floor slab. See Action 10/4.

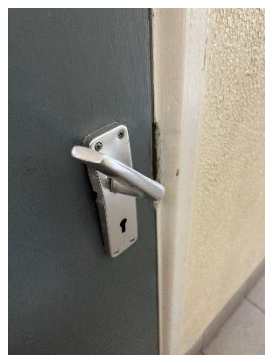
- 7) The cleaner's cupboard door under the stairwell in the entrance foyer requires a repair to its door handle. See Action 10/7.

10/7	The cleaner's cupboard door under the stairwell in the entrance foyer requires a repair to its door handle.
