# **Fire Risk Assessment**

## **Howard Street**

**Flats 1 - 12 – 19 - 30**  
**Howard Street.**  
**Tipton,**  
**DY4 8UF.**

**Date Completed: 08/11/2024.**

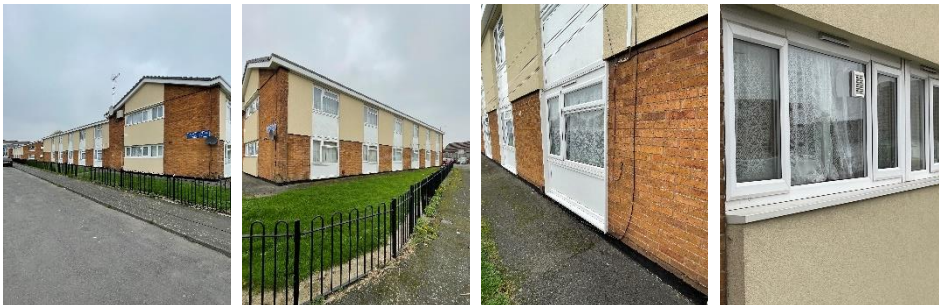
- 1) The external envelope of the premise is predominantly traditional brick, concrete construction, rendered panels, UPVC double glazed window frames surmounted by a pitched tiled roof.

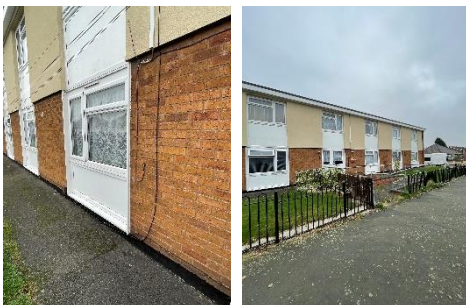
- 2) A number of combination UPVC windows and UPVC panels are evident on the front elevation of the building.

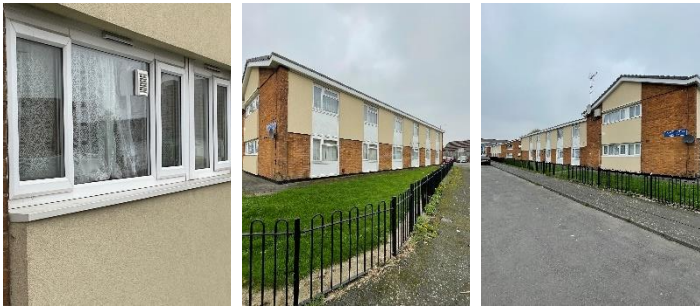
- 3) There are several rendered sections on the building. It is not known what classification these sections are.

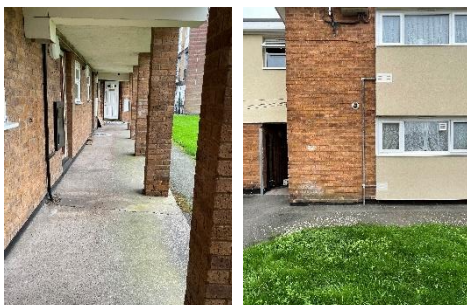
- 5) The majority of gas supplies to residents flats are by means of an external gas pipe which are predominantly located at the rear of the buildings. However, there are a small number of gas pipes located at the front of the property.

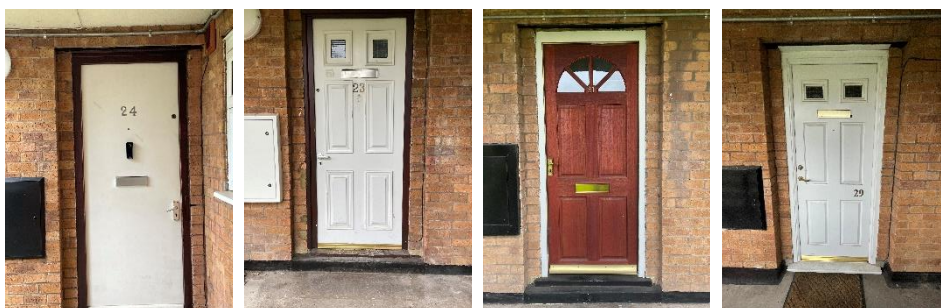
- 6) There is an out of hour's service that allows combustible items of furniture / rubbish to be removed.
- 7) Automatic smoke ventilation is not employed as areas are open deck. However, there is an openable double glazed window on the first floor which could be used for ventilation if necessary.
- 8) The means of escape are protected to prevent the spread of fire and smoke with a combination of nominal FD30s doors consisting of composite and timber front doors. Where applicable, timber flat entrance doors should be replaced when the fire door replacement programme commences.

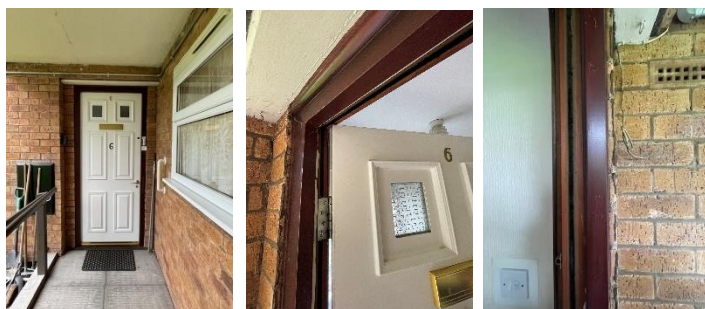
**The resident at flat number 1 provided information on the flat entrance doors. This door appeared to be an FD30s door. However, it did not have a self-closer fitted. Images below.**

- 10) **The resident at flat number 6 provided information on the flat entrance doors. This door appeared to be an FD30s door. However, it did not have a self-closer fitted.**

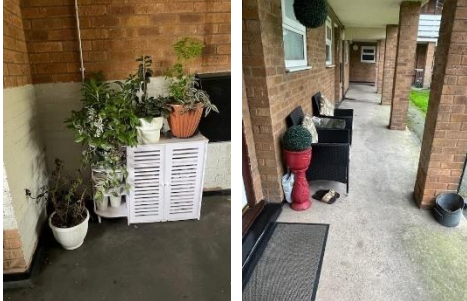
- 12) There were examples of combustible items, furniture and plants being left outside flat entrance doors, in one case outside flat 9, a shoe cabinet had been left on the first-floor landing. (Email sent to housing).

- 11) All means of escape areas should be maintained as sterile areas. (Email sent to housing).
-

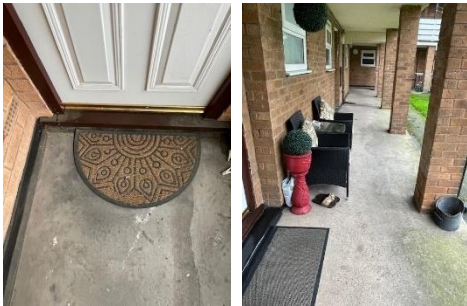
- 7) It was noted that some front entrance doors had floor mats in place, the fire rating of these mats is unknown but deemed to be of low risk.

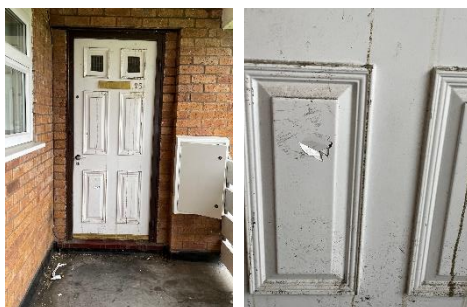
- 8) There was evidence of slight damage to flat 25 entrance door. This was deemed to be ok by the assessor.

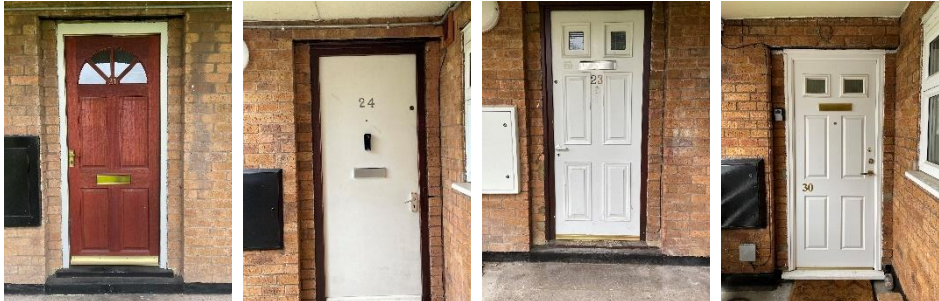
- 6) Generally, the means of escape is protected from flats with the use of a combination of notional & nominal doors & timber doors. These doors should be upgraded to FD30's when the door replacement programme commences.

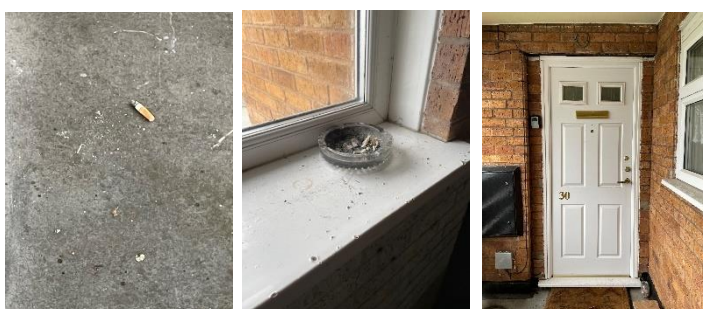
- 1) Smoking is prohibited within any communal parts of the building in line with Smoke Free England legislation.
- 2) There was evidence of smoking in communal areas, and this should cease with immediate effect. (Email sent to Housing)

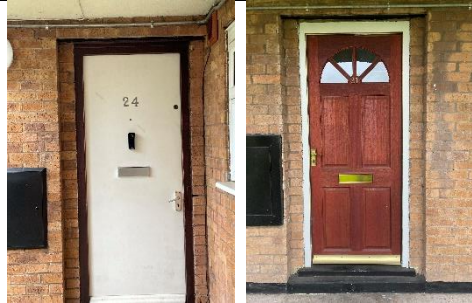
<b>Observations</b>		
As part of any future upgrades, replace timber flat entrance doors for FD30s.
