Fire Risk Assessment

Kynaston House

**Rydding Lane, Millfields,
B71 2HD**

Date Completed: 02/01/2026

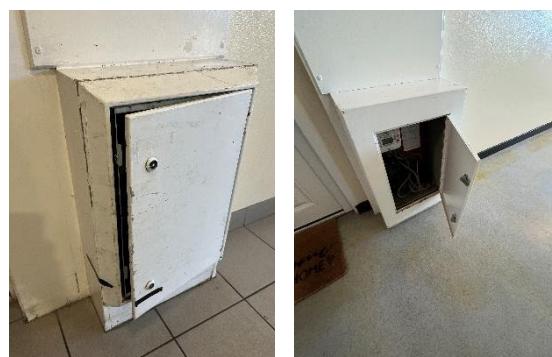
15) Residents electrical meter cabinets are situated in the corridors. Several of these cupboards are unsecured. Residents should be reminded to keep these electrical cabinets secured closed. See action 7/15.

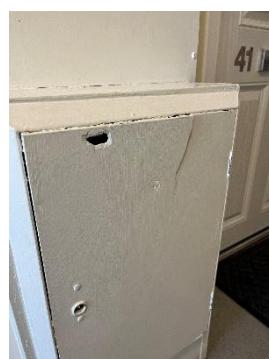
16) Residents electrical meter cabinets are situated in the corridors. Flat 40 has a damaged electrical cabinet door, requiring repair. See action 7/16.

P3	Housing manager 3 – 6 months.	
7/16	Flat 40 has a damaged electrical cabinet door, requiring repair.

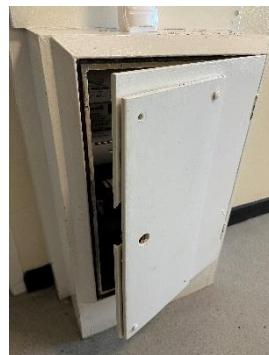
17) Residents electrical meter cabinets are situated in the corridors. Flat 41 has a damaged electrical cabinet door, requiring repair. See action 7/17.

P3	Electrical 3 – 6 months.	
7/17	Flat 41 has a damaged electrical cabinet door, requiring repair.

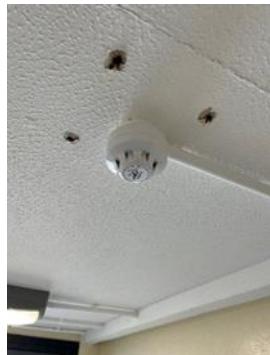
5) The AOV detector protection grill is missing on the 10th floor near flats 40 and 41. This grill is required to be replaced. See action 8/5.

8/5	The AOV detector protection grill is missing on the 10 th floor near flats 40 and 41. This grill is required to be replaced.

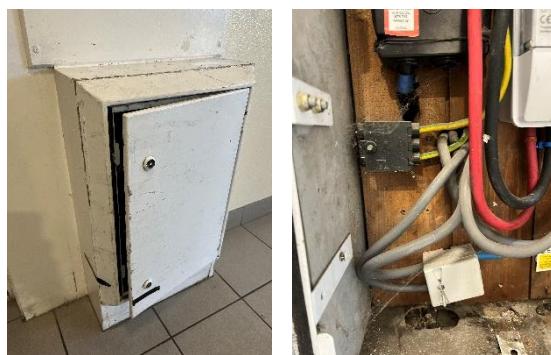
13) **Flat 1 electrical meter cabinet appears to have insufficient fire stopping around cabling entering the flat. It is required that the fire stopping around cabling is improved. See action 10/13.**

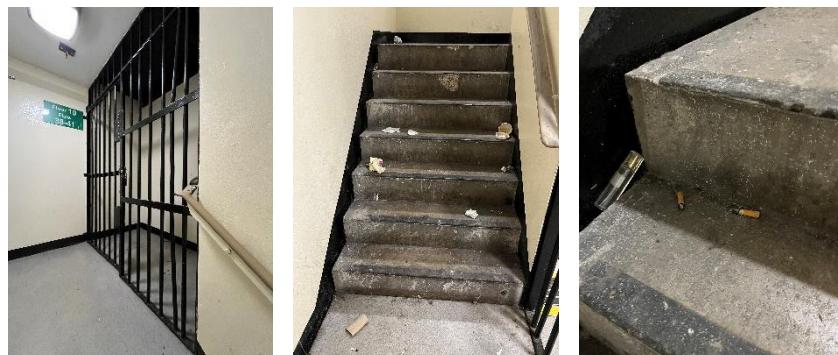
- 2) Evidence of smoking is present in the stairwell leading to the lift motor room. This evidence is behind the secured metal door. Smoking is prohibited within any communal parts of the building and measures are required to be taken to stop this activity. See action 14/2.
