Fire Risk Assessment

Sandfield House

**Flats 1 - 14.
Walsall Road.
West Bromwich
B71 3LR.**

Date Completed: 07/01/2025.

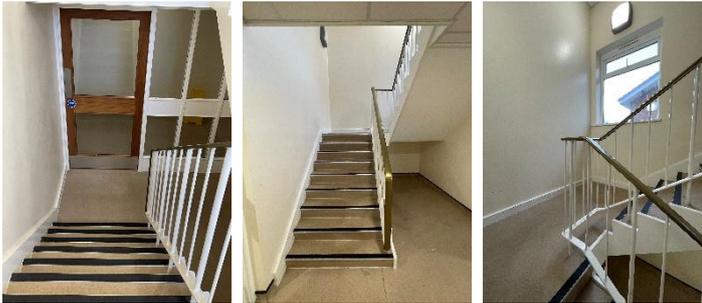
- 1) The building has two staircases that provide the means of escape from the building. Staircases provide a 1050mm width as a minimum.

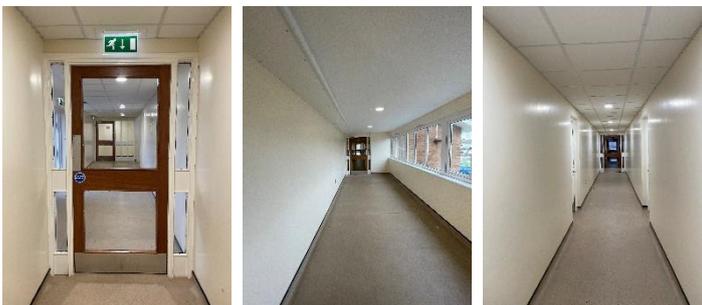
- 2) All corridors are of adequate width (at least 1050mm) and will be maintained clear to that width as a minimum.

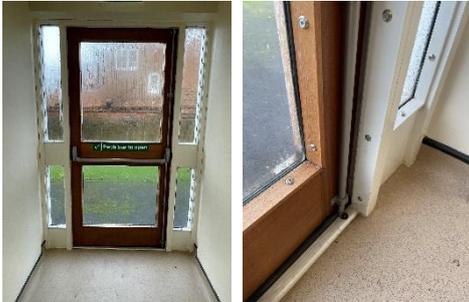
- 5) **The ground floor fire exit door is difficult to open & requires remedial action (adjacent to flat 3). The door appears to be warped and does not sit in the frame correctly. This could also create a security issue if not able to close.**

Question/ Ref No	Required Action	Supporting photograph	Priority	Timescale and Person Responsible	Date Completed
07/05	Repair the ground floor fire exit door. This is difficult to open, and the door does not close correctly onto the frame.

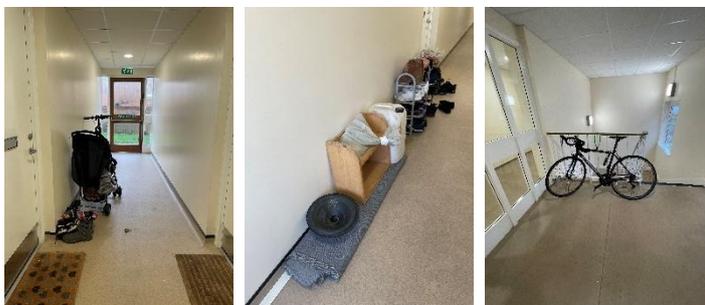
- 9) The communal areas are checked on a regular basis by the Caretaking / Cleaning teams 365 days per year and all items of rubbish are immediately removed.
- 10) There is an out of hour's service that allows combustible items of furniture / rubbish to be removed.
- 11) Communal areas are kept free of flammable items. However, it was noted in some areas that several combustible items were present on the means of escape route, this included a bicycle chained to the head of the staircase. The corridors should be maintained as sterile areas and items combustible items removed. (email sent to housing).

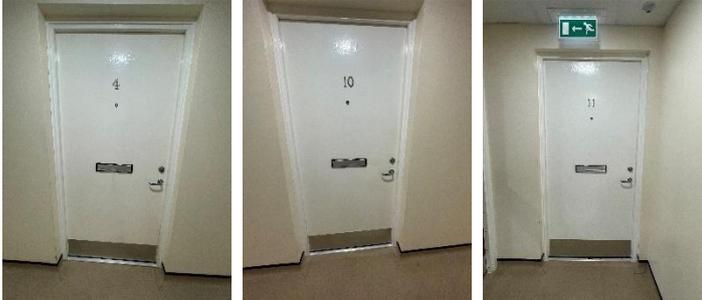
- 15) Individual flat doors are nominal timber flush FD30s rated doors fitted with door closers. Access was gained to a sample of properties as part of the risk assessment to ensure the doors have not been tampered with by residents etc.

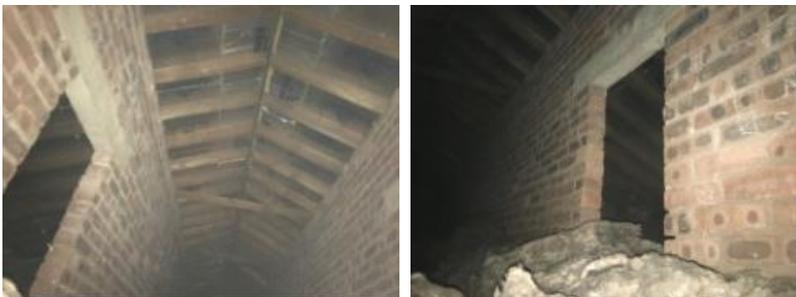
- 10) It was noted that the compartment walls within the loft area of the East Wing had dedicated access apertures within the brickwork, presumably to facilitate access.

The Building Regulations state that each flat shall be compartmentalised as not to allow fire or the effects of fire transfer from one flat to another.

The loft area needs to have full compartmentalised works to provide horizontal compartmentation of at least 30 minutes (**see Appendix 2**)

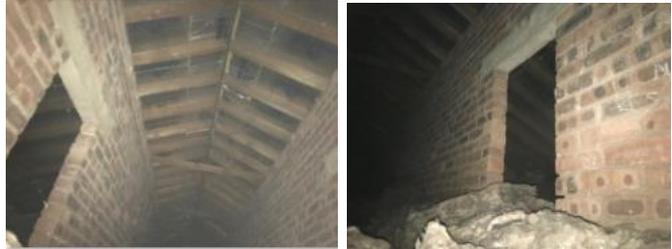
Observations	
<p>Following on from the previous fire risk assessment of 2019, there were concerns with compartmentation in the roof space.</p> <p>The premise was refurbished in 2019 and therefore the renovation was carried out in line with Building Regulations at that time. (See section 10)</p> <p>Residents in first floor flats confirmed that flats on this level do not have access to the roof space.</p>	<p>N/A.</p>
<p>When any future upgrades of the building are carried out consideration should be given to providing additional compartmentation in the roof/loft space. As the building was refurbished in 2019 Architects should design suitable fire stopping to prevent/restrict any smoke spread in the roof space.</p>
