# **Fire Risk Assessment**

## **1-8 Salop Drive**

**Salop Drive, Oldbury,  
B68 9AG**

**Date Completed: 22.05.25.**

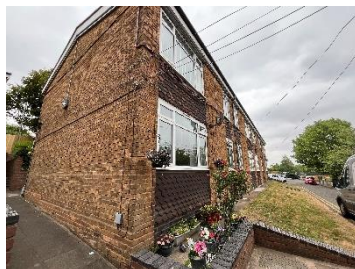
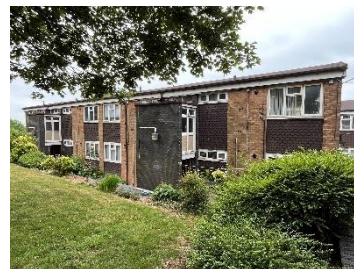
- 1) The external envelope of the premises is predominantly traditional brick construction, with an amount of hung tile cladding, surmounted pitched roof.

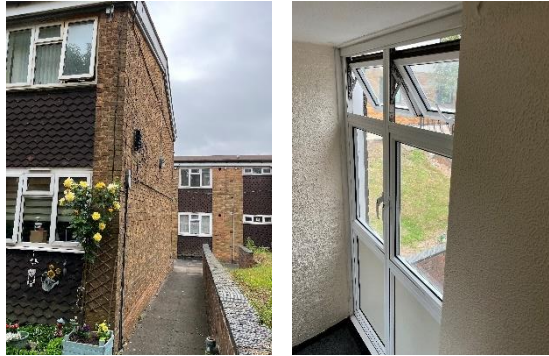
- 2) Individual flat windows are UPVC double glazed window frames. The windows in the communal staircases are UPVC window frames with openable vents. Communal staircases window frames are fitted with spandrel panels.

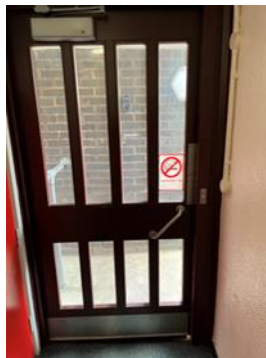
- 3) Access is gained to all flats from the ground floor using the main access door(s) leading to the staircase area, the front access doors are solid timber.

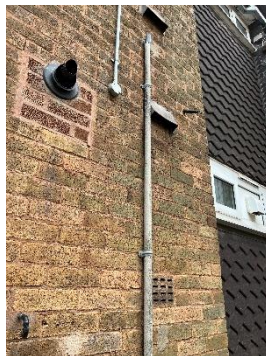
- 4) Gas risers are to the external front elevation of each block.

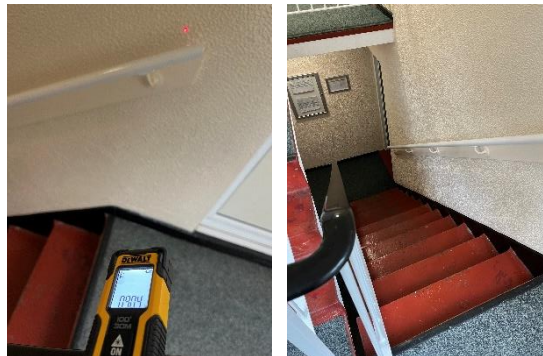
- 1) Each block has a single staircase that provides a means of escape and is **880mm in width**.

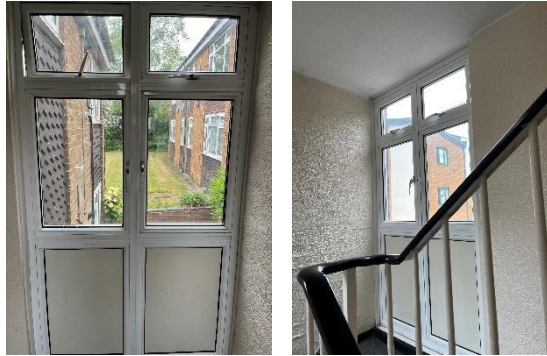
- 7) Ventilation of the common area is facilitated by openable windows in the stairwell.

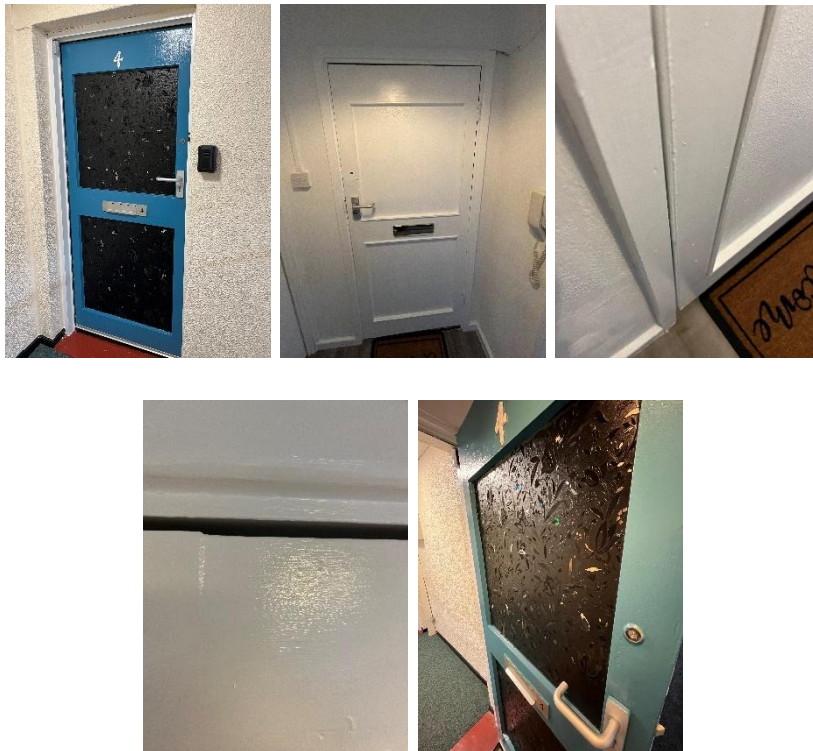
- 11) Accessed Flat 4 has no self-closing device, no combined smoke seal and intumescent seal and the door leaf also appears to be warped and requires adjustment to fit the frame. The glazing in the door could not be verified as being GWG due to it being covered with a plastic membrane on the exterior and painted on the interior. Due to these defects, the flat entrance door should be replaced with a new FD30s door. See Action 7/11.

Question/ Ref No	Required Action	Supporting photograph	Priority	Timescale and Person Responsible	Date Completed
7/11	Flat 4 has no self-closing device, no combined smoke seal and intumescent seal and the door leaf appears to be warped and requires adjustment to fit the frame. The glazing in the door could not be verified as being GWG due to it being covered with a plastic membrane on the exterior and painted on the interior. Due to these defects, the flat entrance door should be replaced with a new FD30s door.

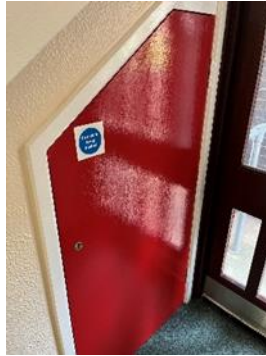
- 13) There is no chute room or dry riser.
- 14) Electrical service cupboards are nominal FD30s rated, secured with type 138 suited locks.

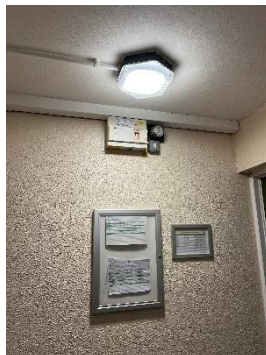
- 15) Both blocks have landlords' electrical distribution boards at high level on the ground floor of the common area. When any refurbishment of the building takes place consideration should be given to enclosing these electrical distribution boards in fire resistant cabinets.

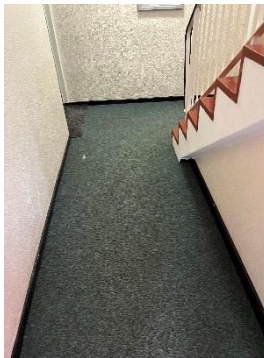
- 16) At the time of the assessment, it was noted that landing floors were fitted with carpet. It is understood that carpets have been procured in accordance with BS 5287: 1988 specification for assessment and labelling of textile floor coverings and & BS 4790 Fire Test to Textile Floor Coverings.

These carpets have been procured by SMBC utilising third party approved contractors. Therefore, it is understood that carpets fitted meet the approved standard.

<b>Observations</b>	
<p>At the time of the assessment, it was noted that landing floors were fitted with carpet. It is understood that carpets have been procured in accordance with BS 5287: 1988 specification for assessment and labelling of textile floor coverings and &amp; BS 4790 Fire Test to Textile Floor Coverings.</p> <p>When any refurbishment of the building takes place consideration should be given to replace existing flooring for an approved floor covering that complies to EN 13501-1 for floor coverings in common areas.</p>

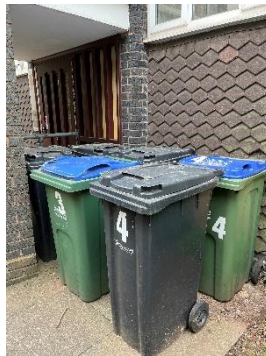
- 1) Refuse containers are emptied at regular intervals.
- 2) There is an 'Out of Hours' service in place to remove bulk items.
- 3) Refuse containers are emptied at regular intervals.
- 4) Refuse bins are situated too close to the fabric of the building in block 1-4 and should be moved to the designated bin store area. An email was sent to the Housing manager to correct this situation.

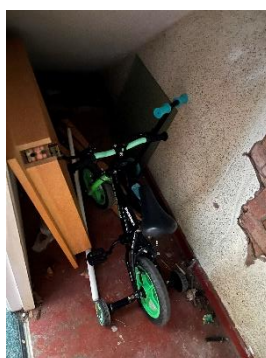
- 5) As per tenancy agreements, flammable liquids or gas cylinders should not be stored on site.
- 6) The landlord's electrical cupboard in block 1-4 has residents' belongings stored within. These items are required to be removed. Electrical service cupboards should be maintained free of combustible items. Email sent to Housing manager to remove these items.
