# Fire Risk Assessment

## 1-8 Beever Road

Tipton  
DY4 0FE

**Date Completed:** 14/05/2025

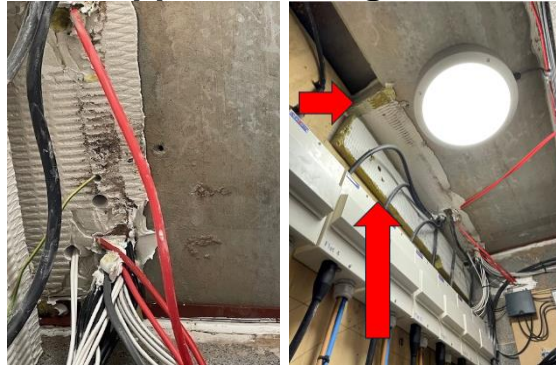
- b) Ground floor meter cupboard, penetration holes not fire stopped, and edges of ablative batt are exposed.**

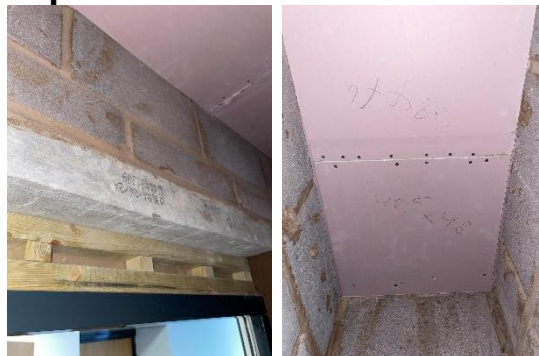
- c) 2<sup>nd</sup> floor cupboard in lobby corridor – stud work between FD60s door and compartment wall is exposed / not appropriately finished. Also fire rated plasterboard above has not been skimmed / fixings are exposed.**

P2	Within 1-3 months Urban Designs	
10/3c	2 <sup>nd</sup> floor cupboard – exposed studwork to be suitably finished to create 60 minutes integrity. Also fire rated plasterboard to be finished / skimmed.

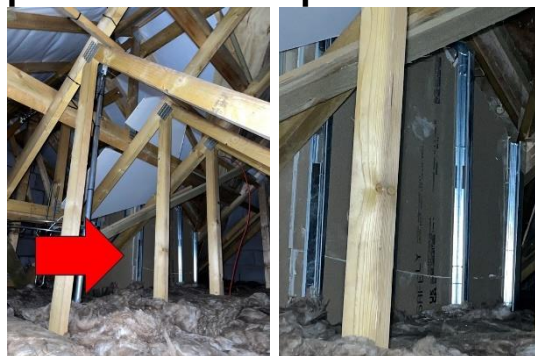
- d) AOV shaft walls on the roof void side appear to be single boarded therefore not providing 60 minutes fire protection as required.**

P2	Within 1-3 months Urban Designs	
10/3d	AOV shaft to be suitably boarded on roof void side to ensure 60 minutes integrity.

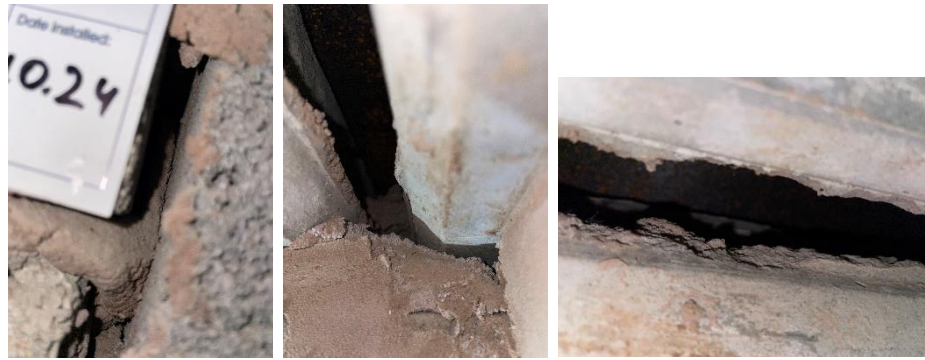
- e) Various gaps noted in service cupboards concerning blockwork and between blockwork and exposed floor slabs above. Firestopping required.**

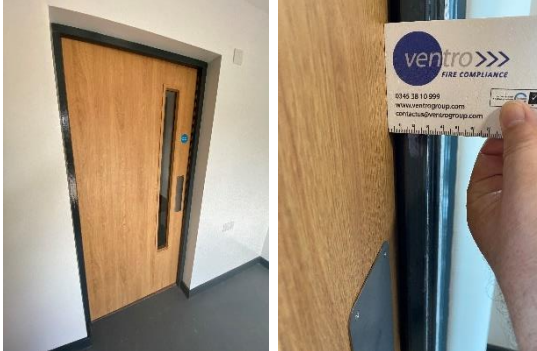
**a) Ground floor stairwell door not reliably self-closing fully.**

P2	Within 1-3 months Urban Designs	
10/12a	Ground floor stairwell door requires adjustment to ensure it reliably fully self closes into frame.

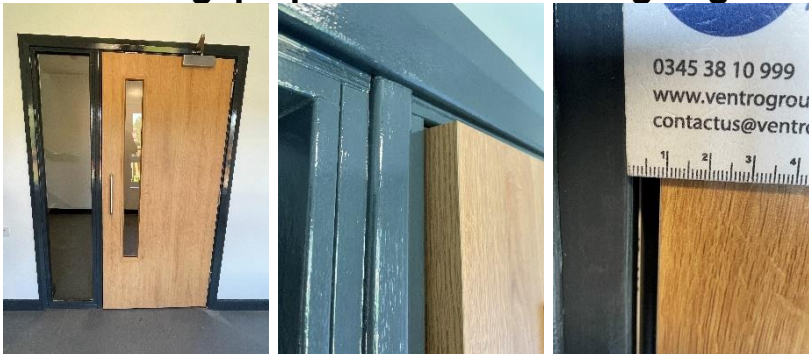
**b) 1<sup>st</sup> floor stairwell door not reliably self-closing fully and excessive gap up to 8mm on leading edge.**

P2	Within 1-3 months Urban Designs	
10/12b	1 <sup>st</sup> floor stairwell door requires adjustment to ensure it reliably fully self closes into frame.  Also, excessive gap (8mm) on leading edge to be corrected.

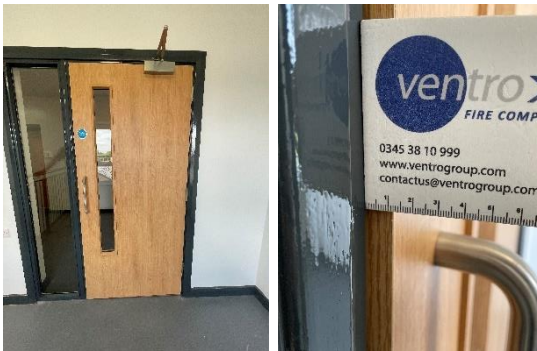
**c) 2<sup>nd</sup> floor stairwell door not reliably self-closing fully.**

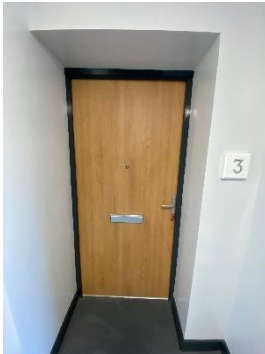
**a) Flat 3 - Not reliably fully self-closing.**

P2	Within 1-3 months Urban Designs	
10/14a	Flat 3 – Adjust entrance door to ensure it reliably fully self closes into frame.

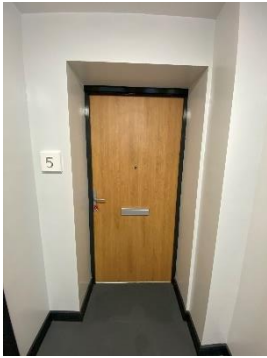
**c) Flat 5 - Not reliably fully self-closing.**

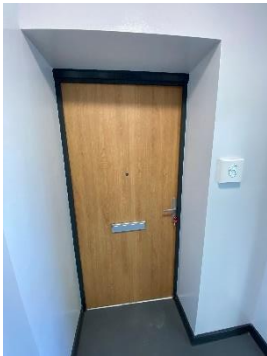
**d) Flat 6 - Not reliably fully self-closing.**

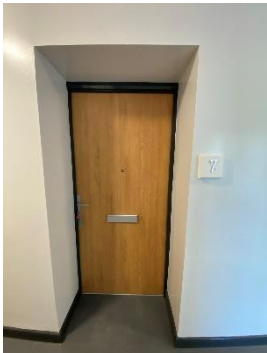
**e) Flat 7 - Not reliably fully self-closing.**

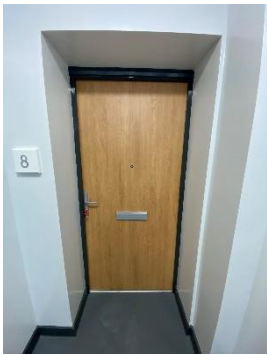
**f) Flat 8 - Not reliably fully self-closing.**

10/14f	Flat 8 - Adjust entrance door to ensure it reliably fully self closes into frame.

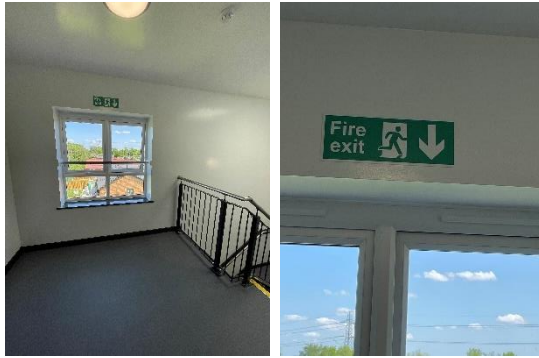
**5) Escape signage on stairwell 1<sup>st</sup> and 2<sup>nd</sup> floor landings display incorrect arrow. The arrow should be pointing diagonally downwards and right to signify “progress down to the right” as per BS 5499 - 4.**

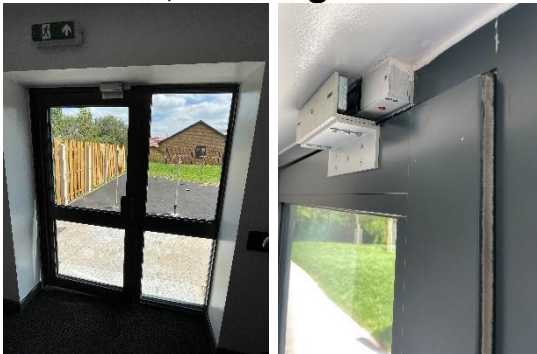
- 1) Once occupied regular checks will be undertaken by Caretakers / Cleaning Team(s) 365 days per year which helps reduce the risk of arson.
- 2) Access to the building is restricted by a door entry system.
- 3) **The rear entrance / exit door is failing to reliably self-close therefore, the magnetised latch is not holding the door.**
