# Fire Risk Assessment

## **Flats 76-98 & 100-116. Edinburgh Road Oldbury B68 0ST.**

**Date Completed:** 20/05/2025

**Current Risk Rating = Tolerable**

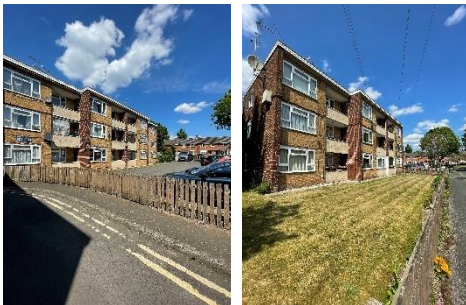
- 1) The external envelope of the premises is predominantly traditional brick, concrete construction, surmounted by a flat roof. The roof can be accessed via the second floor.

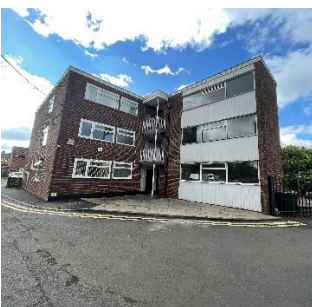
- 2) PVC cladding has been installed to a single side elevation to the stairwell in both blocks.

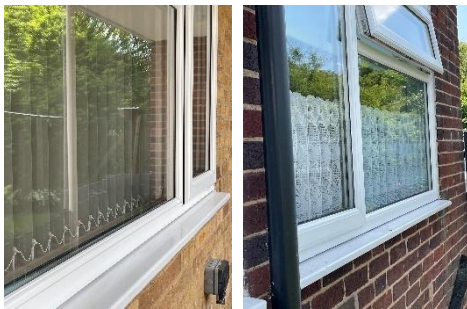
- 6) Individual flat windows are UPVC double glazed window frames.

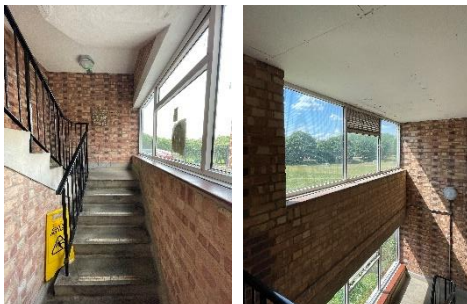
- 7) Windows in the stairwell are UPVC single glazed unit of Georgian wired glass. There is a louvred vent on the top floor to assist with any smoke clearance.

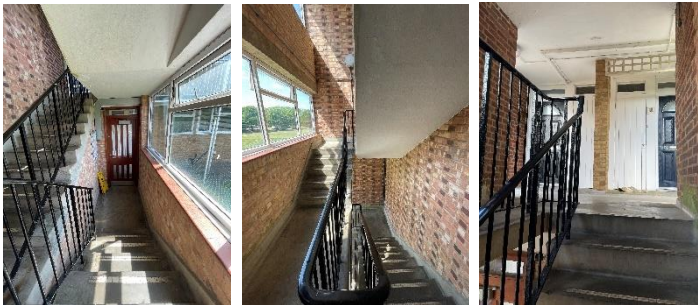
- 1) Each building has a single staircase that provides a means of escape and is 920mm in width.

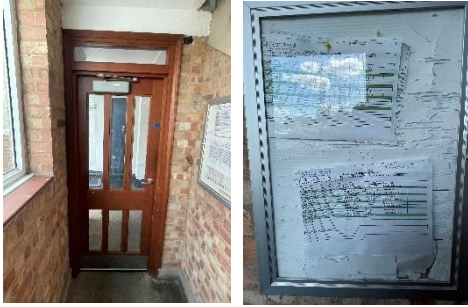
- 5) The means of escape are protected to prevent the spread of fire and smoke.
- 6) The only communal door within the block is the final exit door which is fitted with automatic closing devices that are checked on a regular basis by Caretaking Teams as part of their daily checks. Defective closing devices are reported to an external contractor.

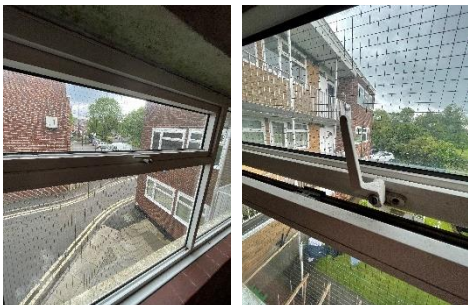
- 7) None of the corridors that form part of the means of escape are dead ends.
- 8) The final exit door has a door entry system installed. These systems are designed to fail safe i.e., door unlocked in the event of a power failure. This prevents residents being locked in or out of the building.
- 9) Communal areas are kept free of flammable items. The communal areas should be checked on a regular basis by Caretaking / Cleaning teams and all items of rubbish removed.
- 10) Communal windows are located within the stairwell and can be opened with the use of a key.

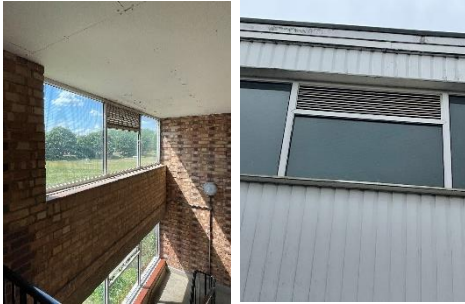
- 11) There is a louvre vent within the 2<sup>nd</sup> floor stairwell of each block.

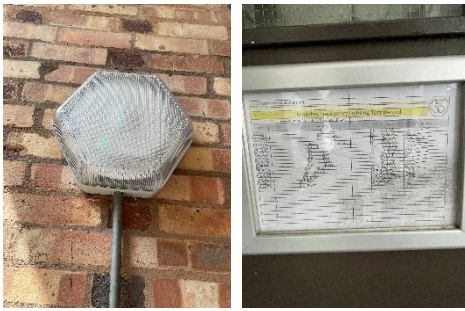
- 12) Emergency lighting is provided to communal landings and stairs. Checks are done on a monthly basis by Sandwell MBC in house electrical team or approved contractor.

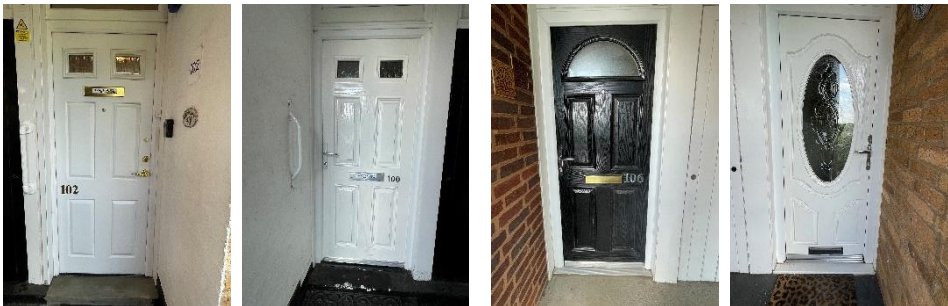
- 13) Flat entrance doors are an unknown composite type door. These doors should be upgraded to certified FD30s as part of any future refurbishments.

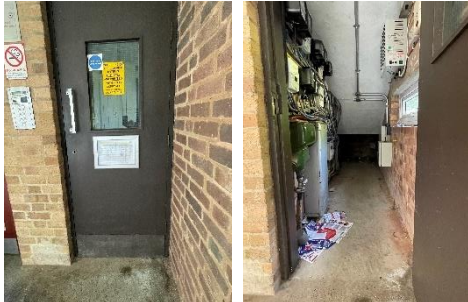
- 14) Electric meter cupboard doors are FD30s rated, secured with a type 138 suited mortice lock. Residents have been provided with a key for access to their electricity meters.

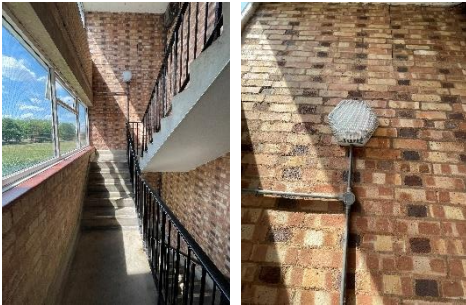
- 1) The premises has a sufficient emergency / escape lighting system in accordance with BS 5266 and has test points strategically located.

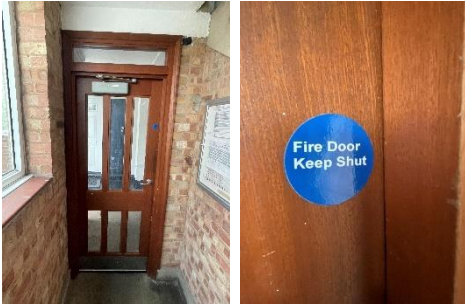
- 1) All fire doors display “Fire Door Keep Shut” where appropriate.

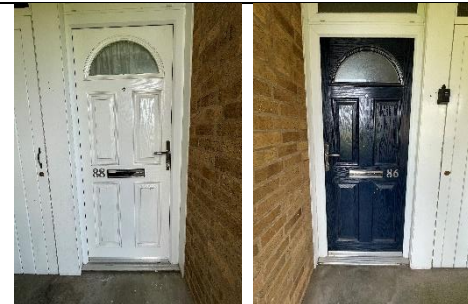
As part of any future upgrades consideration should be given to replacing residents' storage cupboard doors for FD30 fire doors.
