# Fire Risk Assessment 1-14 Langley Mede

#### Crosswell's Rd, Oldbury B68 8HD

**Date Completed:** 15/05/2025

**Current Risk Rating = Tolerable**

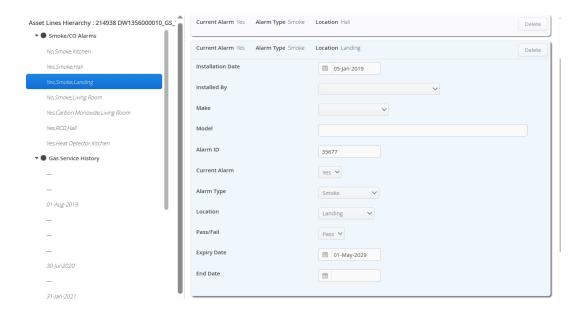
- Early warning is limited to hard wire or battery smoke alarms within each of the resident's Maisonettes. The equipment is subjected to a cyclical test.
- 2) No Access was gained into Maisonettes during this risk assessment. information collated from in house teams (JM) and previous risk assessments the smoke alarms within resident's Maisonettes are installed to a minimum of an LD3 Standard. Example of alarms in place

Maisonette 8 – LD2 – Hardwired Maisonette 9 – LD2 – Hardwired
