Fire Risk Assessment

1-9 Keats House

**Tudor Road, Oldbury,
B68 9RE**

Date Completed: 03/06/2025.

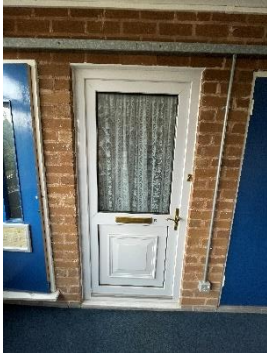
- 1) Individual flat doors appear to be predominantly FD30s rated composite fire doors.
- 2) **Flat 5 appears to be non-fire rated UPVC door set. The previous FRA from 2022 reports the leaseholder of this property has been contacted by SMBC Leasehold Management reference replacing the door with a certified FD30s fire door set.**

Question/ Ref No	Required Action	Supporting photograph	Priority	Timescale and Person Responsible	Date Completed
7/2	Flat 5 – Entrance door is not a suitable fire door. FD30s certified door set to be installed. <i>Leaseholder property.</i>

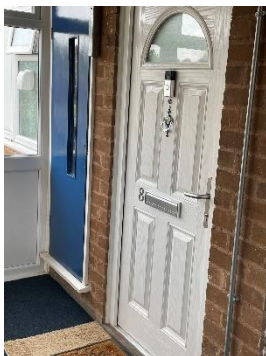
- A. Flat 8. This FD30s door displayed the BM Trada Q Mark and was correct.

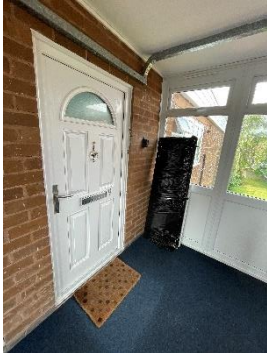
- B. Flat 9. This FD30s door displayed the BM Trada Q Mark and was correct.
-

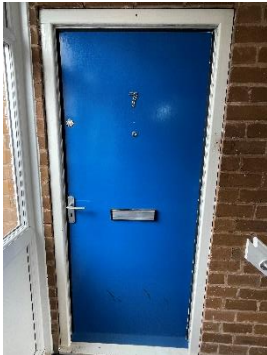
- C. Flat 7. This door appears to be a 44mm softwood, non-fire rated timber door and is without a self-closing device. The flat is a leaseholder property.**

7/3c	Flat 7 – Entrance door is not a suitable fire door. FD30s certified door set to be installed. <i>Leaseholder property.</i>	 	P4	Programmed Work Leasehold Manager	
7/3d	Flat 6 – Entrance door is not a suitable fire door. FD30s certified door set to be installed. <i>Leaseholder stated they have already requested SMBC replace the door.</i>	 	P4	Programmed Work Leasehold Manager

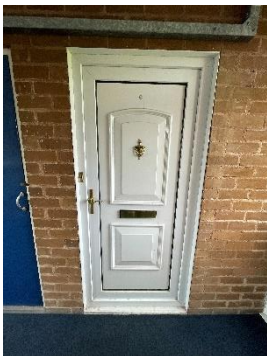
- D. Flat 6 appears to be non-fire rated UPVC door set. The previous FRA from 2022 reports the leaseholder of this property has been contacted by SMBC Leasehold Management reference replacing the door with a certified FD30s fire door set.**

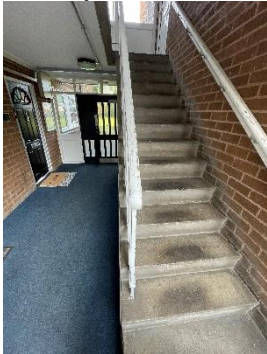
- 4) The building has a single staircase that provides a suitable means of escape and is approximately 870mm in width.

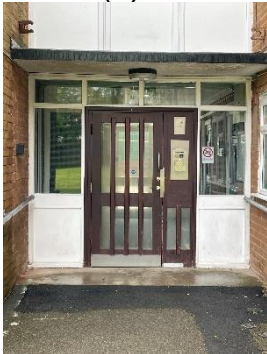
- 5) The only communal doors within the block are the final exit doors to the front of the building and a door to the rear courtyard. Both doors are fitted with automatic closing devices. These are checked on a regular basis by Caretaking Teams as part of their cyclical checks. Defective closing devices are replaced either by the Caretaking Team(s) or the in-house repairs team(s).

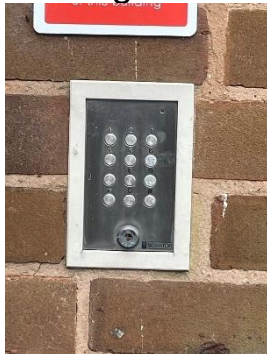
- 6) The front final exit door has a door entry system installed. These systems are designed to fail safe i.e., door unlocked in the event of a power failure. This prevents residents being locked in or out of the building.

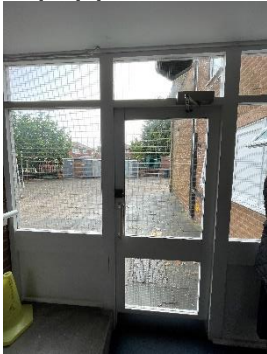
- 7) The rear final exit door is secured with a simple cylinder lock equipped with a thumb turn to exit.

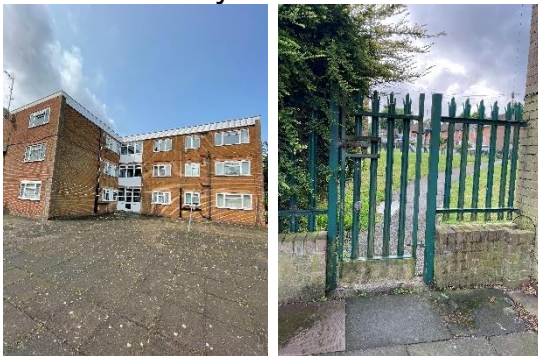
- 8) The rear courtyard is enclosed with perimeter fencing and a gate. The rear courtyard is suitable as a place of reasonable safety because residents can stand at a safe distance greater than the height of the building. The gate was unlocked at the time of the survey however residents are provided with a key. Access through the gate leads to ultimate safety.

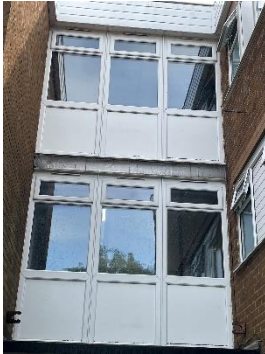
- 11) Automatic smoke ventilation is not employed; the staircase is open plan with ventilation possible via openable windows.

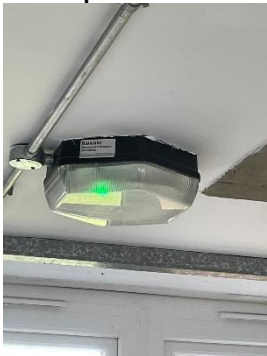
- 12) Emergency escape lighting is present throughout the means of escape.

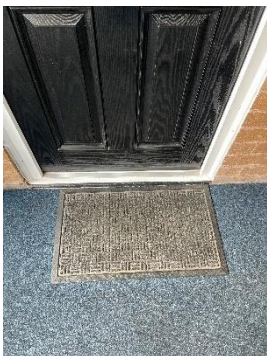
- 13) A number of residents have floor mats outside their flat entrance doors. The floor mats are deemed a trivial risk.

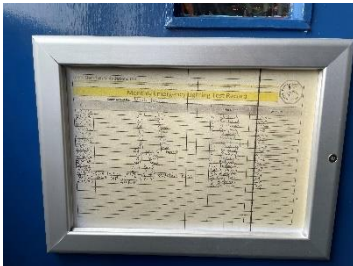
- 3) All installed equipment is checked and tested on a monthly basis by Sandwell MBC in house electrical team or approved contractor, in accordance with current standards. The equipment was last tested 20/05/2025.

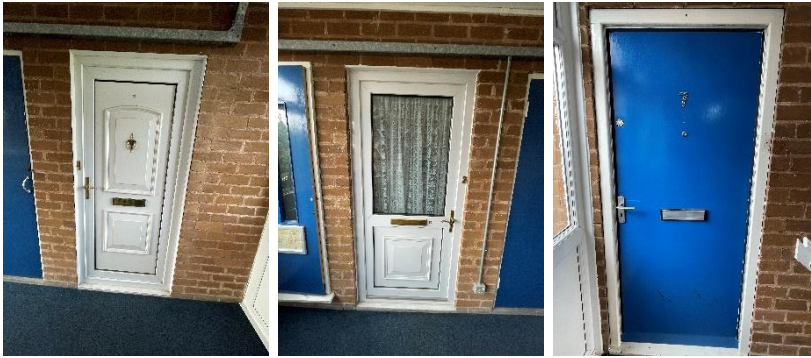
Doors to flats 5, 6 & 7 are non fire rated doors sets and have been detailed in section 7 of the report.

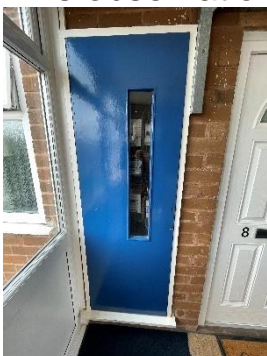
- 4) Doors to the meter cupboards are non-fire rated 40mm timber doors. The doors are secured with budget locks. Consideration should be given to upgrading the cupboards doors / frames to FD30s standard. This observation has been recorded within section 19.

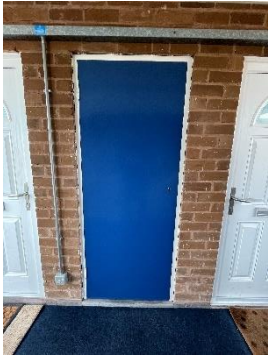
- 5) 1st and 2nd floor cupboard doors are 44mm timber doors, with 2 hinges and a 25mm stop. Consideration should be given to upgrading the cupboards doors / frames to FD30s standard. This observation has been recorded within section 19.

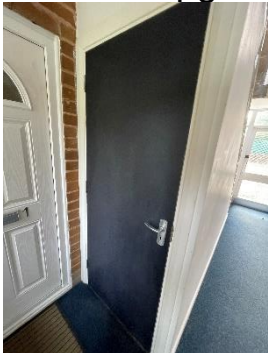
- 6) The ground floor cupboard door beneath the stairs was locked at the time of the inspection. It was evident that the door has 3 x hinges as per a fire door install however, the responsible person should also consider upgrading this cupboard door if applicable.

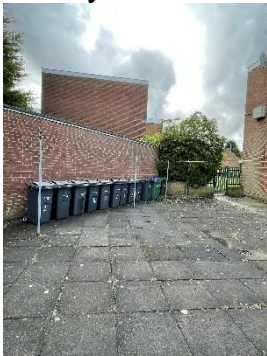
- 2) Refuse containers are stored on hard standing within the rear courtyard at a safe horizontal distance from the building.
