**Lovett Avenue, Oldbury,  
B69 1BT**

Sandwell  
Metropolitan Borough Council

Burnett House  
Lovett Avenue  
Oldbury  
B69 1BT

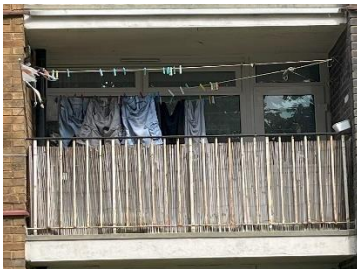
- 4) Flat 5 has wicker type screening attached to the balcony rails.

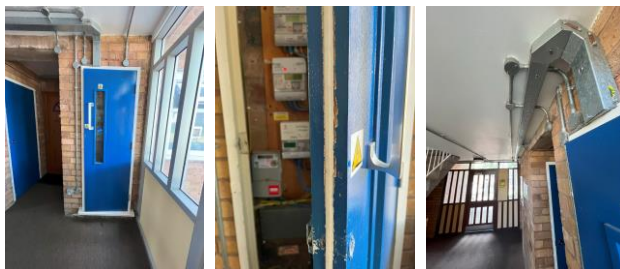
- 2) Near the rear final exit there is a resident's meter cupboard, this is protected by a FD30s rated fire door. The door is secured by a budget lock; residents have been provided a key for access to this cupboard. There is metal box trunking that is installed above the door and across the ceiling providing electrical supply to each flat.

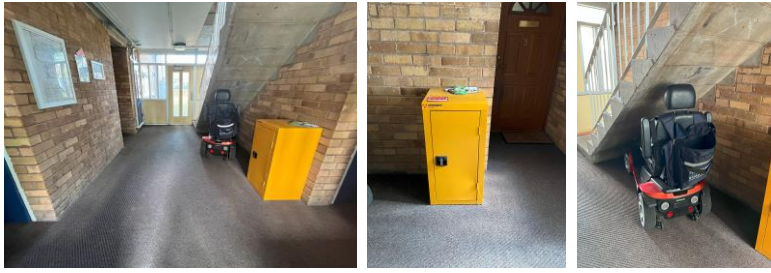
- 3) There is a metal safe placed under the stairs, but this does not impact the means of safe escape, there is also a mobility scooter under the stairs, this has been recorded in section 14, Means of Ignition. Email sent to the Housing Manager on 24/07/25.

- 10) On the ground floor a mobility scooter has been stored under the stairs, this is a potential source of ignition due to containing batteries. Will need to be removed.**

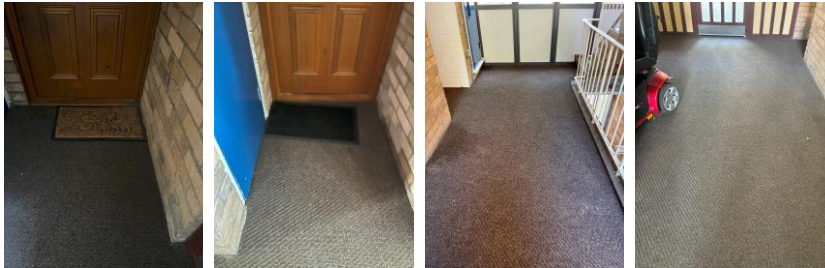
- 4) All communal hallway floors are carpeted, the flat entrances have door mats, the fire rating is not known on the door mats.

All floors have S.M.B.C fitted carpet. Due to the fact S.M.B.C specified and managed the installation of the carpets it has been presumed that it is class 0 fire rated.

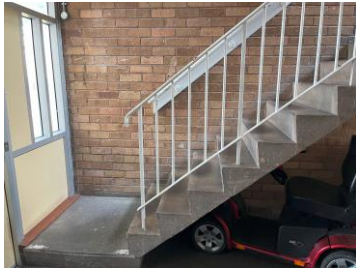
- 6) The premises consists of a single staircase that provides means of escape, this is located as you enter the building, this has been measured at 855 mm in width.
-

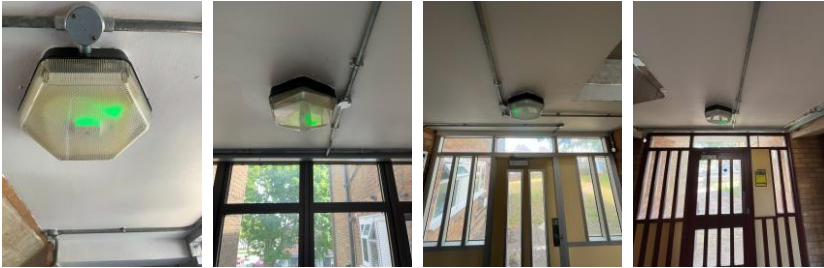
- 5) 1st floor emergency light over the staircase does not show the green illuminated L.E.D. Not sure if this functioning.

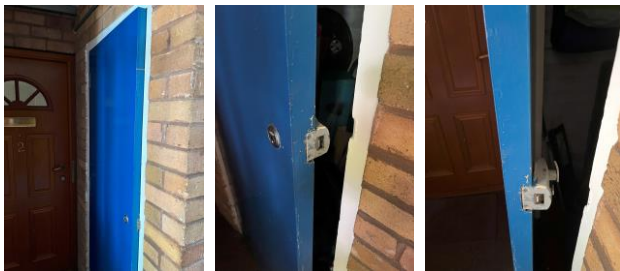
- 6) All residents' storage cupboards next to their own front entrances are secured by residents own key. The door is a notional fire door. On this FRA, flat 2 door was found to be open.

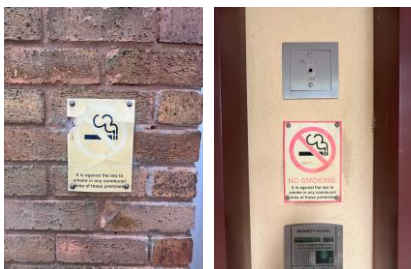
- 2) Fire Action Notices are not displayed throughout the building. The signs are not necessarily due to the building not having a complex layout.
- 3) Yellow LPG warning signs are not displayed within the block. [refer to section 18](#)
- 4) Smoking is prohibited within any communal parts of the building in line with Smoke Free England legislation.

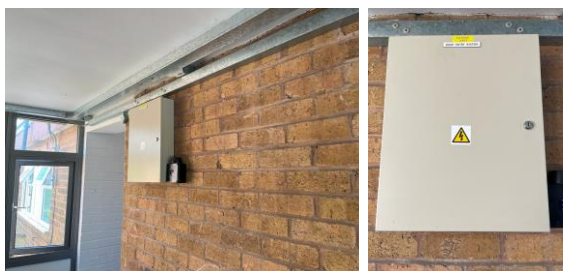
9) 2<sup>nd</sup> floor has door entry system power supply unit installed on the wall, this is secure and away from resident's reach, all cabling is housed within boxed metal, trunking above.
