Fire Risk Assessment

Grasmere House

**Lovett Avenue, Oldbury,
B69 1DQ**

Date Completed: 3rd July 2025

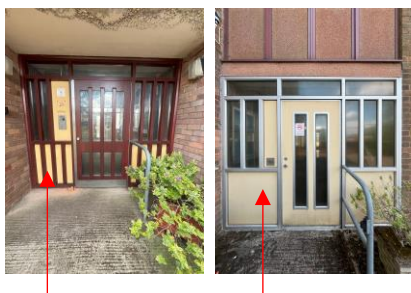
- 2) The entrance is of a timber frame and glass with timber and glass side panels to either side of the door. Within each side panelling there is Spandrel boarding installed. The rear door entrance is of Aluminium construction and has Spandrel panelling installed within the side panelling.

Spandrel panelling within inserts

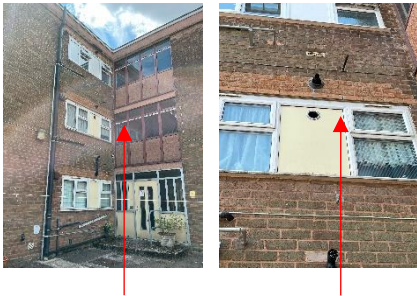
8) On the rear of the building, first floor flat 5, ducting from kitchen has no cover on the external face of the building, this needs covering. An Email has been sent to housing manager enquiring about relevant permission.

Extraction duct opening

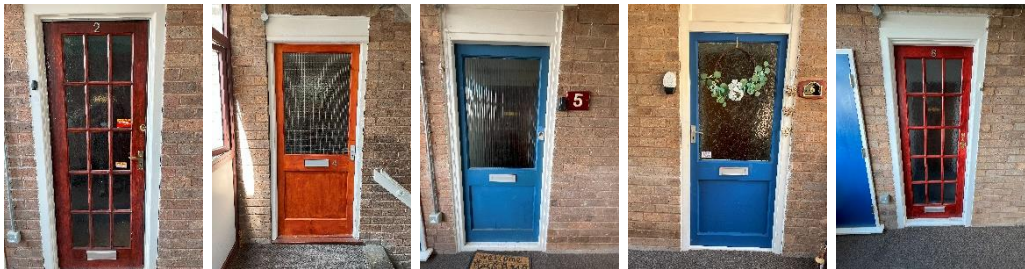
- 1) There are flats with in the block that have non-Fire Rated doors installed on the front of the alcove that leads to the front entrance of the individual flats, this creates a porch within the communal area of the building. These non-rated doors are secured with a mix of Mortice and Yale Type locks.

Flats 2,4,5,6,8 are non-Fire Rated doors with Yale and Mortice type locks

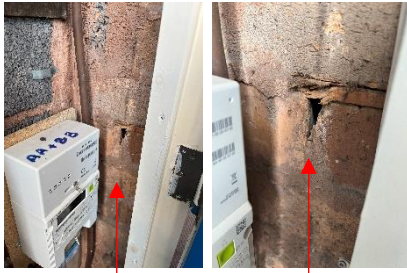
- 8) First floor resident's electrical cupboard has exposed cavity in the brick work, the size of this opening is approximately 30mm and near to the electrical units. On investigation, the cavity appeared to travel 200mm into the brick work, but is blocked of by secondary blockwork, there are no other openings either side of the gap.

Cavity within brick work

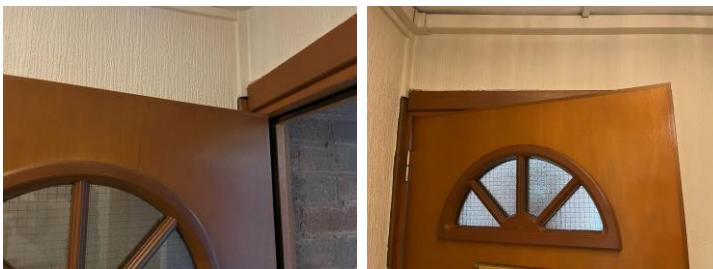
- 10) Flat 3 on door inspection, no door closure installed, resident has said that they never had one, there is no evidence of previous mounting hole or signs on the door.**

P2	1-3 Months Fire Rapid Response	
10,11	Flat 3 no door closure installed, Door closure needs reinstalling on to the door

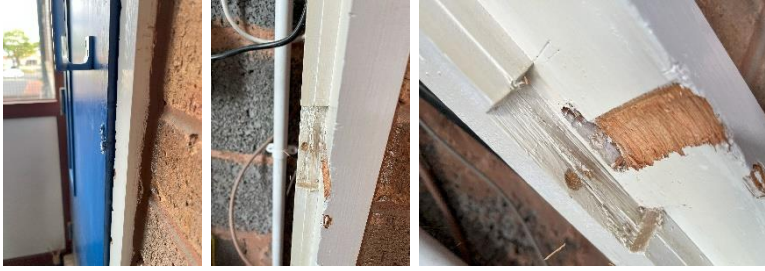
- 11) 2nd floor electrical cupboard door is not shutting securely to create a seal, it sits away from the frame, on investigation it seems that the door latch will not sit well within the fitting of the frame.**

- 2nd floor electrical rise cupboard door is not shutting securely to create a smoketight seal, will not sit well within the fitting in the frame. Needs redoing to fit.

10,10	2 nd floor electrical rise cupboard door is not shutting securley to create a smoketight seal, will not sit well within the fitting in the frame.Needs redoing to fit.

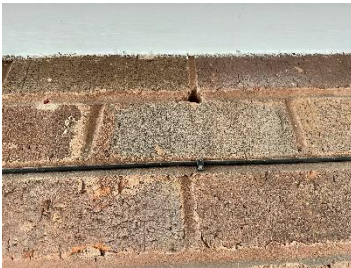
- 12) Ground floor brick wall near flat 3 entrance has a drilled hole in the brickwork that exits into the resident's store cupboard, the cupboard itself has combustibles stored within it, this will need blocking up with suitable fire stopping.**

P2	1-3 Months Fire Rapid Response	
10,12	Ground floor flat 3 has cavity in brick work from communal area leading into residents' stores.

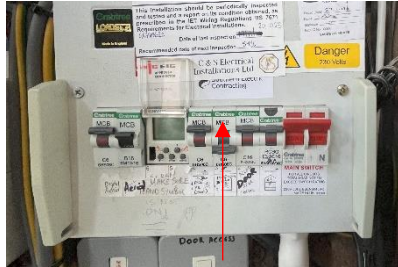
- 5) Distribution board in 1st floor electrical riser, circuit to the front door lighting has been tripped.

Tripped Circuit

14,6	Distribution board in 1 st floor electrical riser, circuit to the front door lighting has been tripped. Needs further investigating
