Fire Risk Assessment

Martley Road 48-58

**Martley Road, Oldbury,
B69 1DZ**

Date Completed: 4th August 2025

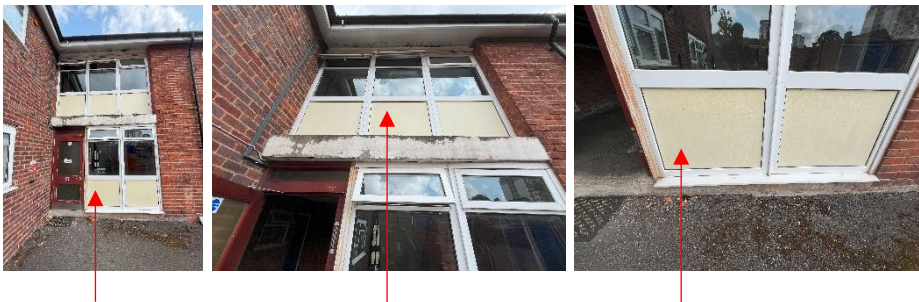
Rear Spandrel panelling under the window units

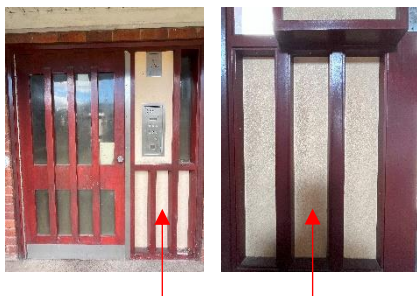
Spandrel panelling insets on the front entrance

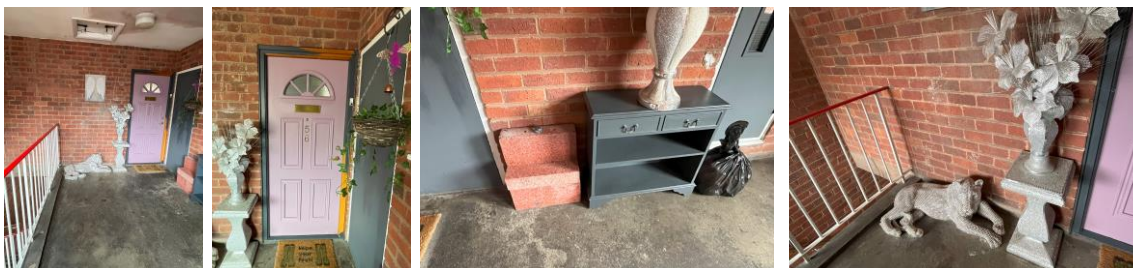
- 1st floors landing and outside flat 56 entrance, there are numerous amounts of ornamental items, resident has said they will remove them.
- Ground floor communal entrance near to the front entrance door, there is a wall light unit that is damaged, cover needs securing properly

- 4) **Flat 56 has various items placed within the communal landing area, these items will impact the means of escape in an emergency, I have spoken to the tenant, and they have said that they will remove them, this needs to be regularly managed by the caretakers covering this building.**

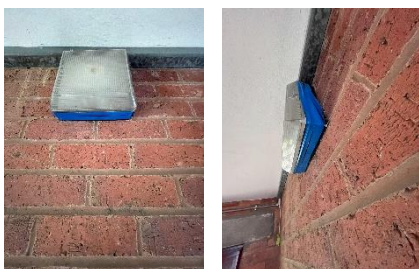
- 12) Ground floor communal entrance near to the front entrance door, there is a wall light unit that is damaged, the plastic cover is secured with gaffer tape, this will need a new secure fitting.**

7/12	Ground floor communal hallway, damaged light. Needs replacing	 		P2	1-3 Months Electrical Team	
------	---	--	--	----	-------------------------------	--

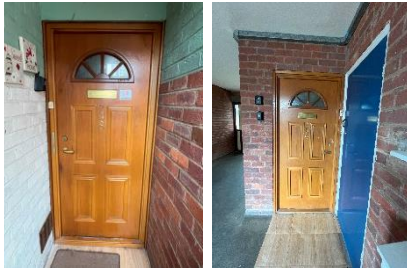
- 13) Ground floor flats 48,50 have Lino placed outside the entrance to individual flats, the fire rating is not known on these, the condition of the Lino does not warrant as a tripping hazard.

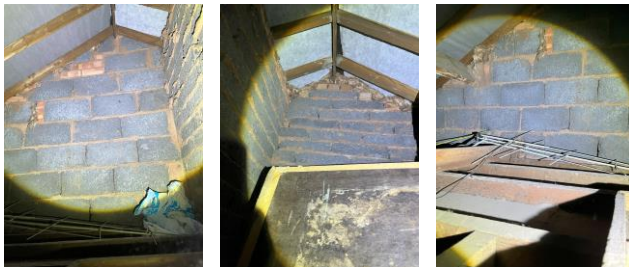
- 10) Roof space investigated for compartmentation, there is suitable compartmentation in the form of block work, which is intact along the roofline, there are no other visible cavities or breaks in the compartmentation.

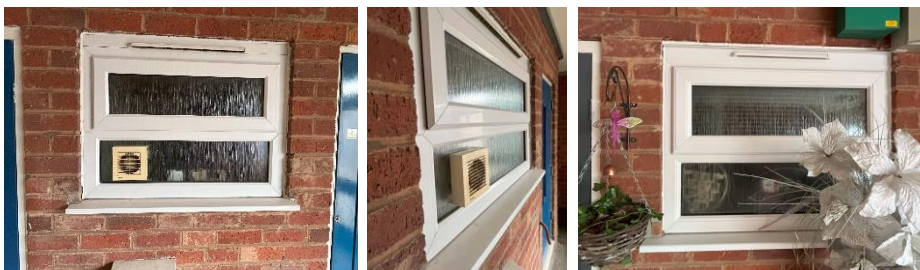
- 11) There is a UPVC framed unit installed in flat 48 and 56. This has been noted in observations for future works. Email has been sent to Capital Investment 12th August 2025.

Flat 48 & 56 has UPVC windows installed, it is assumed that these windows are from the bathrooms of the flats, for future renovation works integrity of the compartmentation between flats and the common area needs to be considered e.g. fire-resistant glazing could be installed.

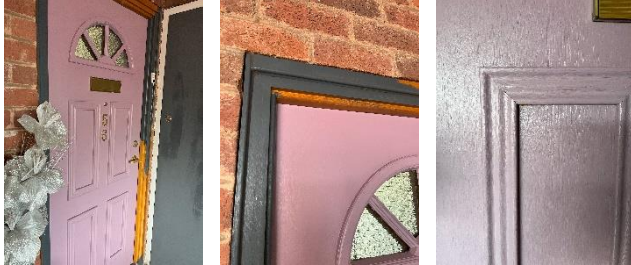
- 13) Flat 56 FD30s front entrance door has been painted by the resident with a paint that the fire rating is not known. Email has been sent to the housing manager regarding if permission was obtained by tenant.
