Fire Risk Assessment

1-12 Davies house

Lodge street, Oldbury
B69 4JE

Date Completed: 14th August 2025

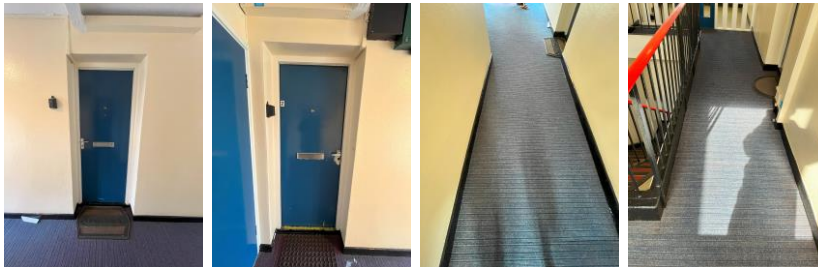
All floors have S.M.B.C. fitted carpet. Due to the fact SMBC specified and managed the installation of the carpets, they are in accordance with BS EN 13501-1.

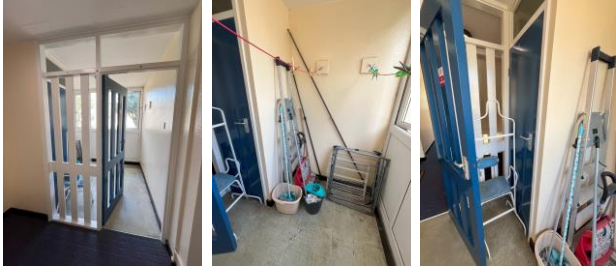
- 12) The former drying area on block 1-6, on the 1st floor outside flat 3 has various items stored in it, these will need to be removed to discourage any future storage of items.**

07/12	Former drying area on block 1-6, on the 1 st floor outside flat 3 has various items stored in it,Need to be removed.

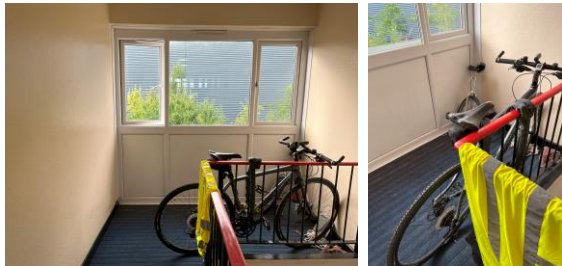
14)On the 2nd floor on block 1-6, there is a bike and other items stored at the end of the landing, these will need removing to discourage any future storage of items.

P2	1-3 Months Housing Team	
07/14	2 nd floor on block 1-6, there is a bike and other items stored at the end of the landing. Need removing

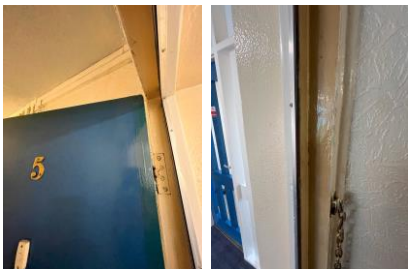
6) Flat 5 has no door closure fitted, there is also no smoke seals on the door or the door frame.

10/6	Flat 5 has no door closure fitted, no smoke seals on the door or the door frame. Needs fitting.

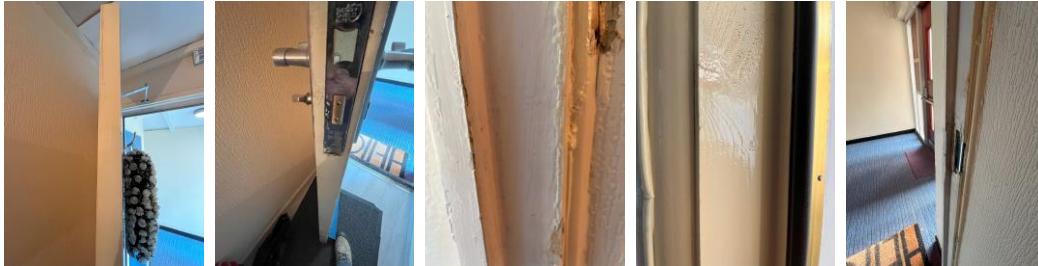
- 7) Flat 7 has no smoke seals on the door or the door frame. No evidence of intumescent seals.**

P2	1-3 Months Fire Rapids Response	
10/7	Flat 7 has no smoke seals on the door or the door frame. No evidence of intumescent seals. Needs Fitting

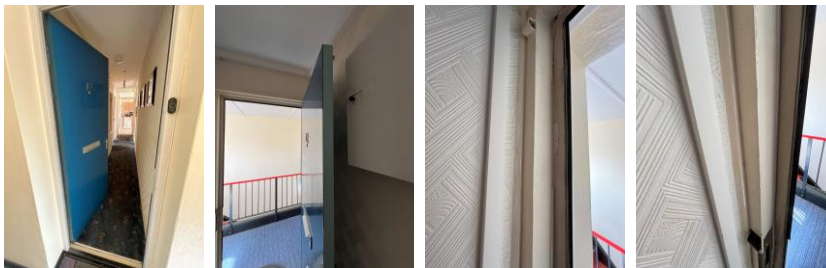
- 9) Flat 12 has no door closure, it's a notional door, no smoke seals, no intumescent strips.**

10/8	Flat 12 has no door closure, it's a notional door, no smoke seals, no intumescent strips. Needs fitting.

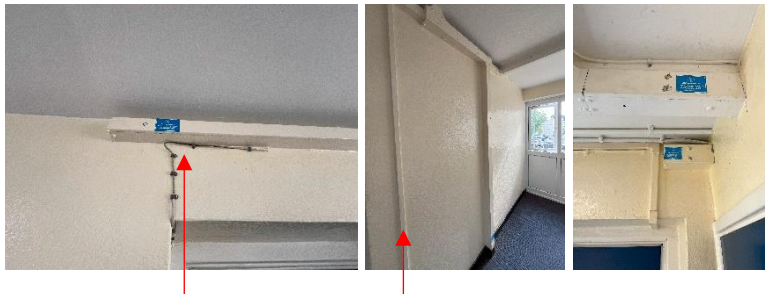
Metal Electrical Trunking

- 9) All electrical cabling feeding supply from electrical risers to residents' flats and other units within the communal areas are channelled through secure metal box trunking that is securely install across the upper walls and ceilings. All electrical trunking is protected by Envirograf Intumescent Pillows or Pads.

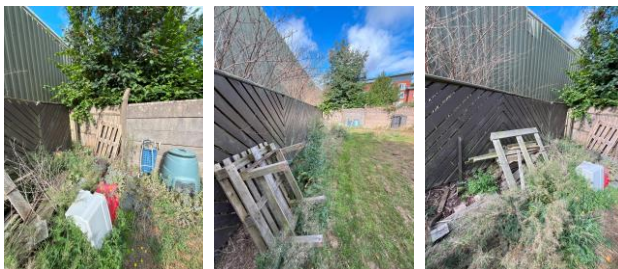
- 4) Was noted that there are discarded timber pallets and plastic containers left to the rear of the building.**

P2	1-3 Months Fire Rapid Response	
15/4	Discarded timber pallets and plastic containers left to the rear of the building. Need to be removed.

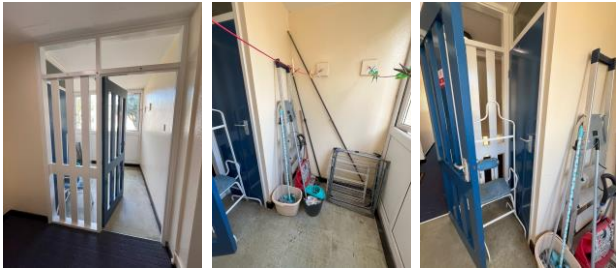
- 6) **The former drying area on block 1-6, on the 1st floor outside flat 3 has various items stored in it, these will need to be removed to discourage any future storage of items.**

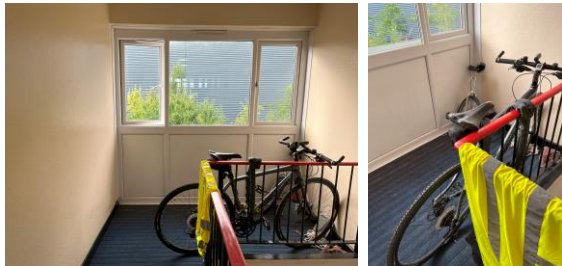
8)On the 2nd floor on block 1-6, there is a bike and other items stored at the end of the landing, these will need removing to discourage any future storage of items.
