# Fire Risk Assessment

**1-12 Parkes House  
Lodge Street,  
Oldbury,  
B69 4JE.**

**Date Completed: 14/08/2025**

**Current Risk Rating = Tolerable**

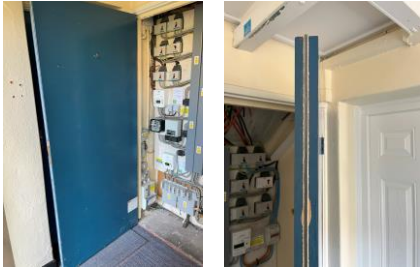
- 5) Service cupboards on ground floor containing residents' meters are notional timber fire doors with upgraded smoke seals and intumescent strips and lockable with a 138 mortice lock.

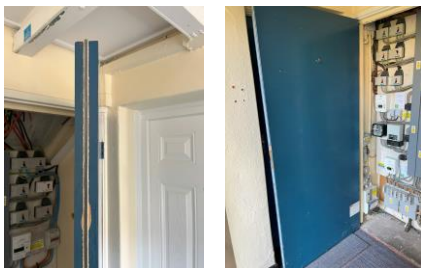
- 6) All Residents service cupboards on each floor are housed behind a notional upgraded FD30s fire rated doors. All cupboards are free from any combustibles.

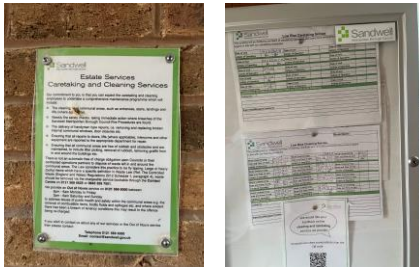
- 3) Regular checks by Caretakers minimise risk of waste accumulation.

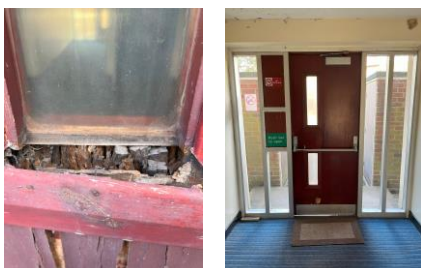
- 5) There have been no reported fire incidents since the last FRA.
- 6) The rear exit door of block 7-12 is rotting and the external glazing could be removed to access internal push bar; this would allow easy access to block. This requires a repair to or a replacement door. Email has been sent to repairs.

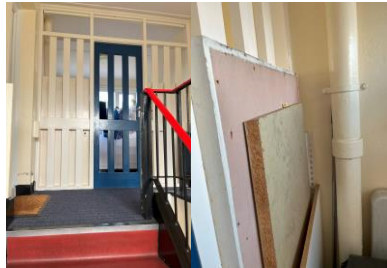
- 10) In block no's 7-12 the drying room on the third floor has been blocked up using old timber doors to block the vision so it can be used for storage. Removal of doors blocking panels due to being flammable, also removal of stored items as this area is a drying room. See Action 7/10.

P3	3-6 Months Fire Rapid Response	
7/10	In block no's 7-12 the drying room on the third floor has been blocked up using old timber doors to block the vision so it can be used for storage. Removal of doors blocking panels due to being flammable, also removal of stored items as this area is a drying room.

P3	3-6 Months Housing Manager

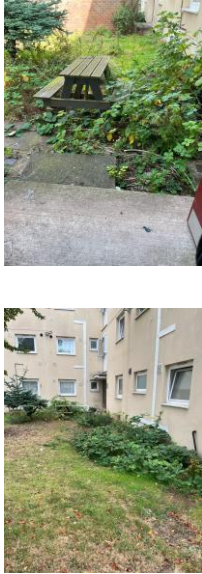
- 17) At the rear exit of flat 7-12 the exit route is overgrown. This requires clearing to provide a clear exit route with no trip hazards. See Action 7/17.**

P3	3-6 Months Fire Rapid Response	
7/17	At the rear exit of flat 7-12 the exit route is overgrown. This requires clearing to provide a clear exit route with no trip hazards.

P3	3-6 Months Housing Manager
