Fire Risk Assessment

1-6, 7-12

Jackson House,
Oldbury,
B69 4JG

Date Completed: 05/09/2025

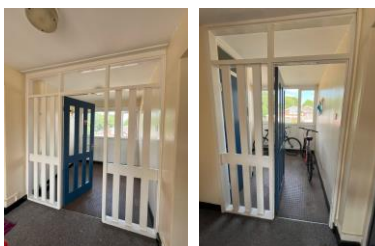
Each landing features a secured drying room, accessible only with a key, intended for drying clothes; some of these areas are also being used for storage.

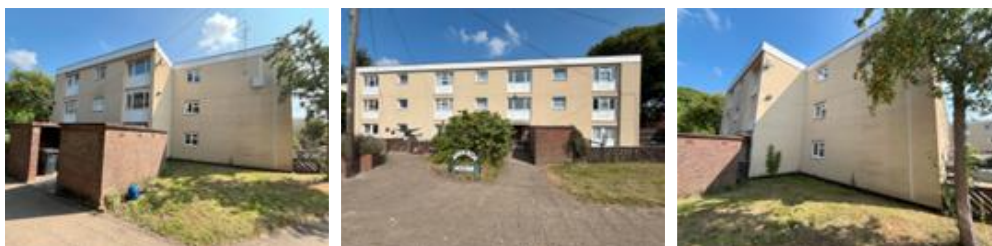
- 1) The external surface of the building is External Wall Insulation (EWI) systems with a silicone render. The roof is flat roof, new roof installed January 2010.

- 2) **The building currently has several areas of damaged render that require repair to maintain fire safety standards. Recommend a joint visit with the repairs team and Fire Risk Assessor to identify areas. Also, to carry out a review of the fire risk assessment every 12 months.**

Question/ Ref No	Required Action	Supporting photograph	Priority	Timescale and Person Responsible	Date Completed
6/2	Repair several areas of damaged render to maintain fire safety standards. Recommend a joint visit with the repairs team and Fire Risk Assessor to identify areas.

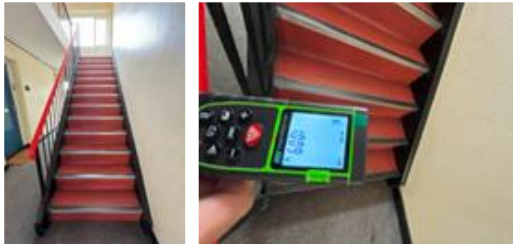
- 1) Each floor is accessed via a single staircase that provides a means of escape and has a width of 1 metre.

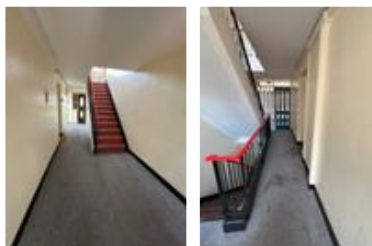
- 2) Corridors are at least 1050mm in width and are kept clear.

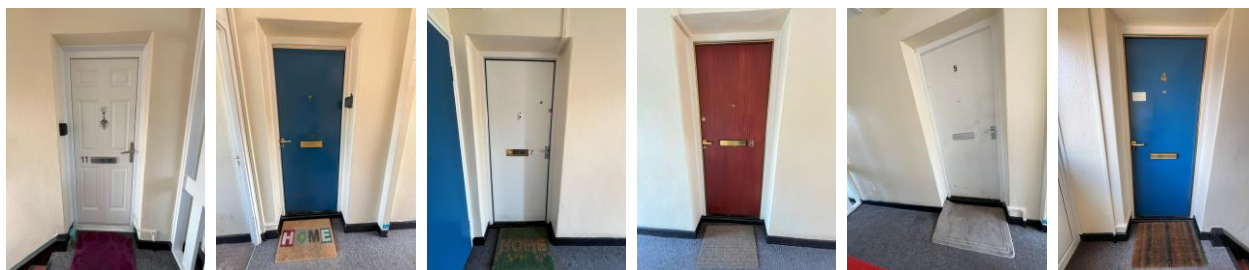
- 7) A number of flats have door mats present at the entrances; the fire rating is not known on these door mats, and these are deemed to be low risk.

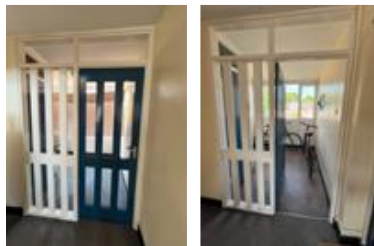
- 9) Drying areas: These areas are for drying clothes only and NOT for storing items, they are situated off the landings on each floor. The door and frame are timber structure with open panels to allow ventilation for the drying of washing also in times to assist in building ventilation. Within this area is a locked cupboard only accessible by SMBC staff. Letter has been sent out to residents to remind them that the areas are for drying of laundry only 27/08/2025.

- Some drying areas are being used as storage areas and left open

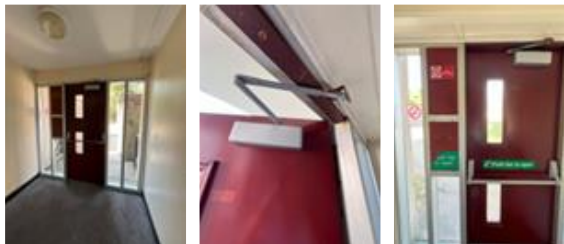
- 12) The front and rear final exit doors are push-bar operated from inside the building, they are also fitted with automatic closing devices. These are checked on a regular basis by Caretaking Teams as part of their checks. Defective closing devices are replaced either by the Caretaking Team(s) or the in-house repairs team(s).

- 13) Glazing on the side panel of front entrance door to block 7-12, cracked and requires replacing.

P3	Within 3-6 months Fire Rapid Response	
7/13	Side panel of door requires glazing due to cracked glass

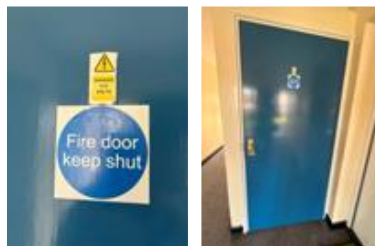
- 1) Fire door keep shut signs are displayed where appropriate. All meter cupboards should display “Fire Door Keep Locked” signage. **Fire Door Keep Locked signage required to replace existing service cupboard signage ‘Fire door keep shut’**

12/1	Replace existing service cupboard signage 'Fire door keep shut' with 'Fire Door Keep Locked'
