Fire Risk Assessment

2 - 26

**Underhill Street,
Oldbury,
B69 4SJ**

Date Completed: 15/09/2025

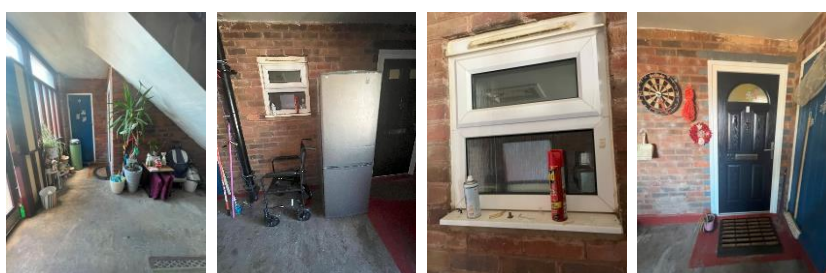
- 8) Within block 2-12 a number of flammable items and trip hazards were being kept within the communal areas.
- a) **Outside flat 6 and under the stairway, flammable items i.e. waste bin, cushions etc are being kept along with plant pots including plants. These items need to be removed from the common area.**
 - b) **On the 1st floor, outside flats 8, 10, and 12 a number of items are being stored i.e. aerosol, fridge freezer, wheelchair etc. These items need to be removed from the common area.**

7/8b	Block 2-12 first floor remove items on the landing ie fridge freezer, wheel chair etc

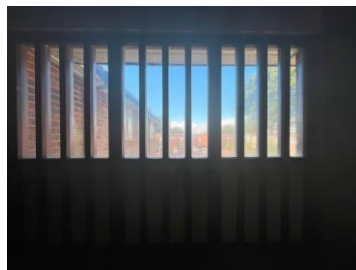
- 10) There is no ventilation given within the communal areas. This is something to be looked at being added with future refurbishment programs.
-

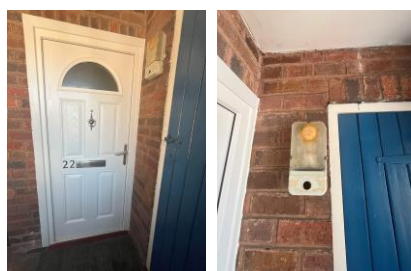
- 13) Light unit fitted to the wall outside flat number 22 has heat damage. It is required to remove the light from the wall and notify resident.**

7/13	Remove light unit. Heat damage to light outside flat 22.

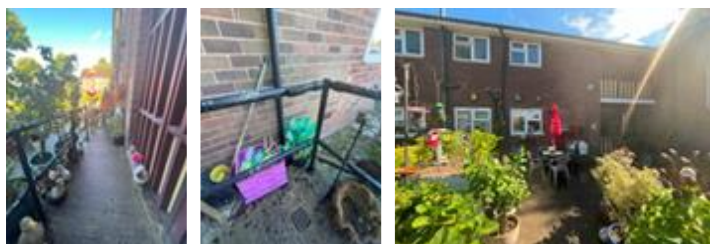
- 14) A number of garden items are being kept upon the external rear exit ramp of block 2-12. These items are to be removed to keep the escape route clear and free of flammable items.**

12/2	Replace x4 smokefree England signage on the front and rear of both blocks (2-12 & 16-26)	 	P3	Within 3-6 months Fire Rapid Response	
7/14	Block 2-12: Relocate items from off and around the walkway to keep the escape route clear.	 	P2	Within 1-3 months Housing Manager

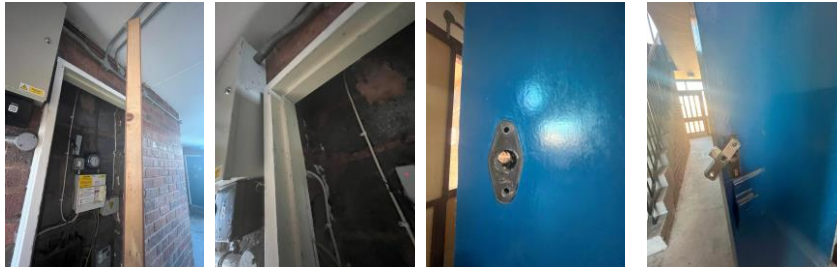
- a) **Service cupboard in block 2-12 requires fire stopping or replacement door due to hole where an old lock has been removed. Service cupboard door requires intumescent strips and smoke seals fitting.**
- b) **Service cupboard in block 16-26 requires replacement lock due to damage and the door not closing.**

P2	Within 1-3 months Electrical Team	
10/7a	Block 2-12: fire stop the hole in door with intumescent filler

P2	Within 1-3 months Fire Rapid Response	
10/7b	Block 16-26: Replace lock due to damage. Fit intumescent strips and smoke seal.

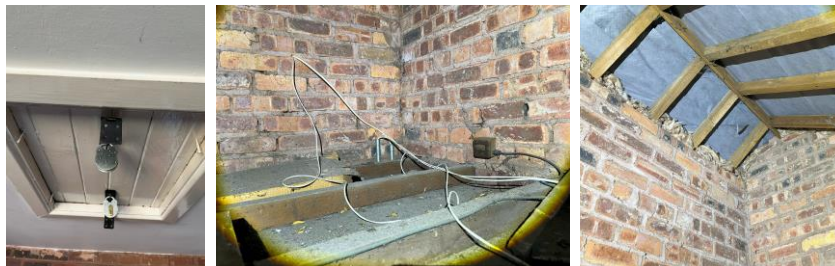
Within block 2-12 the screws had been removed from the hasp, leaving the loft accessible. The loft space was accessed and was clear at the time of the Fire Risk Assessment.

10/10	Block 2-12 1 st floor Replace hasp with the likes of screw eyes and lock to prevent removal, after screws have been removed from hasp.

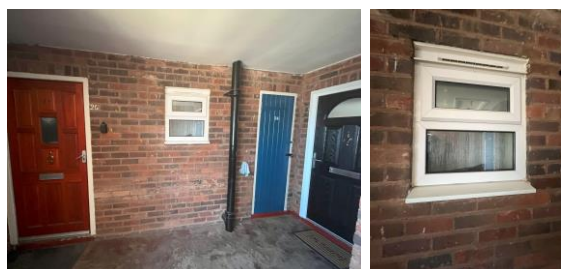
11) On each landing there is none-fire rated uPVC double glazed window from the flat to the communal area. This is low risk as it accesses the bathroom. It is recommended to replace to a fire rated unit in future refurbishments.

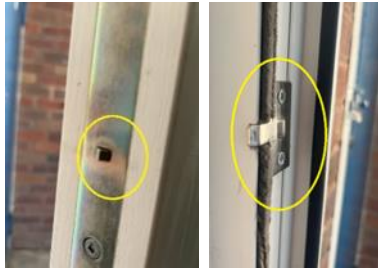
P2	Within 1-3 months Fire Rapid Response	
7/9b	Flat 16: Re-adjust door: Door bolt engages before closing. Trigger plate maybe bent
