# **Fire Risk Assessment**

## **Arden Grove**

**Arden Grove, Oldbury**  
**B69 4SU**

**Date Completed:** 1<sup>st</sup> September 2025

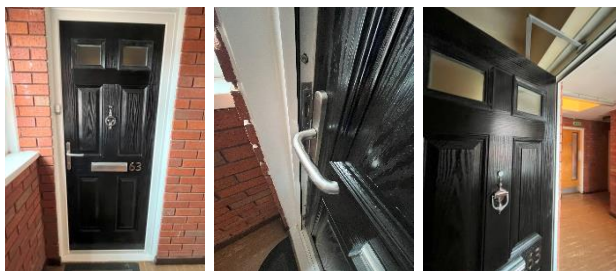
**6) Flat 63 was accessed for condition of door closure and smoke seals, from the recommended 15 degree door opening test, the door did not auto close into the frame, this will need to be adjusted. The smoke seals were intact.**

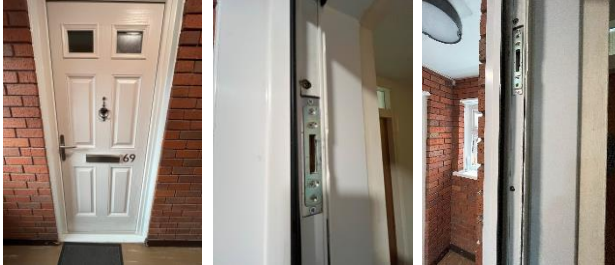
- 7) Flat 69 was accessed to check function of door closure and condition of smoke seals. Door closed as it should from the recommended 15-degree door closure test. Smoke seal is partly missing from door frame; door frame is also damaged partially.**

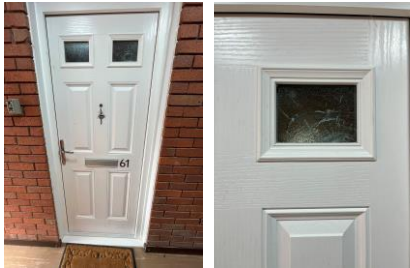
- 8) Flat 61 has a cracked pane of glass in the upper right-hand corner of the door.**

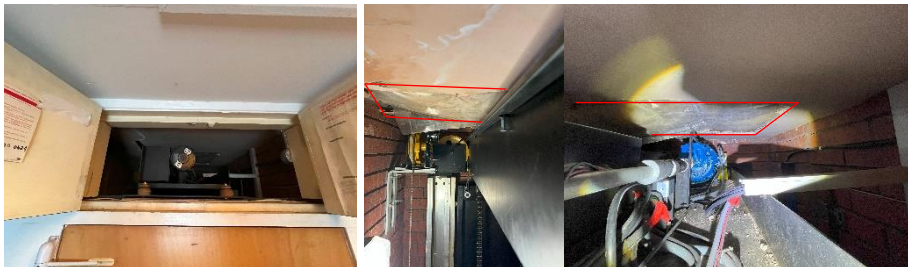
One area of noticeable concern will be within the lift motor shaft on the first floor. Compartmentation above the motor, electricals and mechanics is incomplete, no access could be gained due to the size of the area to check for adequate fire stopping above within the roof void. This will need further investigation.

- 9) Within the lift motor shaft on the first floor, there are sections of plasterboard that have been cut out over the motor, electrical cables and mechanical lift system, the size of this cut out is aproxiametly 1000mm x500mm, could not be for certain if there is rockwool above this section due to restricted access. As this building has a roof void this will require further investigation.**

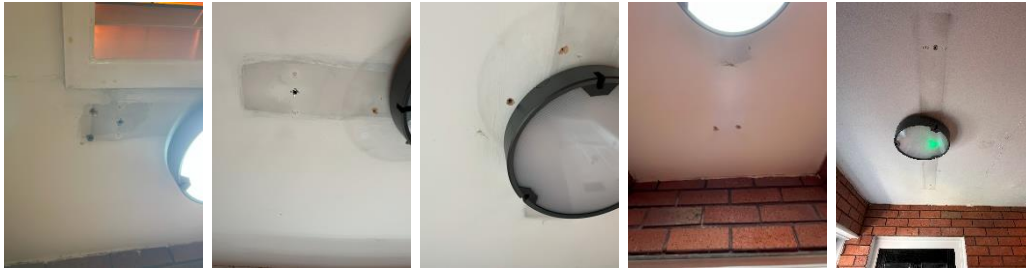
- 10) Throughout the building where previous lighting units were fitted to the ceiling; exposed screw holes need fire stopping.**

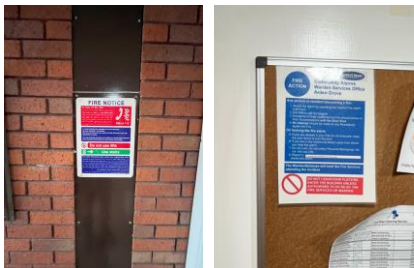
- 2) Fire Action Notices are not displayed throughout the building.

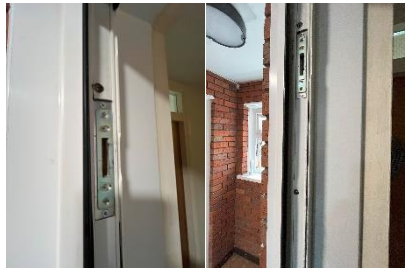
10/7	Flat 69 requires smoke seal fitted to part of frame, also frame needs assessing due to slight damage.

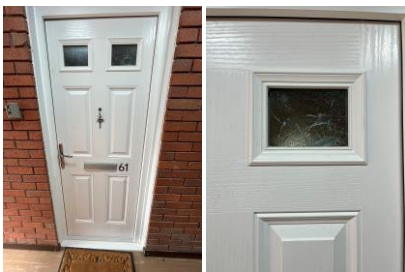
P2	1-3 Months Fire Rapids Response	
10/8	Flat 61 has a cracked pane of glass in the upper right-hand corner of the door. Glass needs replacing.

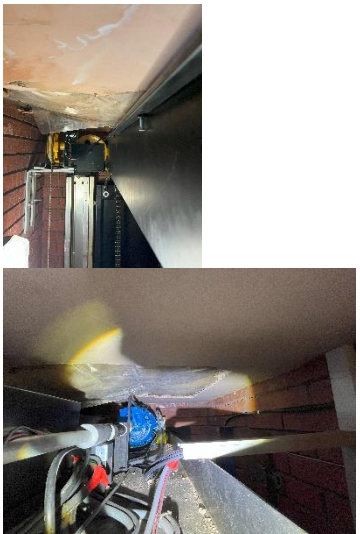
P2	1-3 Months Glazing/ Repairs	
10/9	Compartmentation above lift motor, electrical and mechanics is breached, needs further investigation into roof void for fire stopping.
