Fire Risk Assessment

**12 – 20 Langley High Street,
Oldbury.
B69 4SL.**

Date Completed: 10th September 2025

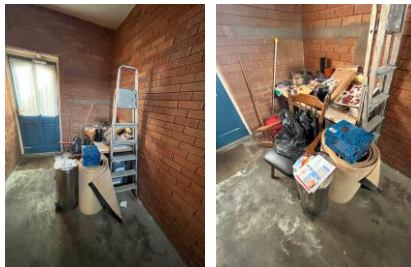
- 8) On the ground floor for flat 20, there are numerous amounts of combustibles stored in the at the bottom of the communal staircase.**

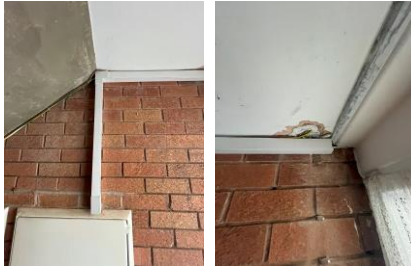
- 11) Ground floor for flats 12 -14 has plastic trunking installed on the ceiling and to the resident's electrical cupboard. This has been actioned in section 14, Source of Ignition

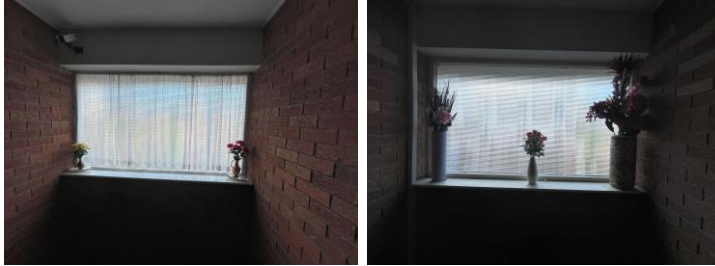
Flats 12,14 & 20

14)Both blocks have plastic flowers placed on the communal landing windowsills.

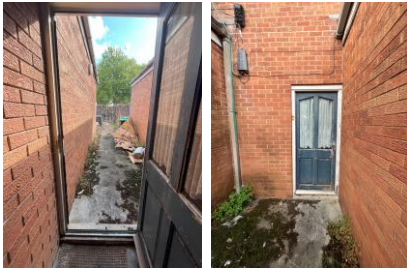
- 18) Rear exit pathway serving flat 20 is not clear of obstruction and ground is covered in moss.**

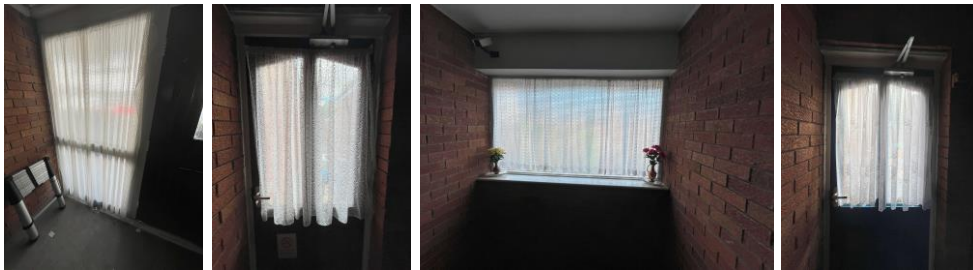
- 19) Flats 12,14,20 have netted curtains installed on the windows and both front and rear doors.**

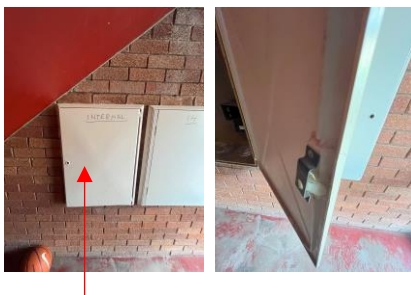
Internal electrical cupboard

- 9) Door lock damaged on the ground floor internal electrical cupboard for flats 12 -14.

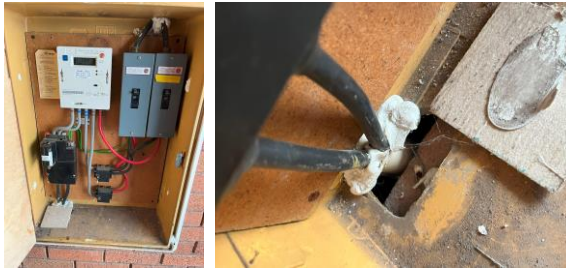
- 10) Acceptable fire stopping is needed in the electrical cupboard on the ground floor to flats 12 -14.

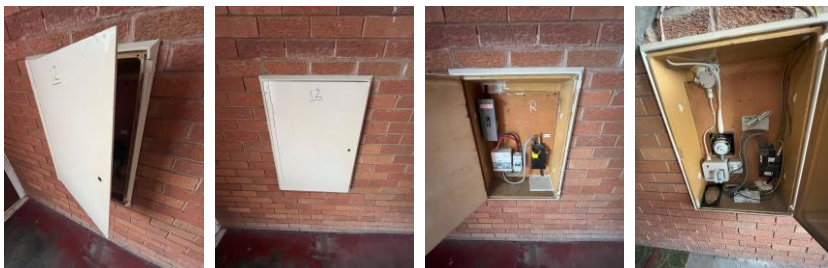
- 12 Recommended that all residents and landlord electrical cupboards are to be upgraded to fire rated units on any future renovation to the blocks.

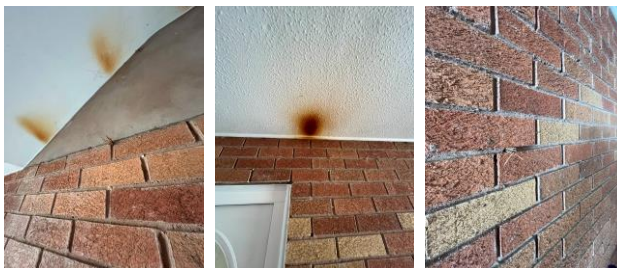
- 7) There is evidence of incense sticks being burnt in the common with burn marks left on the ceiling outside flat 20 and on the lower communal hallway.**

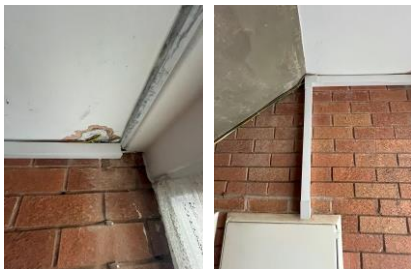
- 9) Ground floor serving 12 -14 has plastic trunking installed on the ceiling and to the resident's electrical cupboard.**

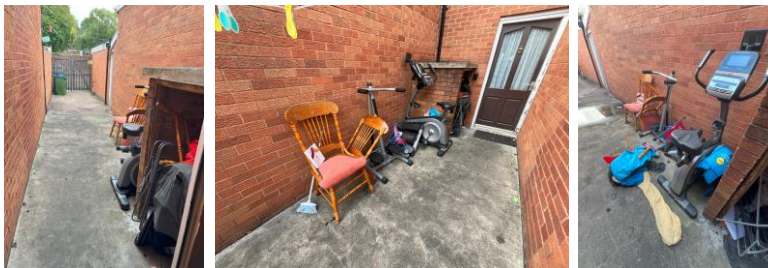
- 3) There is a collection of items left outside in the rear exit that serves 12 and 14.

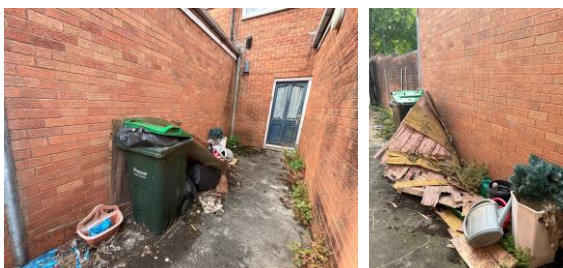
- 4) There is a discarded items left outside in the exit pathway that serves flat 20.

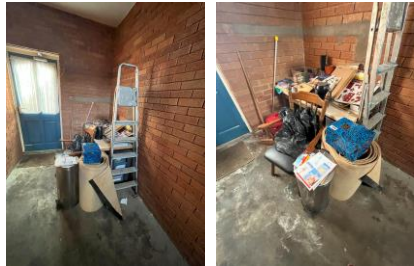
7/8	Block serving flat 20, ground floor communal hallways near stairs has numerous amount of items stored. Need removing.

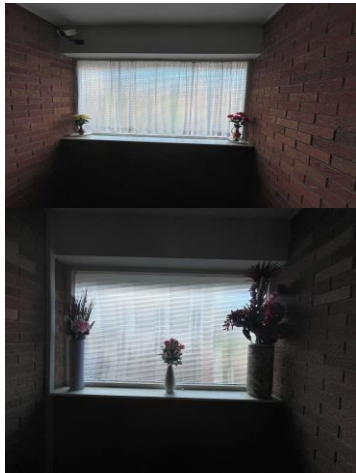
P2	1-3 Months Housing Team	
7/14	Both blocks have plastic flowers placed on the communal landing windowsills. Need removing.

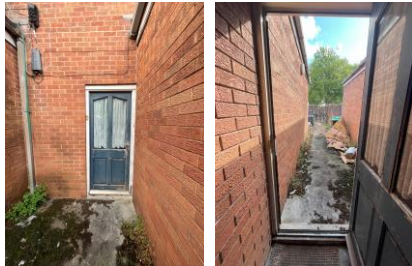
P2	1 -3 Months Housing Team	
7/18	Block serving flat 20, rear exit pathway is not clear of obstruction and ground is covered in moss. Needs clearing.

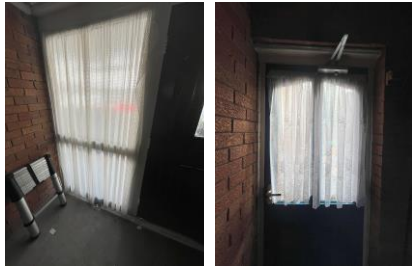
7/19	Both blocks have netted curtains installed on the windows and both front and rear doors. Needs removing.

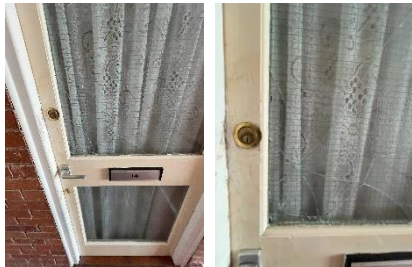
P2	1-3 Months Caretaking Team	
10/6	Flat 14 is a notional timber door, Georgian wired glass, glass is cracked on the upper pane. Door needs replacing.

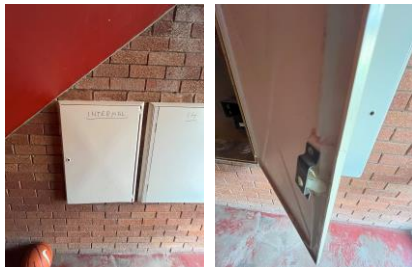
P2	1-3 Months Leaseholder Management	
10/9	Door lock damaged on the ground floor internal electrical cupboard on block serving flats 12 -14. Needs repair.

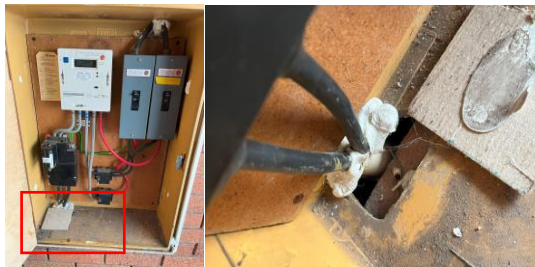
P2	1-3 Months Fire Rapid Response	
10/10	Fire stopping is needed in the electrical cupboard on the ground floor to block serving flats 12 -14.

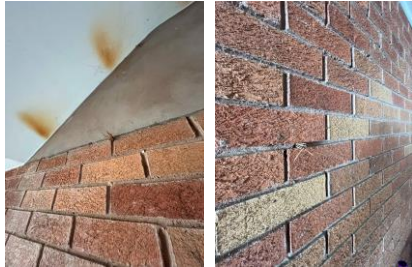
P2	1-3 Months Fire Rapid Response	
14/7	Incense sticks being burnt in the common with burn marks left on the ceiling outside flat 20 and on the ground communal hallway.

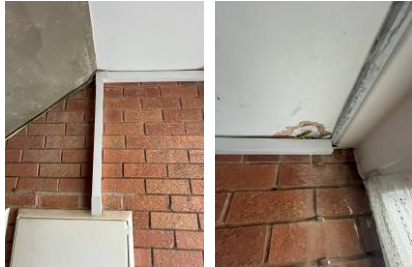
P2	1-3 Months Electrical Team	
14/9	Ground floor on block serving 12 -14 has plastic trunking installed on the ceiling and to the resident's electrical cupboard. Need to replace with metal trunking.

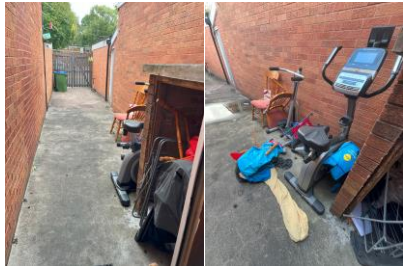
15/1	There is no evidence of any cleaning services attending to the blocks.		P2	1-3 Months Estate Services	
15/3	Collection of items left outside in the rear exit pathway at block serving flats 12 and 14. Need removing.

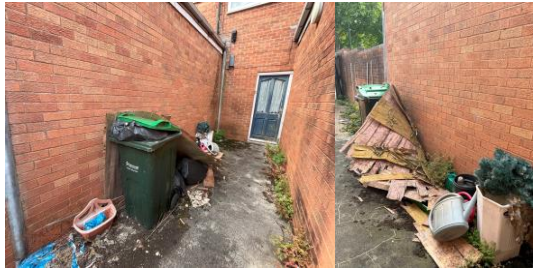
P2	1-3 Months Caretaking Team	
15/4	Discarded items left outside in the exit pathway at block serving flat 20. Need removing.

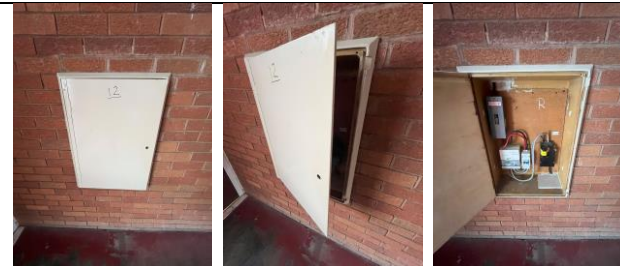
Recommendation for in wall electrical cupboards to be replaced with secure fire rated units on any future refurb of the blocks.
