# Fire Risk Assessment

**30 – 52**

**Groveland Road,  
Tipton,  
DY4 7TN**

**Date Completed: 01/10/2025**

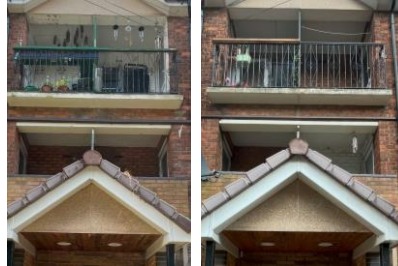
- 3) The flats on the first and second floors each have a small, front-facing balcony. The first-floor balconies are enclosed with a brick-built wall, while those on the second floor are fitted with iron railings.

Some of these balconies have various items stored on them. Due to the low risk these will be ok to stay in place.

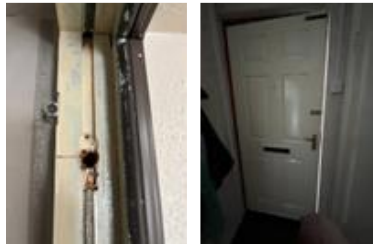
b) **Flat 46: Frame requires a new intumescent strip and smoke seal due to damage. Also, fire stopping required within the hole in the frame.**

| 7/3b | Flat 46: Replace missing intumescent strip and fire stop hole | | P2 | Within 1-3 months<br>Fire Rapid Response | |

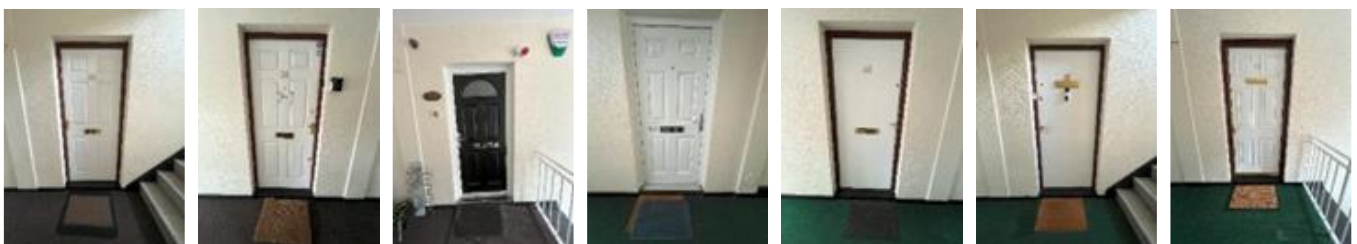
6) **At a number of flat entrances door mats are present; the fire rating is not known on these door mats and are deemed to be low risk.**

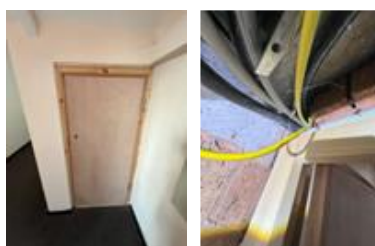
- a) **Within block 30-40 the service cupboard requires fire stopping where the cables run through to trunking.**

| 10/6a | Block 30-40: Fire stop around cables in service cupboard. | | P2 | Within 1-3 months<br>Fire Rapid Response | |

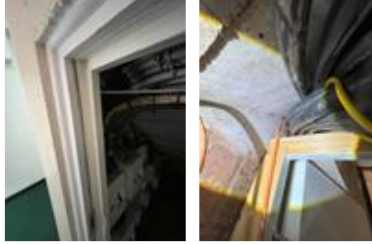
- b) Within block 42-52 the service cupboard requires fire stopping where the cables run through to trunking.**

| 10/6b | Block 42-52: Fire stop around the cables within the service cupboard | | P2 | Within 1-3 months<br>Fire Rapid Response | |

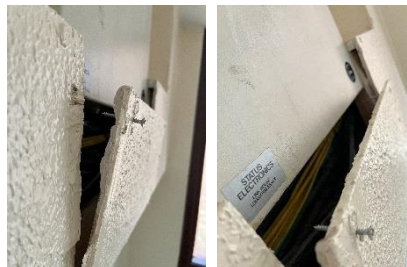
- 9) In block 42-52, beneath the door entry system mains box, the casing around the cables requires repair as the front panel is hanging loose, leaving the cables inside exposed.**

| 10/9 | Block 42-52: Repair boxing around cables. Under the rear door entry system box. | | P2 | Within 1-3 months<br>Fire Rapid Response | |

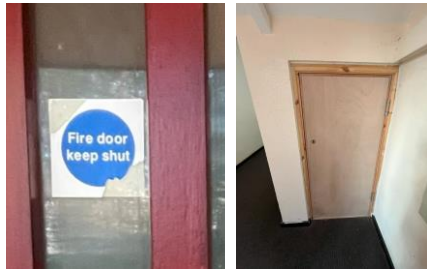
- 1) Fire door keep shut signs are displayed on the entrance and exit doors. The service cupboards should display “Fire Door Keep locked” Due to door upgrades no signage is being displayed at the time of the fire risk assessment.

- a) **Block 30-40: Fit ‘Fire Door Keep Locked’ signage.**  
b) **Block 42-52: Fit ‘Fire Door Keep Locked’ signage.**

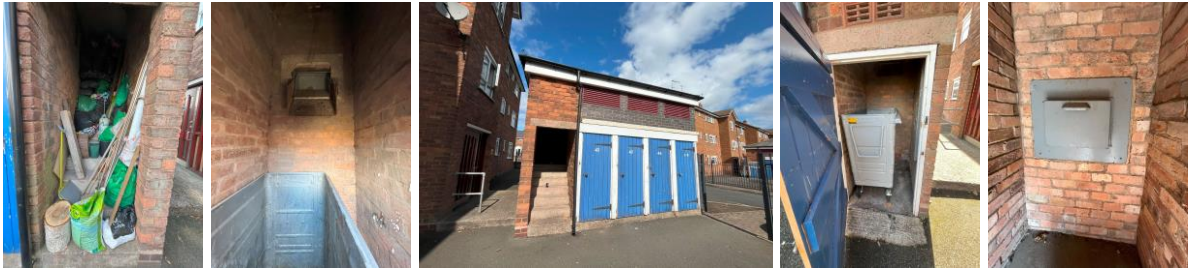
Block 42–52, the chute is currently inaccessible due to numerous items being stored on the steps leading to it. Email sent to the housing manager on the 09/10/2025 to investigate and look to get items relocated. *Resolved*
