# Fire Risk Assessment

**13-18**

**Willow Close,  
Cradley Heath,  
B64 6EG**

**Date Completed: 10/10/2025**

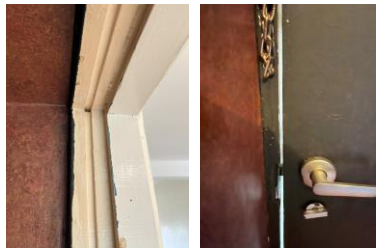
- c) Flat 17: Smoke seal and intumescent strip required within the frame. Check gap around the door as gap was large at the time of visit**

| 7/5c | Flat 17: Smoke seal and intumescent strip required within the frame. Check gap around the door as gap was large at the time of visit | | P2 | Within 1-3 months<br>Fire Rapid Response | |

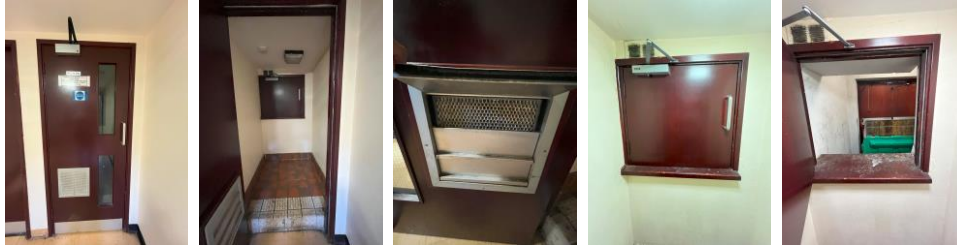
- 7) Bin chute room is fitted with 2 FD30s doors on the communal side of the block. There is a full-size door which also has installed within it an intumescent vent. After this door is a small hatch door, both doors are fitted with self-closers.

| 10/6 | Bin chute room refix the ceiling board and fire stopping required | | P2 | Within 1-3 months<br>Fire Rapid Response | |

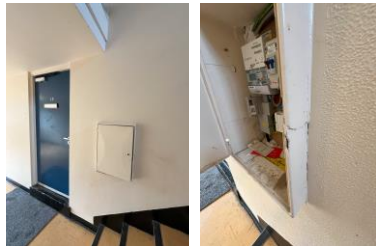
**a) Electric meter overbox outside flat 15 requires replacing or fire stopping due to damage to the case**

| 10/11a | Electric meter overbox outside flat 15 requires replacing or fire stopping due to damage to the case | | P3 | Within 3-6 months<br>Electrical | |

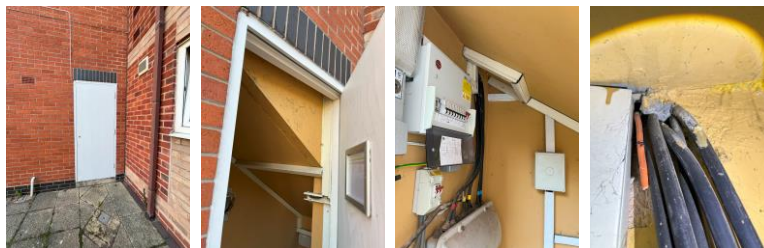
- 12) At the rear of the premises in the courtyard the service cupboard is located. This cupboard is locked with a 054 lock, and the door is an FD30s. **Fire stopping required within this cupboard where the cables pass through the structure.** Fire Door Keep Locked signage required on the door, see section 12

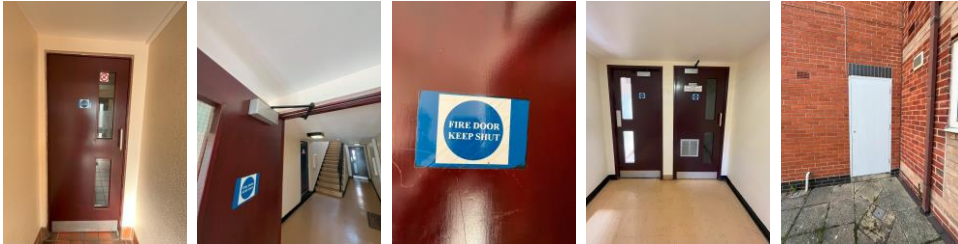
- 1) 'Fire door keep shut' signs are displayed on the entrance and exit doors.  
**The service cupboard requires "Fire Door Keep locked" fitted**

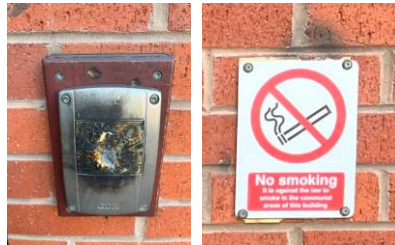
- 1) Regular checks are undertaken by Caretakers / Cleaning Team(s) 365 days per year which helps reduce the risk of arson.
- 2) Restricted access to the premises by means of a key and door entry system to the front and the rear.
- 3) There is evidence of arson at the rear of premise. **The fob reader has been set on fire and small amount of burning around the 'No smoking' signage at the rear door. Replace the fob unit**

| 17/3 | Replace fob reader at the rear of the premises, damage due to arson | | P3 | Within 3-6 months<br>CCTV | |
