# Fire Risk Assessment

**2 -24**

**Monk Close,**

**Date Completed: 06/10/2025**

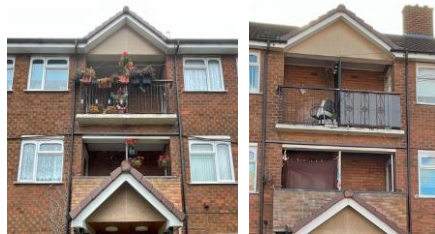
- 3) The flats on the first and second floors each have a small, front-facing balcony. The first-floor balconies are enclosed with a brick-built wall, while those on the second floor are fitted with iron railings.

Some of these balconies have various items stored on them. Due to the low risk these will be ok to stay in place.

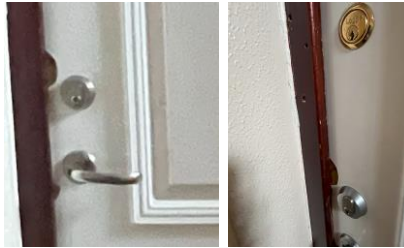
- a) Flat 4: Damage to door around lock and handle. Firestop area or replace door**

| Question/<br>Ref No | Required Action | Supporting photograph | Priority | Timescale<br>and Person<br>Responsible | Date<br>Completed |
|---|---|---|---|---|---|
| 7/4a | Flat 4: Damage to door around lock and handle. Firestop area or replace door | | P2 | Within 1-3<br>months<br>Fire Rapid<br>Response | |

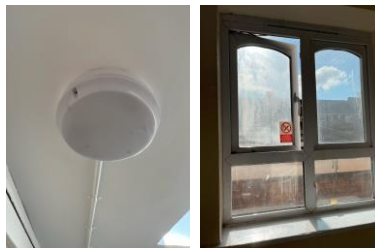
- 15) No emergency lighting is provided to communal landings and stairs.  
[\(Refer to section 9\)](#) It is recommended that emergency lighting is added as required under 3.41 of Approved Document B Volume 1. This will be added to observations to be added to future improvement programs. Landing windows and standard lighting units are the only supply light at the present time.

- 1) These premises have no emergency lighting. It is recommended that emergency lighting is added as required under 3.41 of Approved Document B Volume 1, page 35.

**3.41** Except for two storey blocks of flats, all escape routes should have adequate artificial lighting. If the mains electricity power supply fails, escape lighting should illuminate the route (including external escape routes).

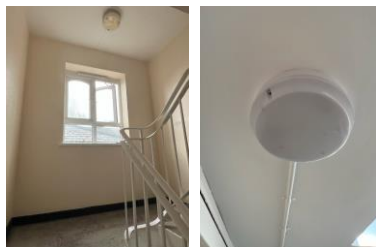
- 3) First floor – block 14-24 light unit is cracked. Temporary repair made using a sticky plastic sheet. Replace the light unit due to damage and unit being discoloured causing lack of light.

| 9/3 | Replace the light unit due to damage and unit discoloured. | | P2 | Within 1-3 months<br>Electrical | |

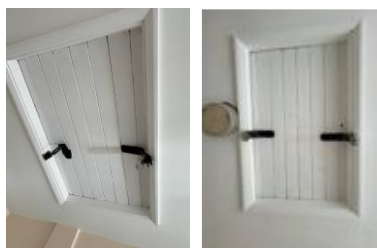
**The loft hatch in block 14-24 requires a new padlock due to one missing at the time of the Fire Risk Assessment.**

| 10/8 | Replace missing lock from loft hatch in block 14-24 | | P2 | Within 1-3 months<br>Fire Rapid Response | |
