# **Fire Risk Assessment**

## **Church Court**

**Church Street,  
Cradley Heath, B64 6DS**

**Date Completed: 1st October 2025**

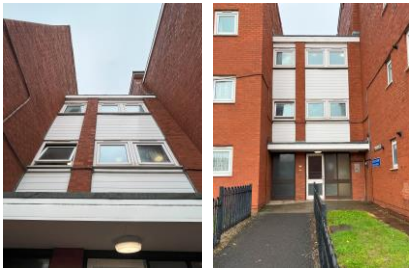
- 4) On the front elevation of the building, there are UPVC cladding installed under the UPVC window units above the front entrances, these window units are part of the communal staircase landing.

Front UPVC cladding under the window units.

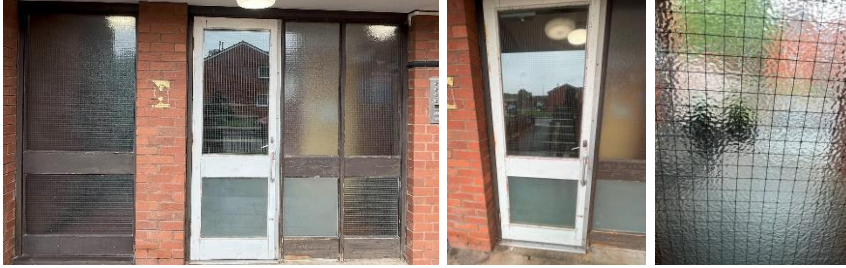
- 6) The front & rear entrance are of a timber frame construction with Georgian wired glazing within the inserts to the frames on either side of the doors.

Timber constructed doors and Georgian wired glass

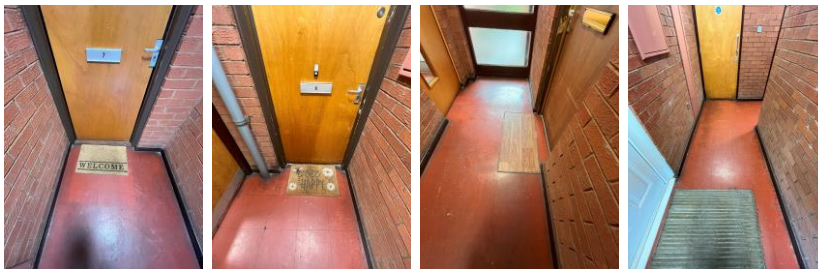
- 1) Each flat is equipped with, as a minimum LD3 fire detection to facilitate means of escape and provide sufficient response time.
- 2) All communal hallway floors are covered in vinyl type of floor tile, residents of flats have various types of door mats placed in front of entrances, the fire rating is not known for the door mats.

Various type of mats and floor coverings.

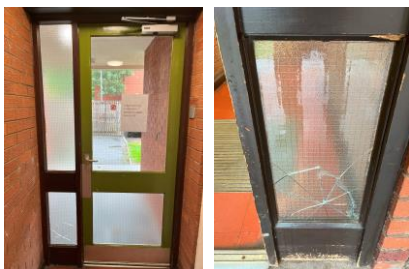
**13) Rear final exit on block serving flats 5 – 8 near flat 5, has a cracked pane of glass.**

| Question/<br>Ref No | Required Action | Supporting photograph | Priority | Timescale<br>and Person<br>Responsible | Date<br>Completed |
|---|---|---|---|---|---|
| 7/13 | Rear final exit on flats 5 – 8 near flat 5, has a cracked glazing. Needs replacing. | | P3 | 3-6<br>Months<br>Repairs/Glazing | |

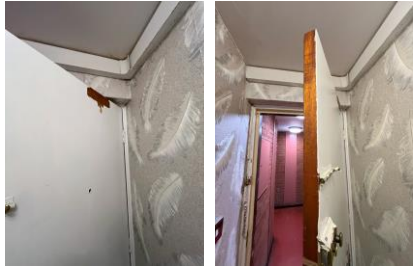
**6) Flat 8 has no self-closing device fitted.**

| 10/6 | Flat 8 has no door closure, needs door closure fitted. | | P2 | 1-3 Months Fire Rapids Response | |

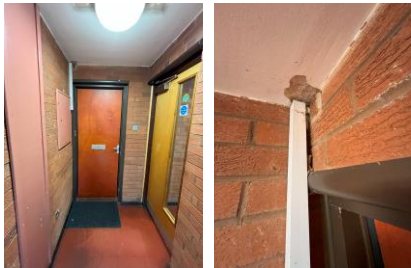
- 9) On Flats 1-4,9-12,18-21, near flat 2, there is a length of plastic trunking that requires some fire stopping to the rear of it.

| 10/9 | On flats 1-4, 9-12, 18-21, near flat 2, there is a length of plastic trunking that requires some fire stopping to the rear of it. | | P2 | 1-3 Months Fire Rapid Response | |
