# Fire Risk Assessment

**1 – 6 Willow Close  
Cradley Heath,  
B64 6LJ**

**Date Completed: 6<sup>th</sup> October 2025**

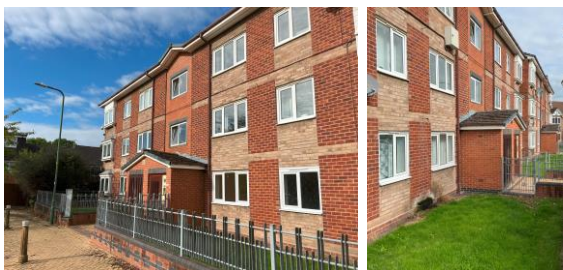
Front Elevation

- 1) The exterior of the building is predominately traditional brick construction with a pitched roof design with UPVC fascia boards to the roof line and concrete roof tiles above. Front entrance is through a brick-built porch with a pitched roof, there are UPVC Dry Verge end caps and UPVC fascias and drainage attached.

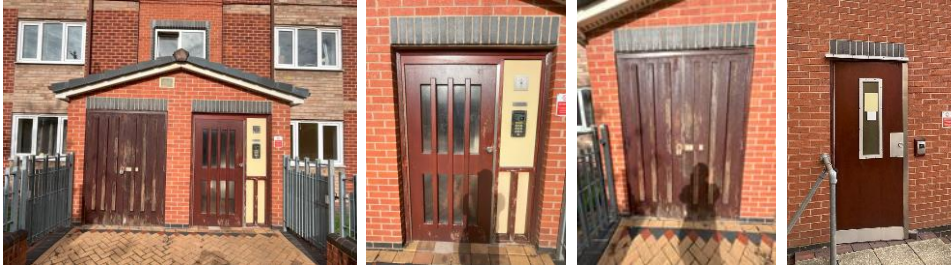
- 2) Both front and rear doors are of timber construction, glazing within the inserts and Spandrel panelling to the side on the front door. The rear door has a single pane of glazing with aluminium trim on the door. On the front elevation next to the front entrance there is a set of timber doors that house the refuse bins for the residents.

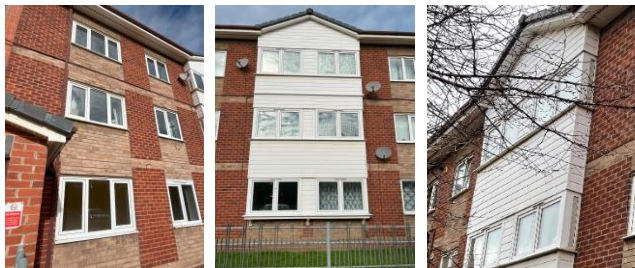
- 3) UPVC double glazed window units have been installed for each flat and communal areas within the block, there is also UPVC cladding on the front elevation of the building which extends from the ground to the 2<sup>nd</sup> floor. This has been previously recommended to be upgraded as part of any future works program.

UPVC window units and section of UPVC Shiplap cladding to the front that is shared between flats 1- 6 & 7-12

It is recommended that the UPVC cladding be considered for removal on any future renovation to the building.

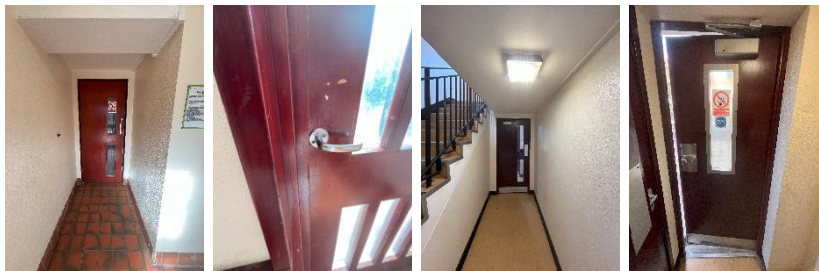
- 9) There is a communal fire door that separates both the front and rear final exit doors from the communal area. These doors are checked on regular bases by the Caretaking Teams as part of their checks. Defective closing devices are replaced either by the Caretaking Team(s) or the in-house repairs team(s).

Communal doors before front and rear final exits doors.

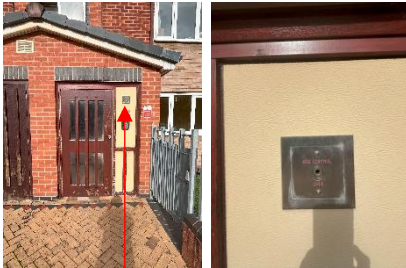
- 11) Firefighters override switch will not access the building. An email has been sent to CCTV team on the 08/10/2025 and again on the 13/10/2025. This has now been logged with a contractor.

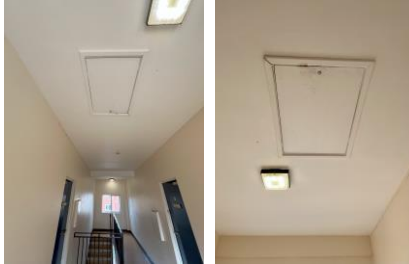
- 4) On the second floor there is a roof hatch, on the day of the FRA, it was not possible to access this hatch to inspect the compartmentation and any fire stopping within the roof void. It's recommended that this FRA is reviewed once access arrangements have been made available.

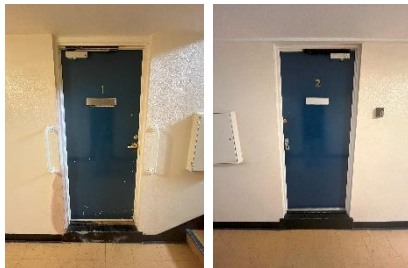
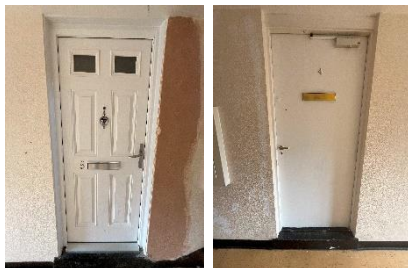
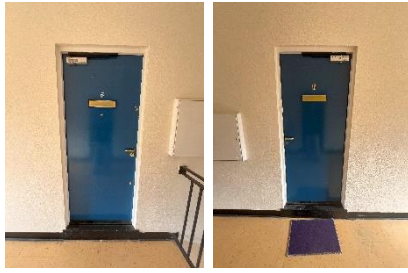
- 5) All individual flats are installed with notional FD30s rated timber doors excluding flat number 3, which has a composite glazed fire rated door. It has been recommended that on the next refurbishment to the building that the FD30s timber doors be upgraded to FD30s certified fire rated doors.

It is recommended that for future renovations of the block that the notional FD30 timber fire doors be replaced with FD30s certified fire rated doors.

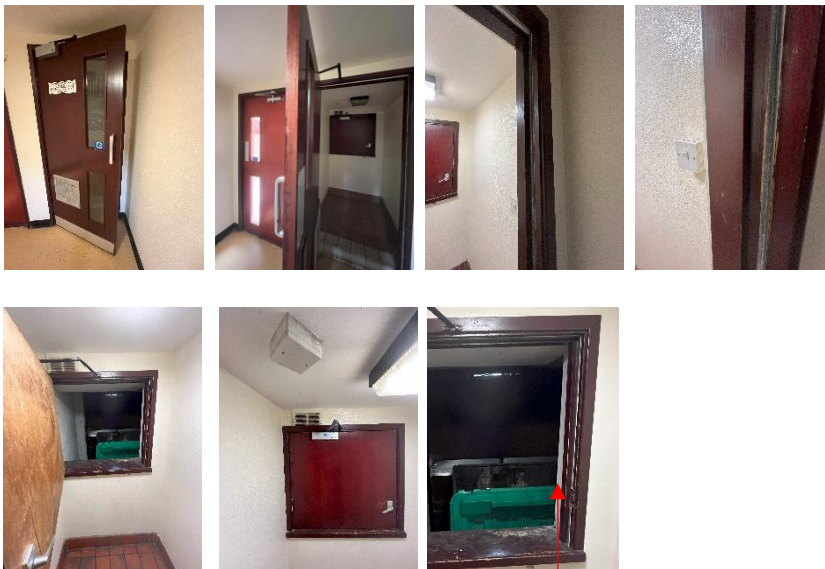
6)The building has sufficient compartmentation between refuse bin room and the communal hallway, this is done by a means of a FD30s timber fire door which has a self-closing device fitted, the refuse bin hatch is also a fitted with a timber fire door with intumescent strips, these were checked for any damage, no issues were found.

Bin store enclosure and smoke seals.

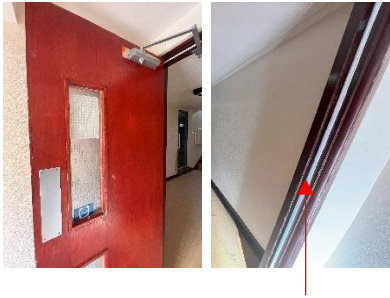
7)Additional FD30s timber fire doors with self closing devices and intumscent seals have been installed seperating the final exit doors from the communal areas.

Fd30s and intumscent strip

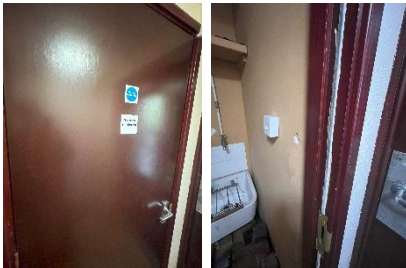
- 8) Cleaners storage cupboard on the ground floor is installed with timber FD30s fire door with combination intumscent and smoke seals. This door is locked by a 54 morice key and only held by authorised staff.

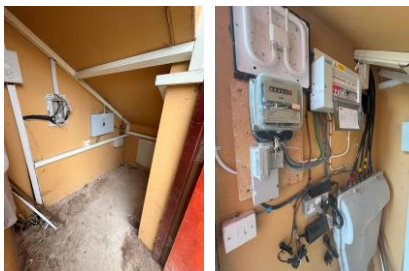
- 7) Electrical service cupboard on the ground floor which is located externally on the rear of the building is secured behind a FD30s fire rated door. Cupboard is free from any combustibles.

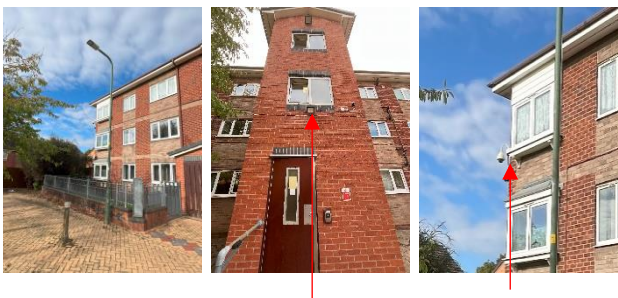
- 3) There is no current evidence of arson.
- 4) The perimeter of the premises is well illuminated. The front does not have any externally lighting installed to the building, however there is sufficient illumination by means of the street lighting. There is also a CCTV camera that is monitored by concierge staff.

Street lighting, rear external lighting & CCTV
