# Fire Risk Assessment

## Trinity Court

Church Street,  
Cradley Heath, B64 6DS

**Date Completed:** 3<sup>rd</sup> October 2025

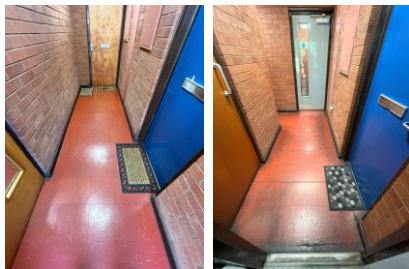
- 1) Each flat is equipped with, as a minimum LD3 fire detection to facilitate means of escape and provide sufficient response time.
- 2) All communal hallway floors are covered in vinyl type of floor tile, residents of flats have various types of door mats placed in front of entrances, the fire rating is not known for these door mats.

Various type of mats and floor coverings.

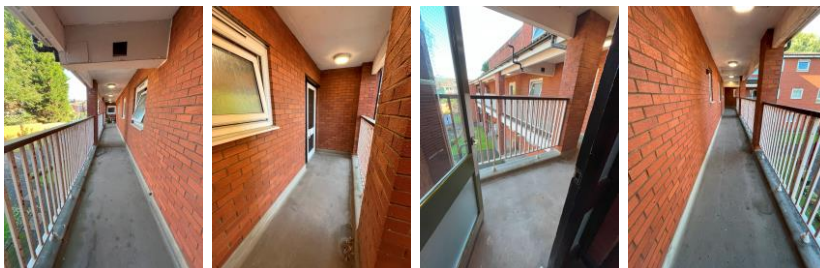
- 7) On the open deck access landing, residents have set up a seating area that includes a bench, a table, and a medium-sized outdoor rug. A couple of bicycles are also stored among these items; however, they do not obstruct the means of escape onto the access route. It is recommended that this area be regularly monitored to prevent the accumulation of additional items and to ensure the escape route always remains clear.

On the landing part of the open deck access, residents have placed a bench and table, at present it does not pose a significant risk. It is recommended that this area is to be monitored to keep items at a minimum and kept clear of access on to the deck.

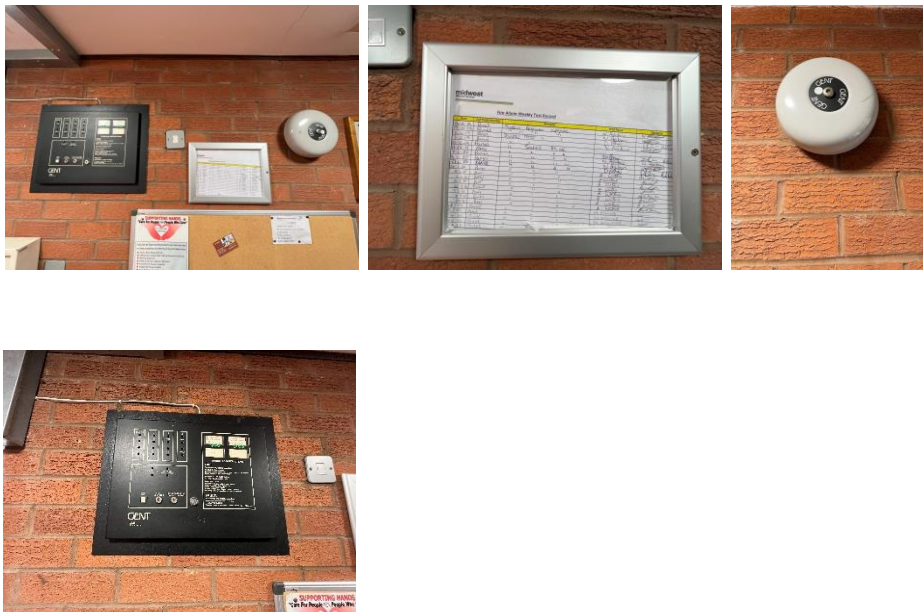
4) A communal fire alarm system that was previously installed in the building has since been decommissioned. Although the system is no longer active, key components—such as the alarm sounders located within the corridors and the main control panel situated in the ground floor communal lobby—remain in place. According to available records, the system has been inactive since 2020. However, there is currently no signage or labelling on the control panel to clearly indicate that it is out of service. This could potentially cause confusion in the event of an emergency or for visiting contractors and should be addressed to ensure clarity and compliance with best practice.

| 8/4 | Decommissioned alarm panel and sounders still present within the building. Need labelling on panel to indicate that it is not in use. | | P2 | 1-3 Months<br>Community Alarms | |

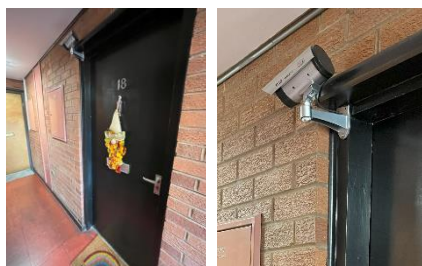
7) Flat 18 has installed a CCTV camera system which is secured onto the door frame, the cabling is running through the frame, this could potentially reduce the integrity of the compartmentation between the flat and communal corridor.

| 10/7 | Flat 18 has installed CCTV with channelling of cable through door frame. Needs removing to inspect and rectify. | | P2 | 1-3 Months<br>Fire Rapid Response | |

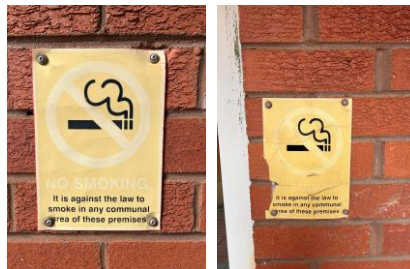
- 5) External No Smoking signs need replacing due to fading and damage.

| 12/5 | External No Smoking signs need replacing due to fading and damage | | P2 | 1-3 Months<br>Fire Rapid Response | |
