# Fire Risk Assessment

**7 – 12 Willow Close  
Cradley Heath,  
B64 6LJ**

**Date Completed: 6<sup>th</sup> October 2025**

**Current Risk Rating = Tolerable**

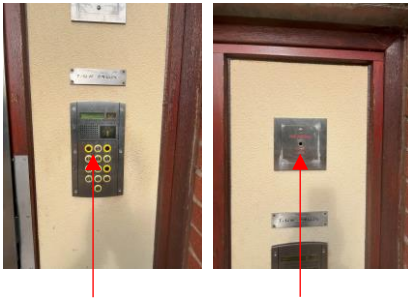
The main entrance to the building is through a porch, with both front and rear doors secured by fob readers. Tradespeople and visitors use an intercom system for access. For emergencies, a firefighter manual override switch is located above the door intercom panel. However, during the assessment, the firefighter switch did not grant access to the building. This issue is noted in Section 7, Means of Escape.

Intercom access and firefighter's switch

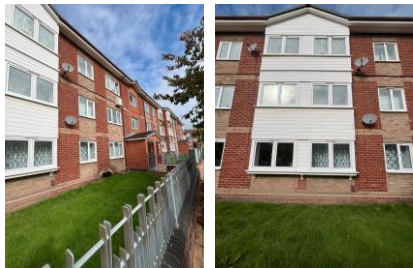
- 3) UPVC double-glazed window units have been installed in each flat and in the communal areas within the block. Additionally, UPVC cladding is present on the front elevation of the building, extending from the ground to the second floor. Upgrading this cladding has been previously recommended as part of any future works program.

UPVC window units and section of UPVC Shiplap cladding to the front that is shared between flats 1- 6 and 7 -12

It is recommended that the UPVC cladding be considered for removal on any future renovation to the building.

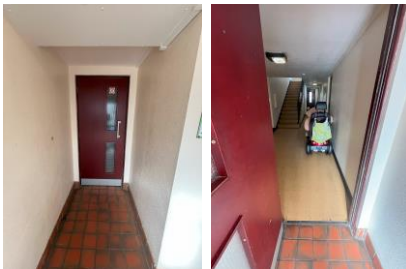
- 3) Front entrance doors to residents' flats have floor mats placed in communal area, they are of a suitable size and in acceptable condition, the fire rating for these mats is not known.

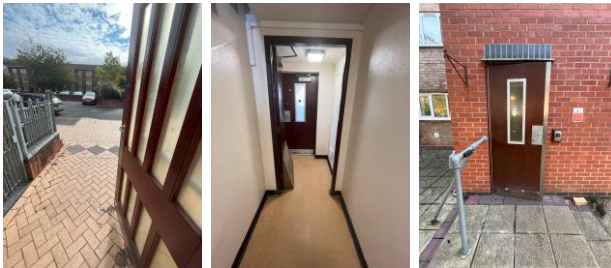
Front final & Rear final exits.

- 12) There is a clear and safe exit out of the building via the two-ground floor exits. A timber block used to prop open a communal fire door adjacent the final exit door, was removed during the survey.

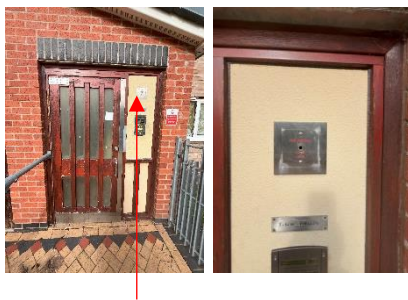
The issue of the firefighter override switch failing to provide emergency access has been reported to the contractor for repair.

- 13) Firefighters override switch will not allow access into the building. An email has been sent to CCTV team on the 08/10/2025 and on 13/10/2025. This has now been logged with a contractor to be resolved.

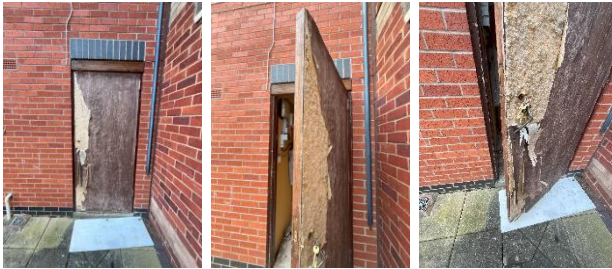
- 4) The external door leaf to the electrical cupboard has sustained significant weather damage, requires replacement.**

| 10/4 | The external door slab to the electrical cupboard has sustained damage due to prolonged exposure to rain. Needs replacing. | | P2 | 1 -3 Months<br>Fire<br>Rapid<br>Response | |

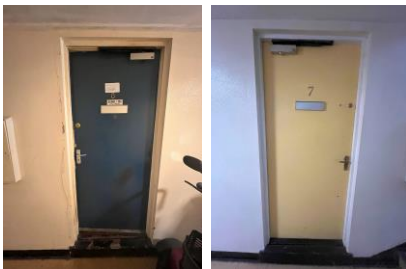
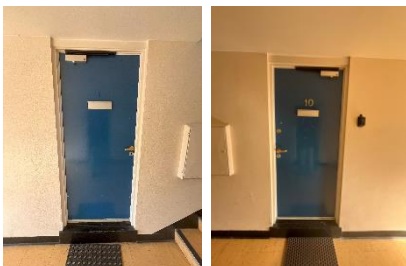
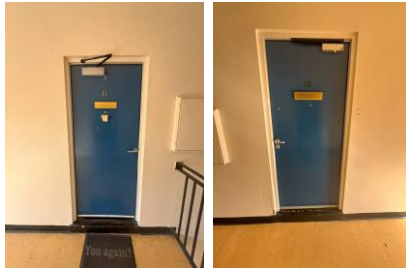
- 5) All individual flats are installed with of notional FD30s fire rated timber doors. It has been recommended that on the next refurbishment to the building that the FD30s timber doors be upgraded to certified FD30s fire rated doors.

At present it is tolerable to have notional FD30s timber doors but would be recommended that on any future refurbishment of the block that these doors be replaced with certified FD30s fire rated doors to residents front entrances.

It is recommended that for future renovations of the block that the notional FD30s timber fire doors be replaced with certified FD30s fire rated doors.

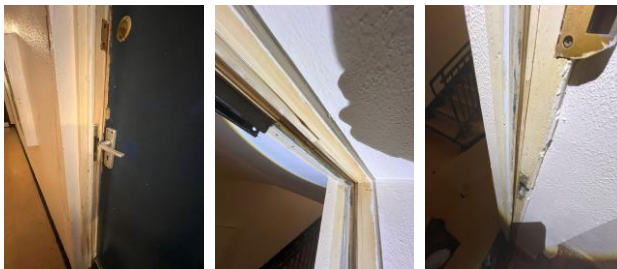
## 6) The self-closing device on Flat 8's entrance door requires adjustment, as it failed to fully close into the frame during the 15-degree opening test

| 10/6 | Flat 8 self-closing device did not close on test. Needs adjusting | | P2 | 1 -3 Months<br>Fire<br>Rapid<br>Response | |

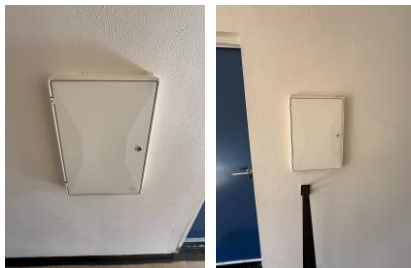
- 10) Resident electrical cupboards are located next to residents flats. The cupboards inset into the block work with over units as a closure. It is recommended that on any future refurbishment of the block that the electrical cupboards are to be relocated within the residents flat at housed within the required compartmentation.

It is recommended that the residents' electrical cupboards be relocated to within the residents' flats and housed within the required compartmentation on any future refurbishment of the block.

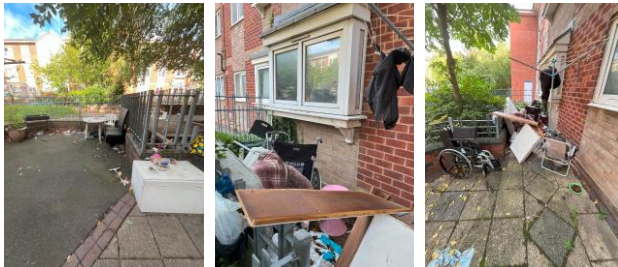
- 6) Discarded combustible items were noted against the building in the rear courtyard, present an unnecessary risk.

| 15/6 | All combustible materials discarded / stored in court yard against the building to be removed. | | P2 | 1 -3 Months<br>Housing<br>Manager | |
