# Fire Risk Assessment

**19-24**

**Peartree Lane,  
Cradley Heath,  
B64 6EH**

**Date Completed: 11/11/2025**

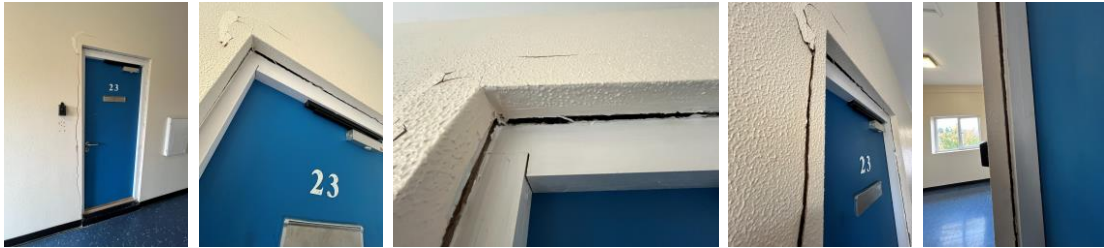
**f) Flat 23: Door frame and wall need repairing due to damage**

| 7/3f | Flat 23: Repair/replace door frame and door. | | P3 | Within 3-6 months<br>Asset Management | |

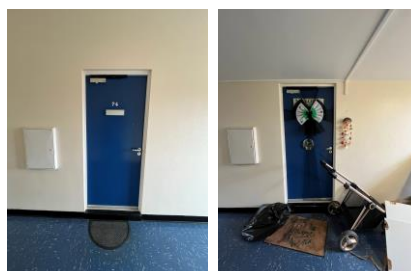
- 4) At a couple of flat entrances door mats are present; the fire rating is not known on these door mats and are deemed to be low risk.

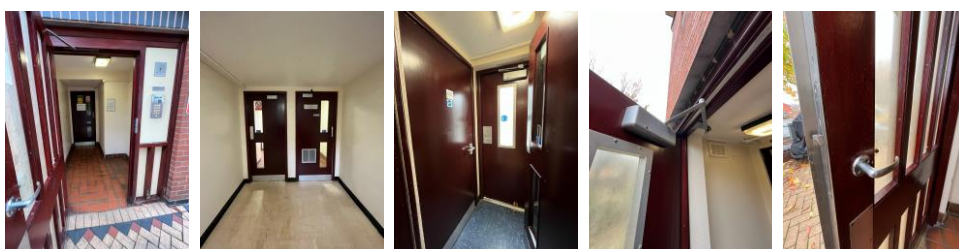
- 8) The means of escape are protected to prevent the spread of fire and smoke. There is an FD30s fire door prior the final exit door of the block at the front and rear of the block. These doors are fitted with automatic closing devices. To exit the doors, you do so by using a regular levered handle. These are checked on a regular basis by caretaking teams as part of their checks. Defective closing devices are replaced either by the Caretaking Team(s) or the in-house repairs team(s). These systems are designed to fail safe i.e. door unlocked in the event of a power failure. This prevents residents being locked in or out of the building.

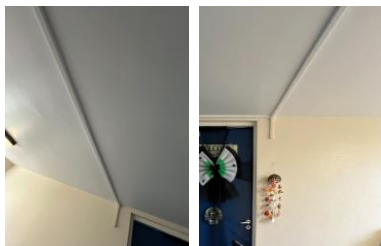
- 13) Recommend plastic trunking be upgraded to metal trunking in any future renovations, or at least D Clips are added or metal ties to the exterior of the trunking.

Replace plastic trunking with metal in future refurbishment or at least add D clips or metal ties to the exterior of the trunking. Plastic cable management systems cannot be the sole means of support. All cables must have supplementary, heat-resistant (metallic) supports, clips, or ties spaced at intervals specified in the IET On-Site Guide (typically in accordance with Regulation 521.10.202). This is to prevent cables from collapsing prematurely in a fire and obstructing the escape route or hindering firefighting efforts.

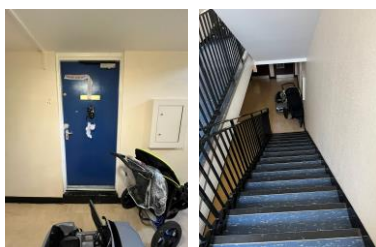
- 14) Flat 19: items being left outside flat door need relocated away from the escape routes. Emailed housing manager 22/10/2025**

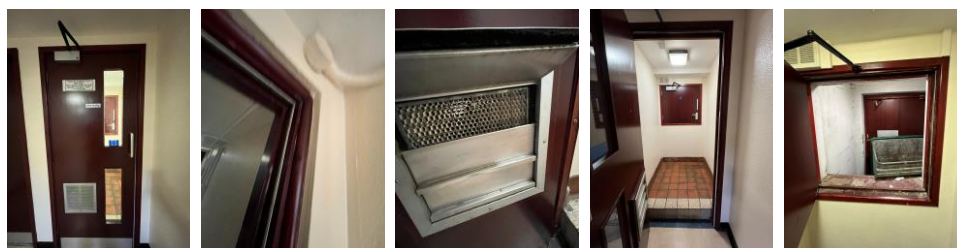
- 5) A variety of methods / materials have been used to achieve fire-stopping such as intumescent mastic around penetrations.
- 6) Bin chute room: There is a full-size door to access the room, the door has an intumescent vent installed within it. After this door there is a small FD30s hatch door, both doors are fitted with self-closers.

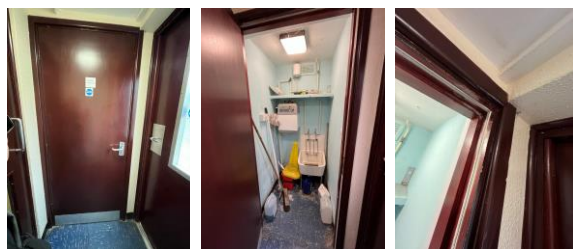
- 7) Flats are fitted with a minimum of timber notional FD30s doors. A number of flat doors were assessed at the time of the visit and require upgrading see section 7/3
- 8) On the ground floor next to the rear final exit door is situated a storeroom that is used by the cleaner. This room is fitted with an FD30s door that is locked with a 054 lock.

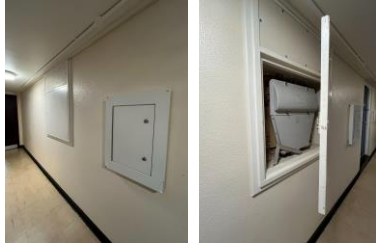
- 10) The service cupboard on ground floor is fitted with Supalux top panel and a 25mm timber door also secured with a budget key. Upgrade the cupboard to a fire rated cupboard, also include intumescent strips and smoke seals.

| 10/10 | Upgrade service cupboard door and frame with appropriate fire rated materials to include intumescent strips and smoke seal | | P3 | Within 3-6 months<br>Repairs | |

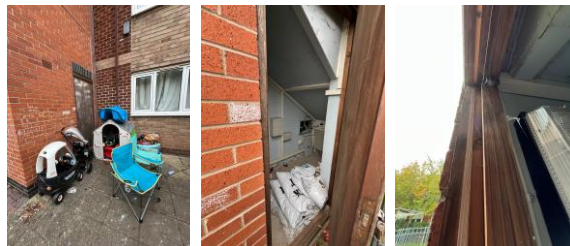
- 12) At the rear of the premises in the courtyard the service cupboard is located. This cupboard is locked with a 054 lock, and the door is an FD30s. Fire Door Keep Locked signage required on the door, see section 12/1

- a) Relocate the items being stored directly outside the service door. Email sent 22/10/2025 to the housing manager.

| 12/1a | Fit 'Fire Door Keep Locked' signage to the external service room door | | P2 | Within 1-2 months<br>Caretaker | |
