# Fire Risk Assessment

**1-6 Elm Tree Way  
Cradley Heath,  
B64 6EN**

**Date Completed: 3rd November 2025**

**Current Risk Rating = Tolerable**

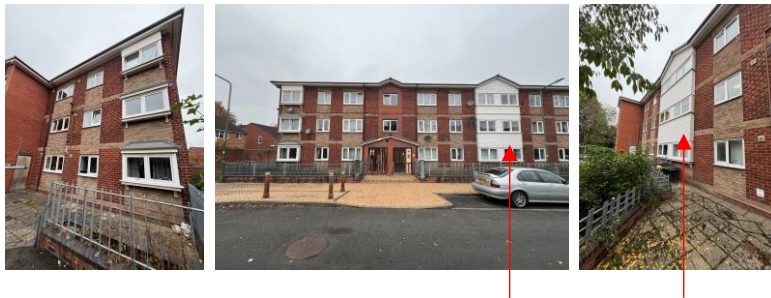
- 3) UPVC double-glazed window units have been installed in each flat and in the communal areas within the block. Additionally, UPVC cladding is present on the front and rear elevation of the building, extending from the ground to the second floor. Upgrading this cladding has been previously recommended as part of any future works program.

UPVC window units and UPVC Shiplap cladding to the front and rear

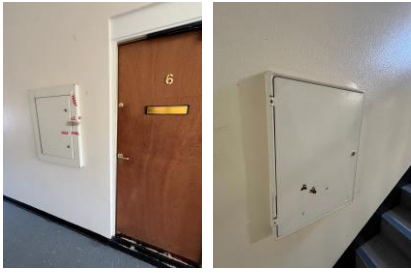
- 4) Resident electrical cupboards are currently located adjacent to individual flats. These cupboards are installed within secure units integrated into the block's structure. It is recommended that, during any future refurbishment works, the electrical cupboards be relocated inside each resident's flat and enclosed within the appropriate fire-rated compartmentation.
-

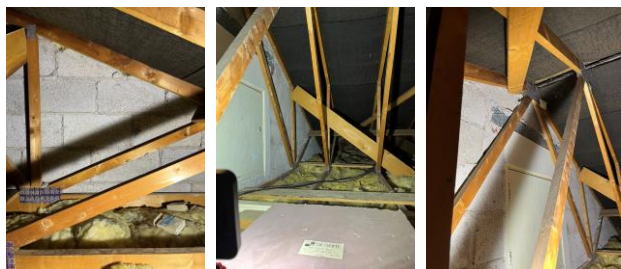
- 4) On the second floor there is a roof hatch, access was gained to this to inspect the compartmentation within the roof void. There was acceptable compartmentation between the flats.

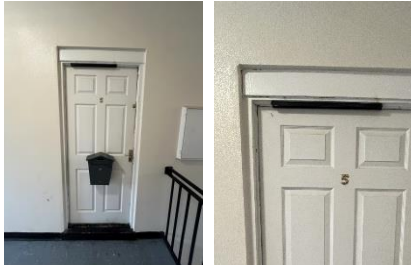
**6) Flat 5 has a missing self-closure device, no access was gained to inspect the door.** *Door previously deemed unacceptable 10/11/2023.*

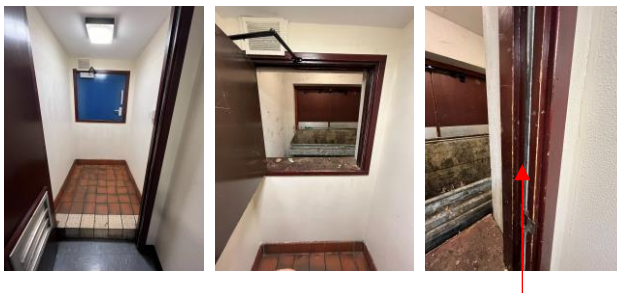
7) The building has adequate compartmentation between the refuse bin room and the communal hallway. This is achieved through an FD30s timber fire door equipped with an automatic self-closing device. The refuse bin hatch is also fitted with a timber fire door that includes smoke seals. These condition of these seals were inspected, and no issues were identified.

Bin store enclosure and smoke seals

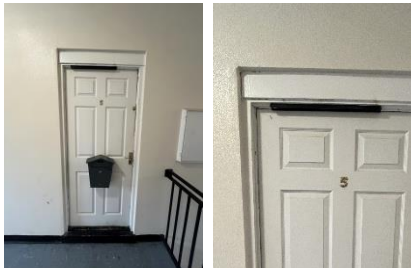
| Question/<br>Ref No | Required Action | Supporting photograph | Priority | Timescale<br>and Person<br>Responsible | Date<br>Completed |
|---|---|---|---|---|---|
| 10/6 | Flat 5 front entrance door missing self-closing device. Reinstallation of door device required.<br><i>Door previously deemed unacceptable 10/11/2023.</i> | | P3 | 3-6 Months<br>Leasehold<br>Manager | |

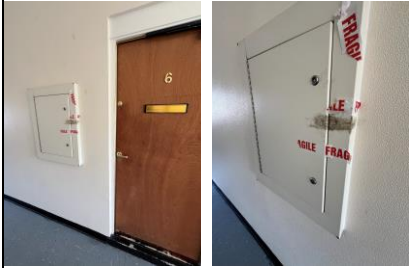
| 10/11 | Flat 6 resident electrical cupboard door locks will not secure unit. Locks are defective, locks need replacing. | | P2 | 1 -3 Months<br>Electrical<br>Manager | |

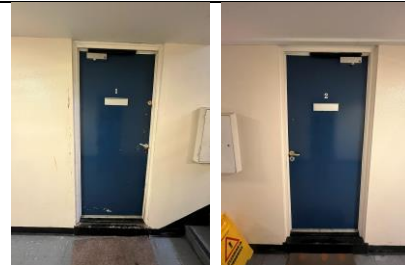
It is recommended that for future renovations of the block that the notional FD30s timber fire doors are to be replaced with FD30s certified fire doors.

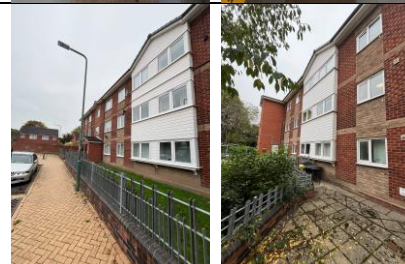
It is recommended that the UPVC cladding be considered for removal on any future renovation to the building.

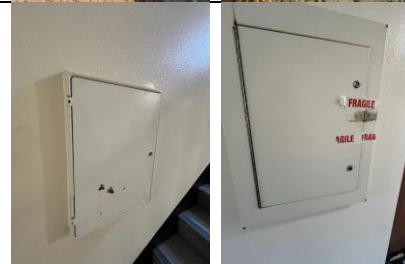
It is recommended that the residents' electrical cupboards be relocated within the residents' flats and housed within required compartmentation in any future renovation program.
