# Fire Risk Assessment

**1 -6 Elm Tree Way**

**Cradley Heath,  
B64 6EN**

**Date Completed: 3rd November 2025**

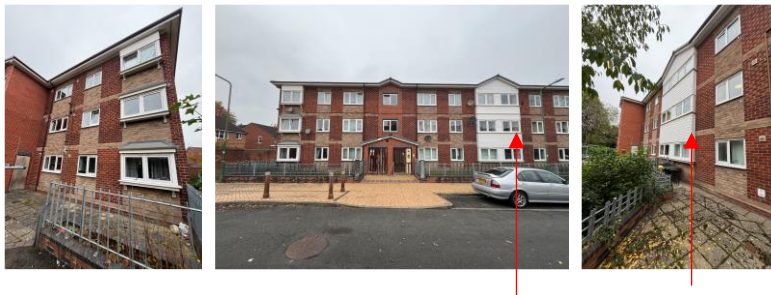
- 3) UPVC double-glazed window units have been installed in each flat and in the communal areas within the block. Additionally, UPVC cladding is present on the front and rear elevation of the building, extending from the ground to the second floor. Upgrading this cladding has been previously recommended as part of any future works program.

UPVC Shiplap cladding to the front and rear and UPVC window units

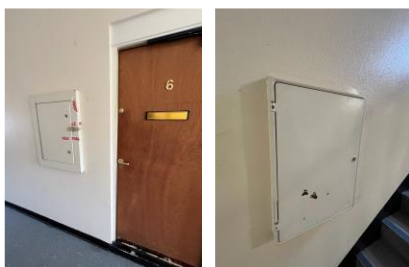
- 4) Resident electrical cupboards are located next to residents flats. The cupboards installed into the block work within secured units. It is recommended that on any future refurbishment of the block that the electrical cupboards are to be relocated within the residents flat at housed within the required compartmentation.

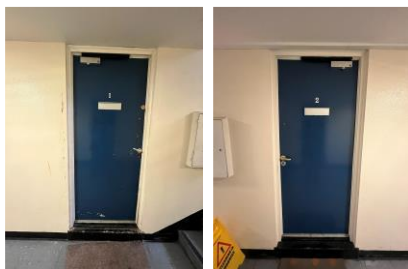
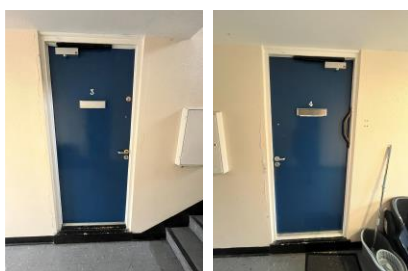
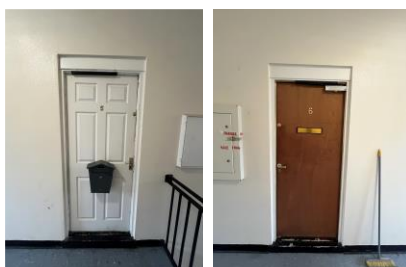
- 5) All individual flats are installed with of notional FD30s rated timber doors. It has been recommended that on the next refurbishment to the building that the notional FD30s timber doors be upgraded to FD30s certified fire doors. Flat 11 self-closing device inspected and tested on the required 15-degree closure test, doors closed into the frames as required.

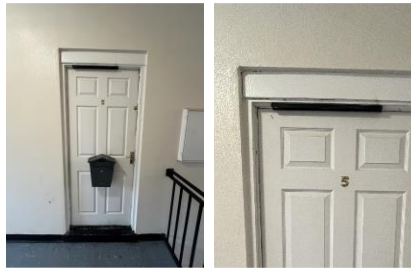
**6)Flat 5 has a missing self-closure device, no access was gained to inspect the door.** *Door previously deemed unacceptable 10/11/2023.This has now been completed as of 10/11/2025*

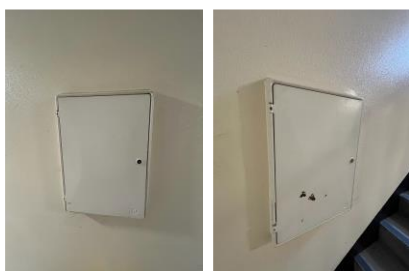
- 7) Residents' electrical meters are housed within secured units apart from electrical cupboard for flat 6 which has been noted in section 10, Compartmentation

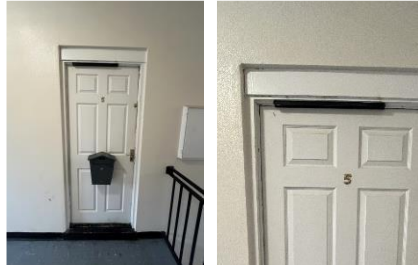
| Question/<br>Ref No | Required Action | Supporting photograph | Priority | Timescale<br>and Person<br>Responsible | Date<br>Completed |
|---|---|---|---|---|---|
| 10/6 | Flat 5 front entrance door missing self-closing device. Reinstallation of door device required.<br><i>Door previously deemed unacceptable 10/11/2023. This has now been completed as of 10/11/2025</i> | | P3 | 3-6 Months<br>Leasehold<br>Manager | |

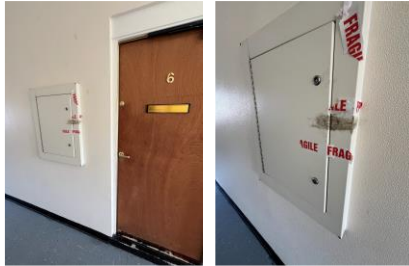
| 10/11 | Flat 6 resident electrical cupboard door locks will not secure unit. Locks are defective, locks need replacing | | P2 | 1-3 Months<br>Electrical<br>Manager | |
