Fire Risk Assessment

**25 - 30 Elm Tree Way
Cradley Heath,
B64 6EN**

**Date Completed: 4th November 2025
Officer: M Zafeer Fire Risk Assessor
Checked By: C. Hill Building Safety Manager**

Current Risk Rating = Tolerable

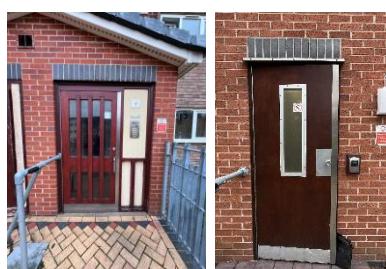
Front and rear entrances to block

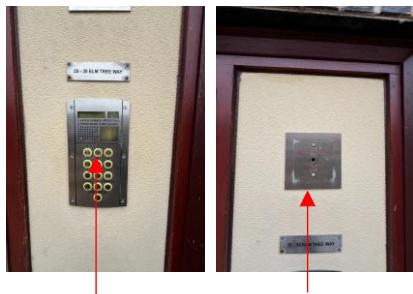
Intercom access and firefighter's switch

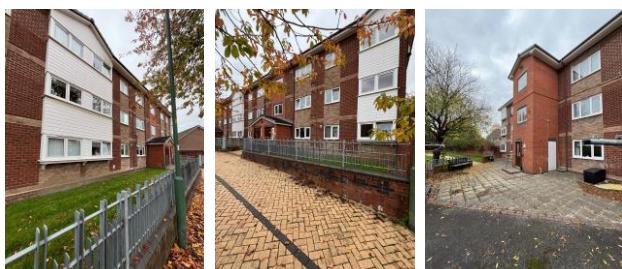
Front Elevation & rear Elevation

- 1) The exterior of the building is primarily traditional brick construction with a pitched roof design. The roof features concrete tiles and UPVC fascia boards along the roofline. The front entrance is accessed via a brick-built porch with a pitched roof, which includes UPVC dry verge end caps, fascia boards, and attached drainage.

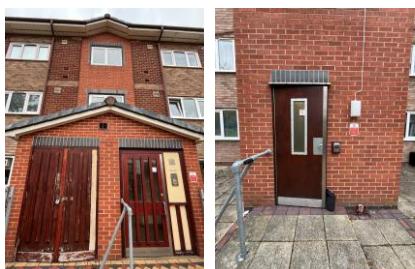
2) Both the front and rear doors are constructed from timber. The front door features glazed inserts and spandrel panelling to the side, while the rear door includes a single pane of glass with aluminium trim. Adjacent to the front entrance on the front elevation, there is a set of timber doors enclosing the residents' refuse bins.

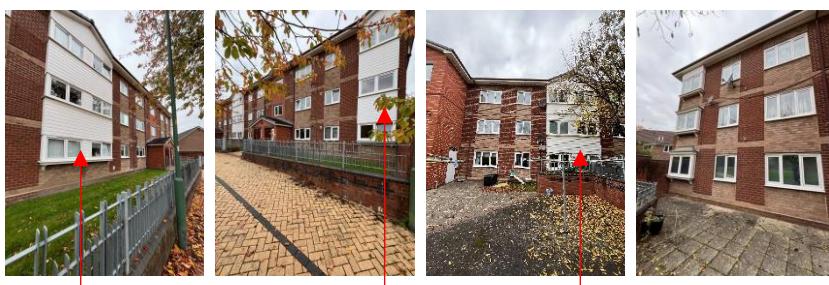
3) UPVC double-glazed window units have been installed in each flat and in the communal areas within the block. Additionally, UPVC cladding is present on the front and rear elevation of the building, extending from the ground to the second floor. Upgrading this cladding has been previously recommended as part of any future works program.

UPVC Shiplap cladding to the front and rear and UPVC window units

It is recommended that the UPVC cladding be considered for removal on any future renovation to the building.

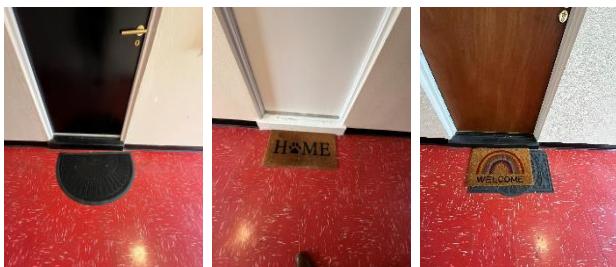
- 3) Front entrance doors to residents' flats have floor mats placed in communal area, they are of a suitable size and in acceptable condition, the fire rating for these mats is not known but deemed to be of low risk.

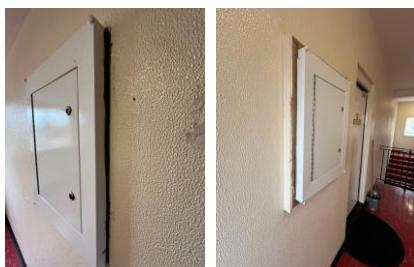
5) Resident electrical cupboards are currently located adjacent to individual flats. These cupboards are installed within secure units integrated into the block's structure. It is recommended that, during any future refurbishment works, the electrical cupboards be relocated inside each resident's flat and enclosed within the appropriate fire-rated compartmentation

It is recommended that the residents' electrical cupboards be relocated within the residents' flats and housed within required compartmentation in any future renovation program.

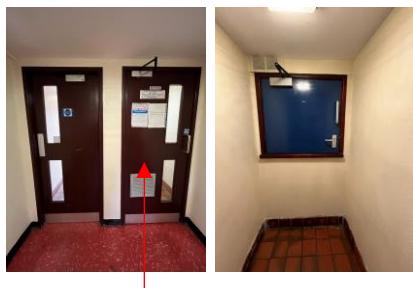
Refuse bin room

10) On the ground floor communal hallway there is access to a bin refuse room which is located behind a FD30s fire door.

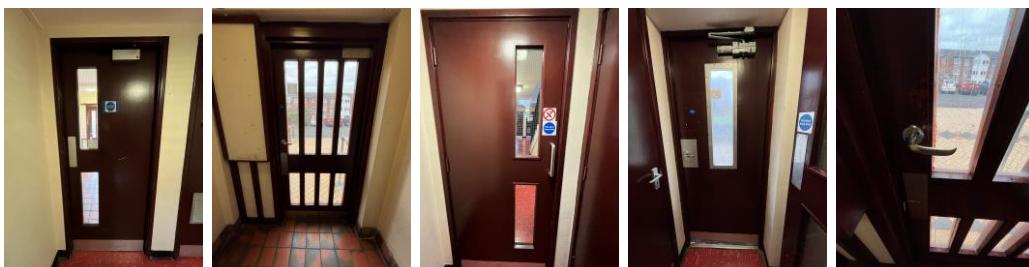
11) A communal fire door separates the front and rear final exit doors from the main communal area. The final exit doors are equipped with levered handle-operated exit system. These doors are regularly inspected by the Caretaking Teams as part of their routine checks. Any defective self-closing devices are replaced either by the Caretaking Teams or the in-house Repairs Team.

Communal doors with front and rear final exits doors with levered handles.

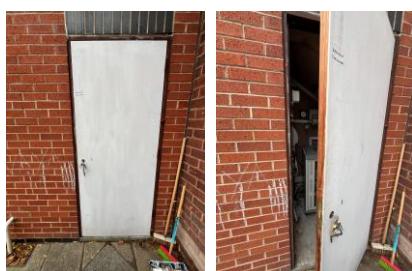
- 3) Electrical Service cupboard on ground floor is located outside to the rear of the block, this is behind an FD30s timber fire door, this secured by 054 mortice lock key; this is only held by authorised staff.

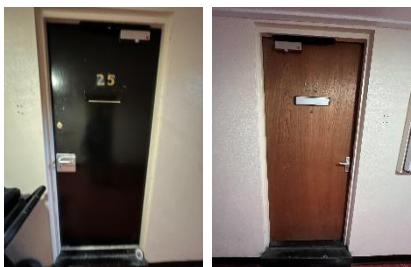
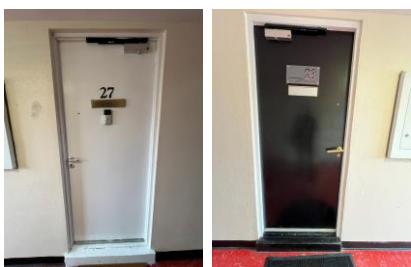
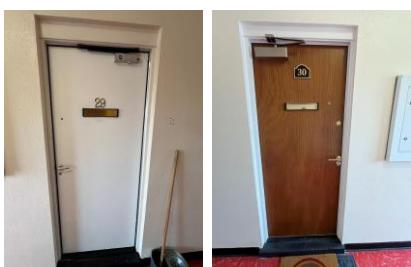
5) All individual flats are installed with of notional FD30s rated timber doors. It has been recommended that on the next refurbishment to the building that the FD30s timber doors be upgraded to FD30s certified doors. Flats 28,29,30 self-closing devices inspected and tested on the required 15-degree closure test, doors closed into the frames as required.

It is recommended that for future renovations of the block that the notional FD30s timber fire doors are to be replaced with FD30s certified fire rated doors.

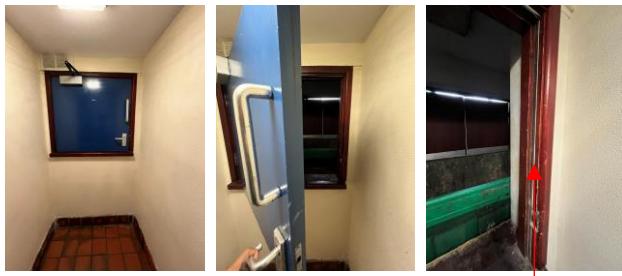
6) The building has adequate compartmentation between the refuse bin room and the communal hallway. This is achieved through an FD30s timber fire door equipped with a self-closing device. The refuse bin hatch is also fitted with a timber fire door that includes smoke seals. The condition of these seals was inspected; no issues were identified.

Bin store enclosure and smoke seals

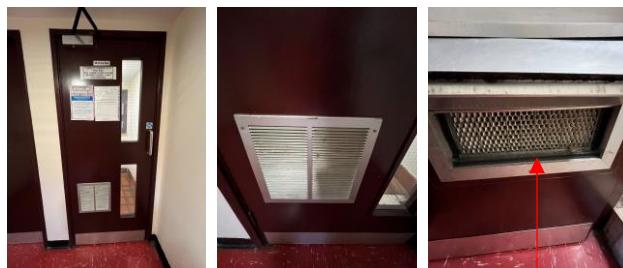
7) The fire door to the refuse cupboard on the ground floor within the communal corridor is equipped with a vision panel and an intumescent ventilation grill.

Refuse bin room door and ventilation intumescent seals.

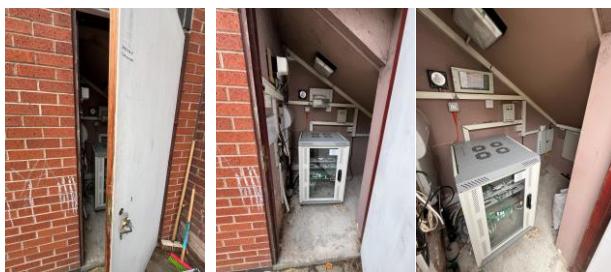
- 5) Electrical service cupboard on the ground floor which is located externally on the rear of the building is secured behind a FD30s fire rated door. Cupboard is free from any combustibles. There is a CCTV server unit placed within the cupboard. This is deemed acceptable.

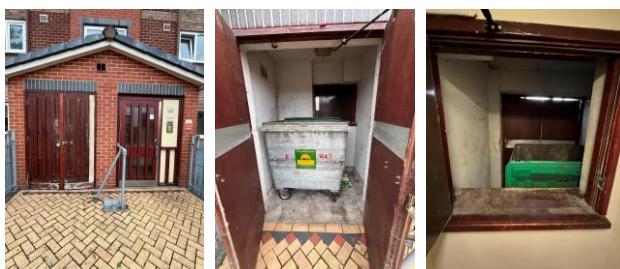
- 2) Refuse bin is stored in a secured bin room that is located next to the front entrance of the building. This can be accessed from both internal and externally and is kept secure. Bins Are regularly emptied by site services. All internal refuse rooms are clear of any rubbish.
