# Fire Risk Assessment

**19 – 24 Elm Tree Way  
Cradley Heath,  
B64 6EN**

**Date Completed: 4th November 2025**

**Current Risk Rating = Tolerable**

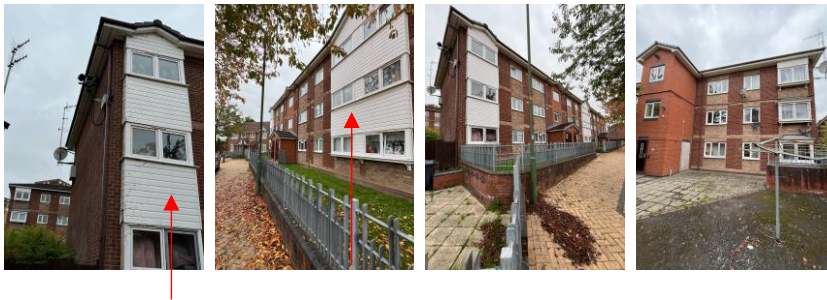
- 3) UPVC double-glazed window units have been installed in each flat and in the communal areas within the block. Additionally, UPVC cladding is present on the front and rear elevation of the building, extending from the ground to the second floor. Upgrading this cladding has been previously recommended as part of any future works program.

UPVC Shiplap cladding to the front and rear and UPVC window units

It is recommended that the UPVC cladding be considered for removal on any future renovation to the building.

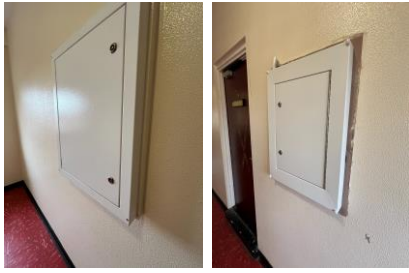
- 4) Resident electrical cupboards are currently located adjacent to individual flats. These cupboards are installed within secure units integrated into the block's structure. It is recommended that, during any future refurbishment works, the electrical cupboards be relocated inside each resident's flat and enclosed within the appropriate fire-rated compartmentation.

It is recommended that the residents' electrical cupboards be relocated within the residents' flats and housed within required compartmentation in any future renovation program.

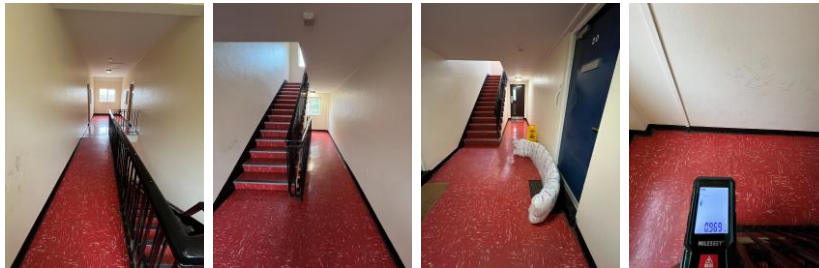
- 5) All corridors, landing and staircase are of adequate width of 969mm and are kept clear to promote maintain safe exit in an event of fire. Noted, a delivery parcel was left in front of flat 20, this was removed.

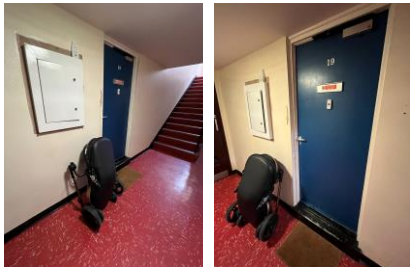
- 6) **Pushchair left outside flat 19. Residents should refrain from storing combustible or items within or that can obstruct the means of escape.**

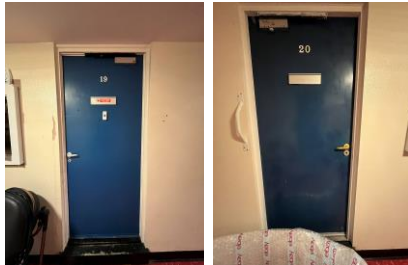
Ground floor flats, 19,20

- 5) All individual flats are installed with of notional FD30s rated timber doors. It has been recommended that on the next refurbishment to the building that the FD30s timber doors be upgraded to FD30s certified doors.

It is recommended that for future renovations of the block that the notional FD30s timber fire doors are to be replaced with FD30s certified fire rated doors.

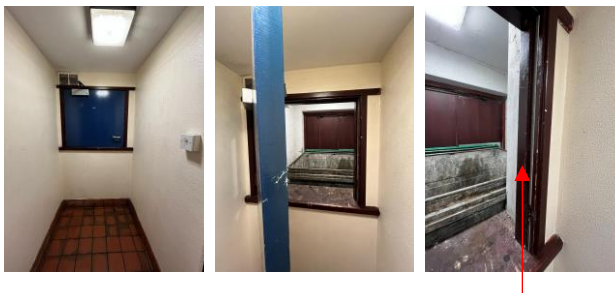
- 6) The building has adequate compartmentation between the refuse bin room and the communal hallway. This is achieved through an FD30s timber fire door equipped with a self-closing device. The refuse bin hatch is also fitted with a timber fire door that includes smoke seals. The condition of these seals was inspected; no issues were identified.

Bin store enclosure and smoke seals
