Fire Risk Assessment

7-12

**Applewood Grove,
Cradley Heath,
B64 6EG.**

Date Completed: 11/11/2025

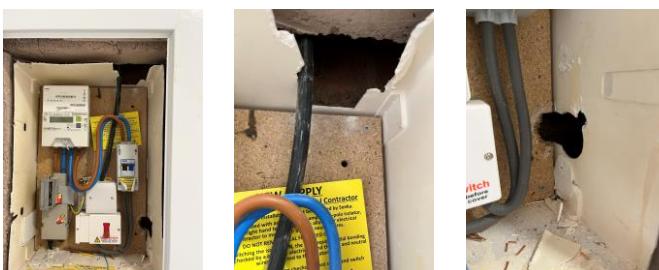
- 7) **The electrical cupboard outside Flat No 12 requires firestopping, see action 7.7.**

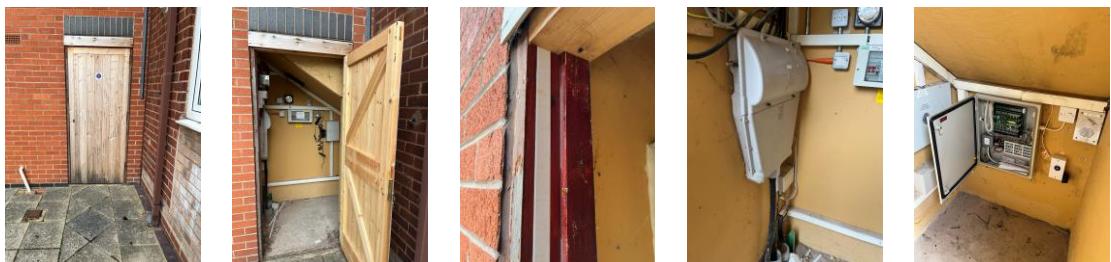
9) Service cupboard on the ground floor is accessible at the rear of the building and contains the electrical intake.

10) The door on the service cupboard is a ledged and braced timber door with some smoke seals and intumescent strips and lockable with a 54 mortice lock the door is not a fire door, see observations.

The door on the service cupboard is a timber door with some smoke seals and intumescent strips and lockable with a 54 mortice lock the door is not a fire door, consideration to upgrade door to a FD30s Fire door and replace all smoke seals and intumescent strips.

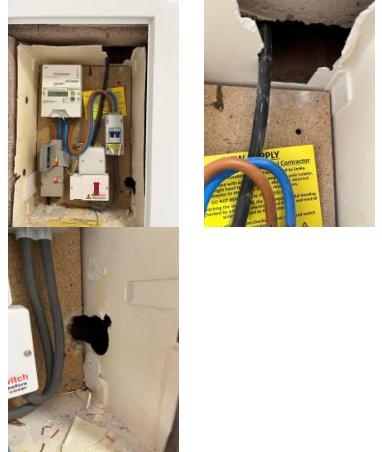
Question/ Ref No	Required Action	Supporting photograph	Priority	Timescale and Person Responsible	Date Completed
7/7	The electrical cupboards outside Flat No 12 Requires firestopping.

P2	1-3 Months Fire Rapid Response	
7/16	The first-floor window at the top of the stairs does not close correctly in to the frame, this requires adjustment.
