Fire Risk Assessment

Kenrick House

**Green Street, West Bromwich,
B70 6DN.**

Date Completed: 1st December 2025

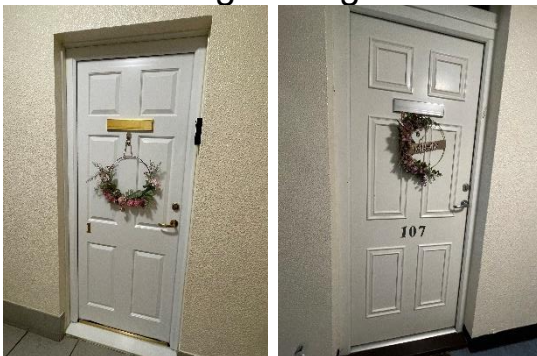
- 20) Wreaths were noted attached to two flat entrance doors. Email sent to the housing manager to liaise with tenants for removal.

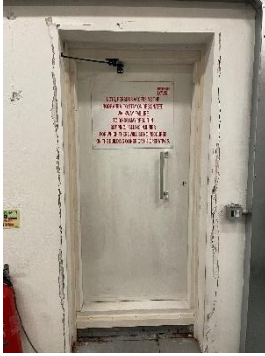
- 21) The door leaf providing access to the external roof is damaged, difficult to open and requires attention.**

P3	Within 3-6 Months Housing Manager	
7/21	Lift motor room – door leaf to roof is split / difficult to open requires repair.

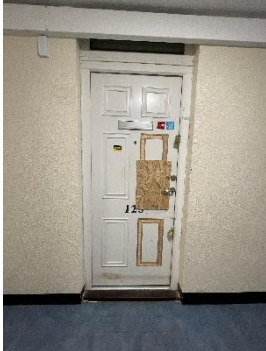
- 15) Flat 125 entrance door noted as damaged due to forced entry. Replacement required.**

10/15	Flat 125 FD30s entrance door to be replaced.

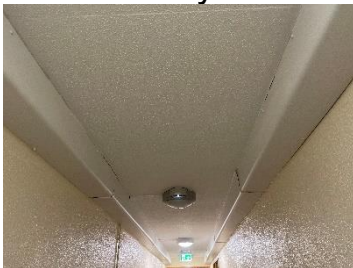
- 17) Boxing housing cabling on the ground floor is presumed to be pre-formed 5mm ply with a coated finish. The assessor has been unable to confirm the specific rating of the product and would therefore recommend it is replaced with a product that is FR rated or fire resistant such as steel or aluminium. It should be noted that the boxing houses cabling which is well maintained and is located in an area which is maintained sterile therefore, replacement under a future programmed / refurbishment work is acceptable because it is sufficiently low risk.

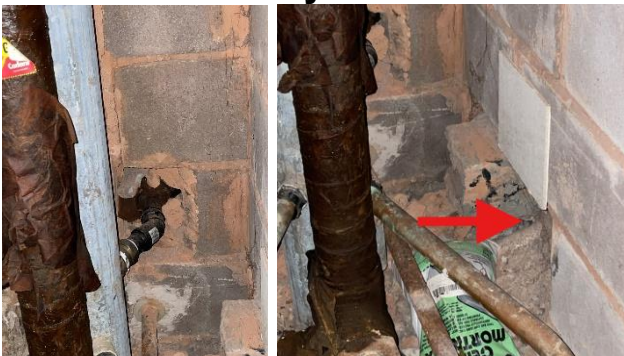
- 23) 13th floor- Gas riser cupboard near chute room – fire stop penetration behind soil stack.**

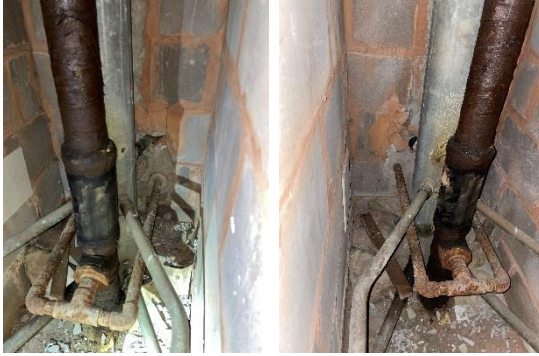
- 26) 7th floor - Gas riser cupboard near chute room –fire stop x 2 penetrations behind soil stack.**

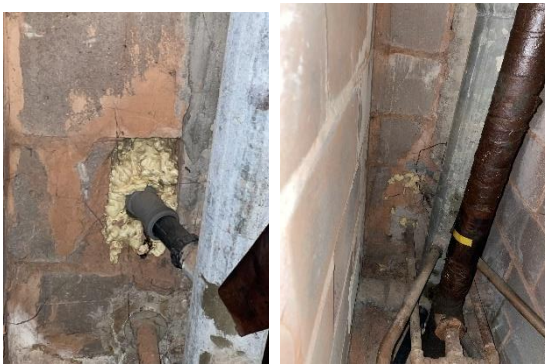
- 27) 6th floor - Gas riser cupboard near chute room – remove expanding foam and fire stop x 2 penetrations behind soil stack.

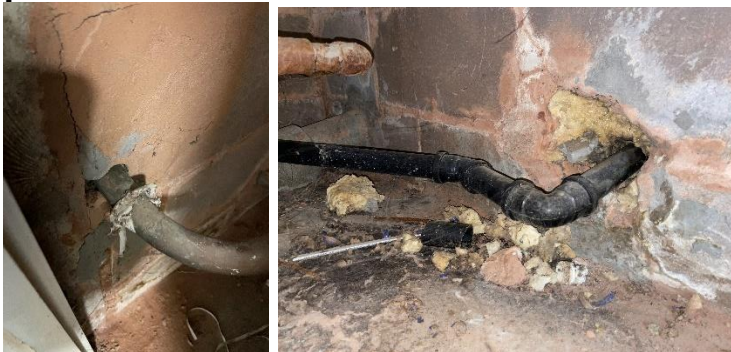
- 28) 5th floor - Gas riser cupboard near chute room – fire stop where intumescent mastic has come away from l/h waste pipe penetration and remove foam and fire stop waste pipe penetration on r/h side.

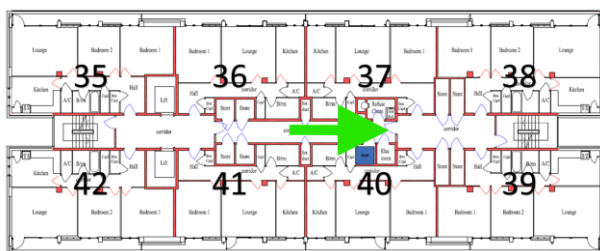
- 29) 5th floor communal door near chute room– reduce excessive gap to threshold.

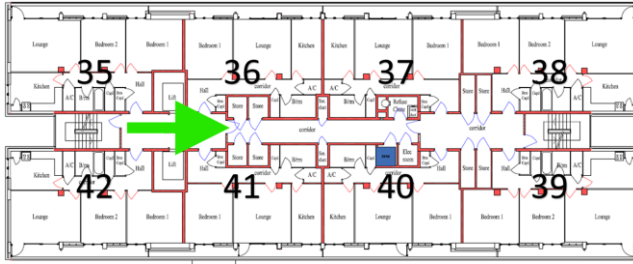
- 30) 5th floor communal door near flat 36 – reduce excessive gap to threshold.**

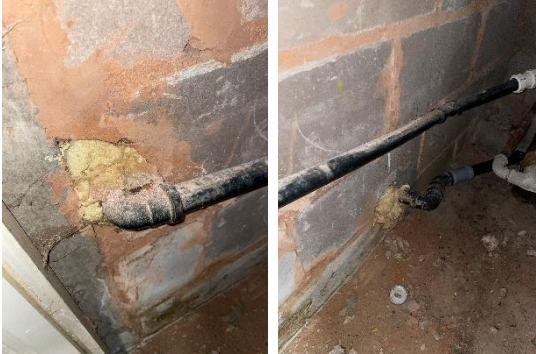
- 31) 4th floor - Gas riser cupboard near chute room – remove expanding foam and fire stop x 2 waste pipe penetrations.**

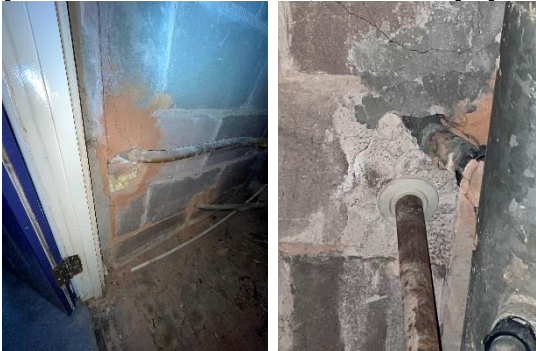
- 32) 3rd floor - Gas riser cupboard near chute room – remove expanding foam and fire stop on l/h side waste pipe penetration. Also, fire stop penetration behind soil stack.**

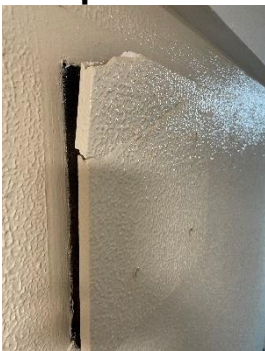
- 33) 3rd floor – replace broken stop tap panel in communal corridor for like or with suitable alternative maintaining compartmentation.**

P2	Within 1-3 Months Fire rapid Response	
10/33	3rd floor – replace broken stop tap panel in communal corridor for like or with suitable alternative maintaining compartmentation.

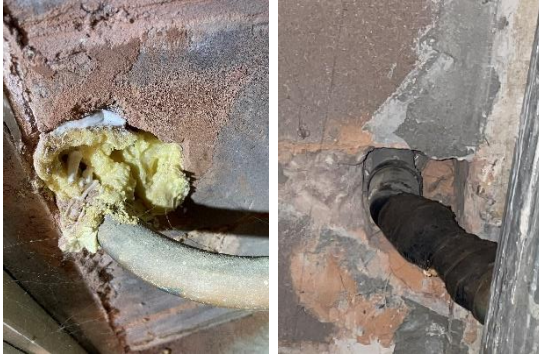
- 34) 2nd floor - Gas riser cupboard near chute room – Remove expanding foam from waste pipe penetration , and fire stop around this one plus one other.**

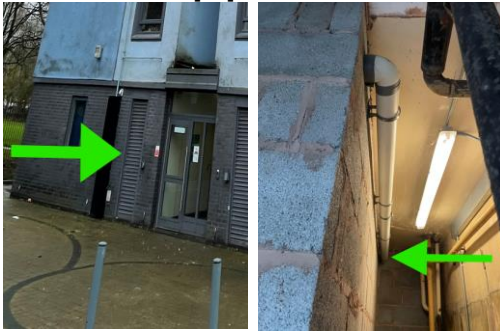
- 35) External ground floor service void behind roller shutter, left of side entrance door – Fit intumescent collar around extraction pipe rear of bathroom compartment wall.**

P2	Within 1-3 Months Fire rapid Response	
10/35	Ground floor service void behind roller shutter, left of side entrance door – Fit intumescent collar around extraction pipe rear of bathroom compartment wall.

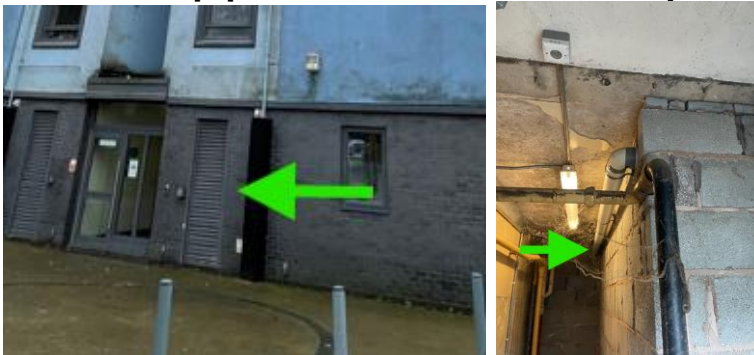
- 36) External ground floor service void behind roller shutter, right of side entrance door – Fit intumescent collar around extraction pipe rear of bathroom compartment wall.**

P2	Within 1-3 Months Fire rapid Response	
10/36	Ground floor service void behind roller shutter, right of side entrance door – Fit intumescent collar around extraction pipe rear of bathroom compartment wall.

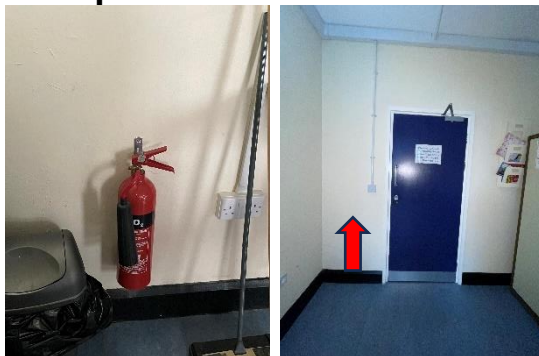
- 5) The portable Co2 extinguisher in the community room should be repositioned beside the exit door.
