Fire Risk Assessment

Kenrick House

**Green Street, West Bromwich,
B70 6DN.**

Date Completed: 1st December 2025

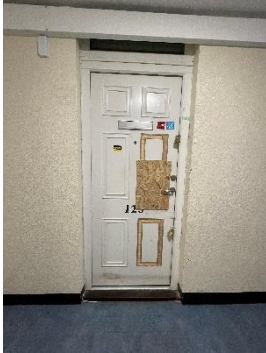
- 15) Flat 125 entrance door noted as damaged due to forced entry. Replacement required.**

10/15	Flat 125 FD30s entrance door to be replaced.

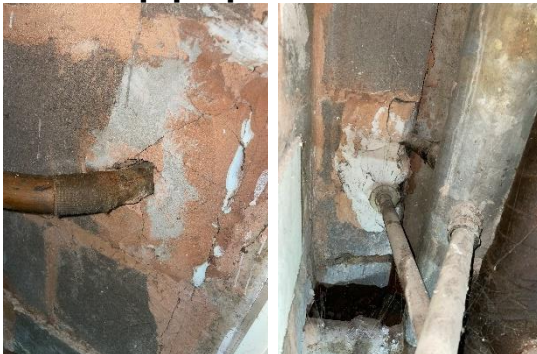
- 21) 15th floor - Gas riser cupboard near chute room – fire stop around pipe penetration and behind soil stack.

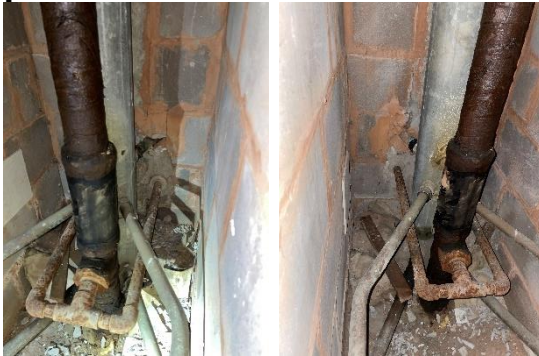
27) 7th floor - Gas riser cupboard near chute room –fire stop x 2 penetrations behind soil stack.

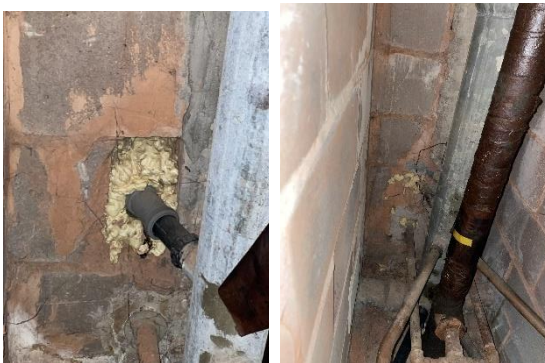
28) 6th floor - Gas riser cupboard near chute room – remove expanding foam and fire stop x 2 penetrations behind soil stack.

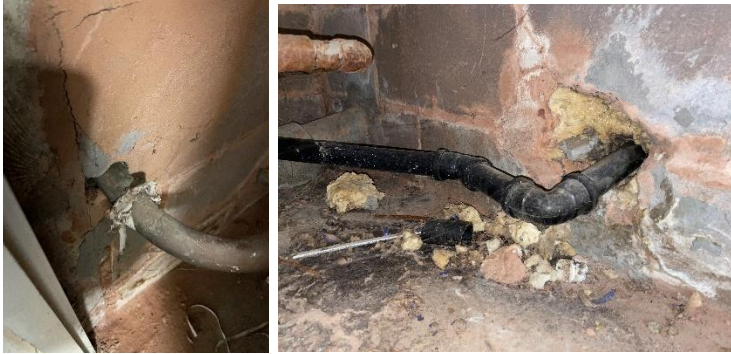
29) 5th floor - Gas riser cupboard near chute room – fire stop where intumescent mastic has come away from l/h waste pipe penetration and remove foam and fire stop waste pipe penetration on r/h side.

P2	Within 1-3 Months Fire rapid Response	
10/29	5th floor - Gas riser cupboard near chute room – fire stop where intumescent mastic has come away from l/h waste pipe penetration and remove foam and fire stop waste pipe penetration on r/h side.

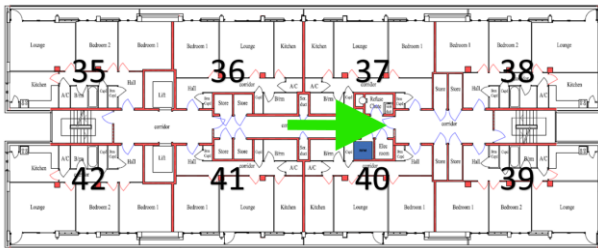
30) 5th floor communal door near chute room– reduce excessive gap to threshold.

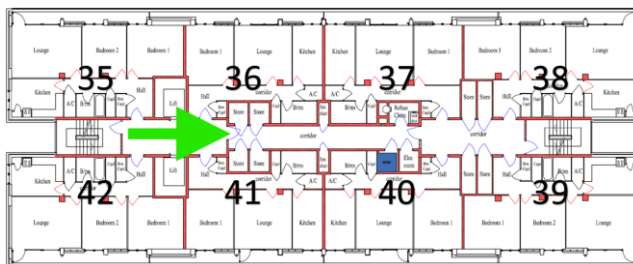
31) 5th floor communal door near flat 36 – reduce excessive gap to threshold.

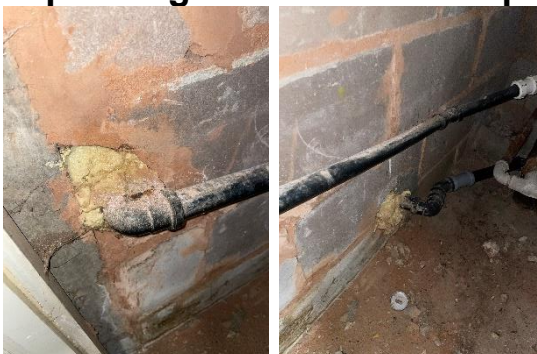
32) 4th floor - Gas riser cupboard near chute room – remove expanding foam and fire stop x 2 waste pipe penetrations.

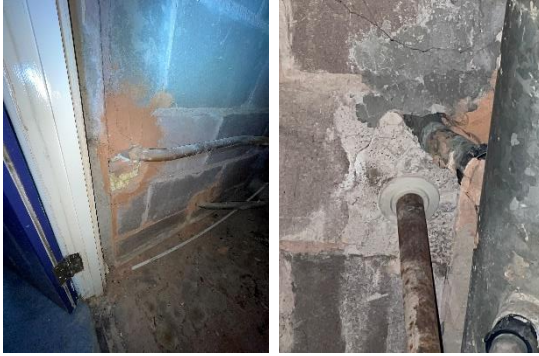
33) 3rd floor - Gas riser cupboard near chute room – remove expanding foam and fire stop on l/h side waste pipe penetration. Also, fire stop penetration behind soil stack.

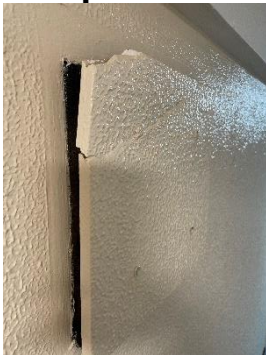
- 34) 3rd floor – replace broken stop tap panel in communal corridor for like or with suitable alternative maintaining compartmentation.**

P2	Within 1-3 Months Fire rapid Response	
10/34	3rd floor – replace broken stop tap panel in communal corridor for like or with suitable alternative maintaining compartmentation.

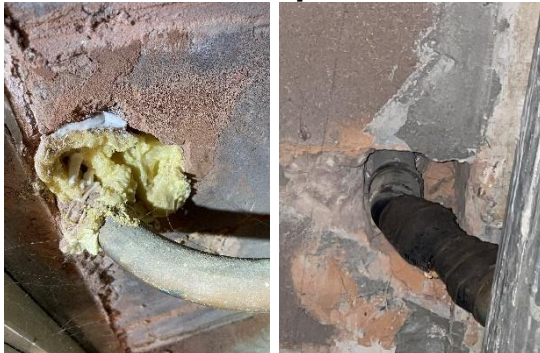
- 35) 2nd floor - Gas riser cupboard near chute room – Remove expanding foam from waste pipe penetration , and fire stop around this one plus one other.**

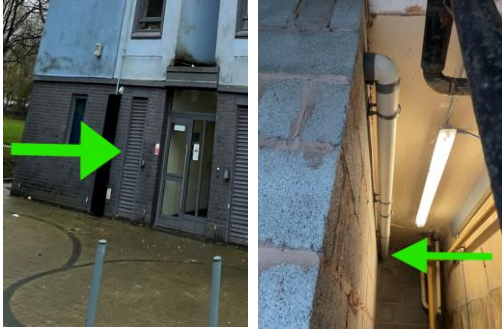
- 36) External ground floor service void behind roller shutter, left of side entrance door – Fit intumescent collar around extraction pipe rear of bathroom compartment wall.**

P2	Within 1-3 Months Fire rapid Response	
10/36	Ground floor service void behind roller shutter, left of side entrance door – Fit intumescent collar around extraction pipe rear of bathroom compartment wall.

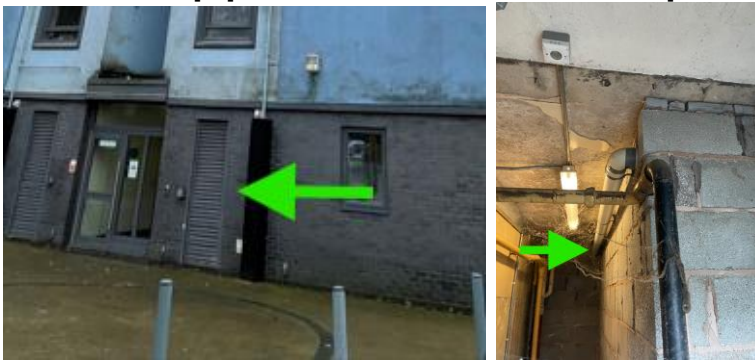
37) External ground floor service void behind roller shutter, right of side entrance door – Fit intumescent collar around extraction pipe rear of bathroom compartment wall.

P2	Within 1-3 Months Fire rapid Response	
10/37	Ground floor service void behind roller shutter, right of side entrance door – Fit intumescent collar around extraction pipe rear of bathroom compartment wall.
