Fire Risk Assessment

1-6 Sherwood House

**Southbank Road,
Cradley Heath, B64 6EW**

Date Completed: 4th December 2025

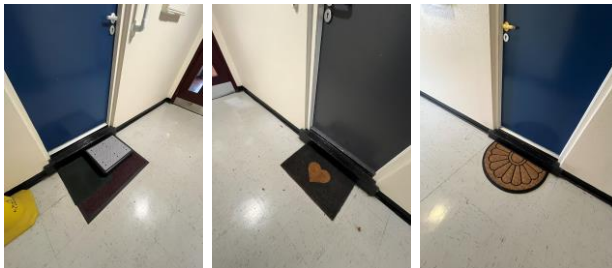
- 3) Front entrance doors to residents' flats have floor mats placed in communal area, they are of a suitable size and in acceptable condition, the fire rating for these mats is not known, but deemed to be sufficiently low risk.

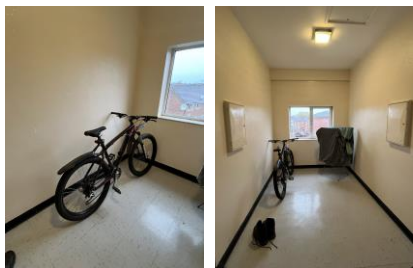
- 6) A non-electrical bike has been stored on the landing outside flat 5.**

7/6	Non-electrical bike has been stored on the landing outside flat 5. Will require removing by resident.

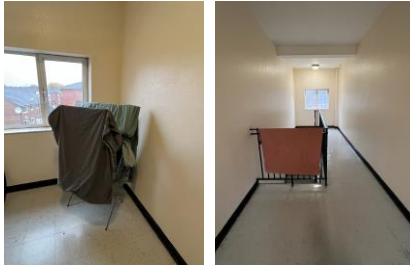
- 7) Combustibles have been placed on the 2nd floor landing for drying, this will need to be discouraged to prevent a build up of combustibles items in the communal area.**

P2	1 -3 Months Housing Manager	
7/7	2 ND floor landing is being used to dry items of combustion. Housing team to inform tenant not to dry clothes in means of escape.

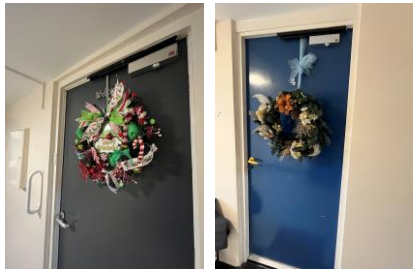
- 14) Seasonal decorative wreaths have been attached to the doors of Flat 2 & 4. Considering its temporary nature and the low risk within the communal area, these items are deemed an acceptable, short-term tolerance.

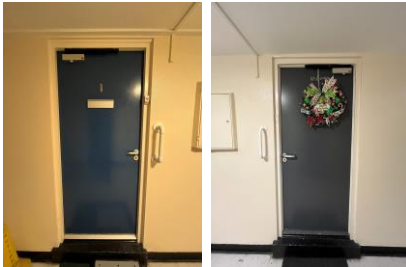
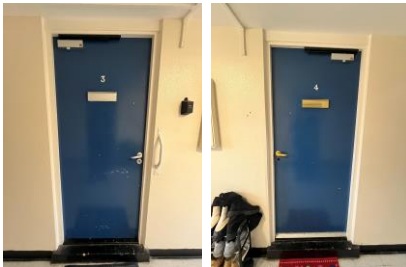
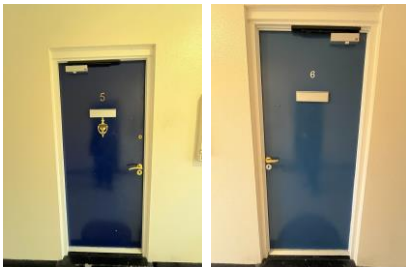
- 5) All individual flats are installed with of notional FD30s rated timber doors. It has been recommended that on the next refurbishment to the building that the FD30s timber doors be upgraded to FD30s certified doors.

It is recommended that for future renovations of the block that the notional FD30s timber fire doors are to be replaced with FD30s certified fire rated doors.

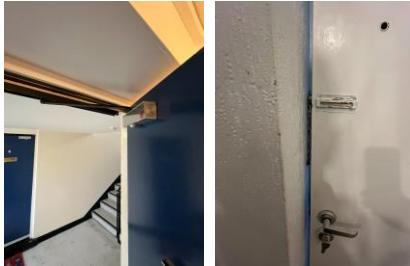
6) Flat 3 self-closing device was checked for auto closing function, the door did not close automatically and smoothly into the frame, will needs adjusting.

P2	1-3 Months Housing Manager	
10/6	Flat 3 self-closing device will not allow door to auto close; this will need adjusting.

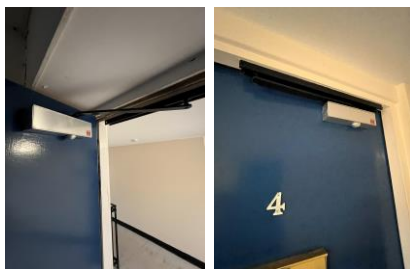
8) Flat 4 self-closing device was checked for auto closing function, the door did not close automatically and smoothly into the frame, will needs adjusting.

P2	1-3 Months Fire Rapid Response	
10/8	Flat 4 self-closing device will not allow door to auto close; this will need adjusting.

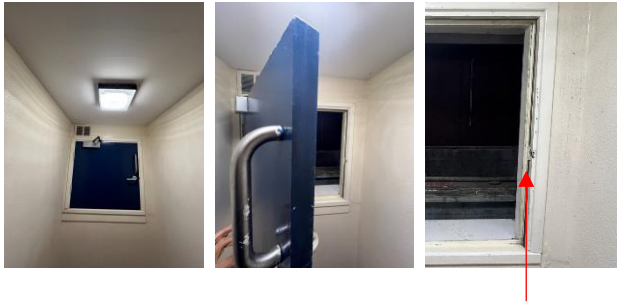
- 9) The building has adequate compartmentation between the refuse bin room and the communal hallway. This is achieved through an FD30s timber fire door equipped with a self-closing device. The refuse bin hatch is also fitted with a timber fire door that includes smoke seals. The condition of these seals was inspected; no issues were identified.

Bin store enclosure and smoke seals

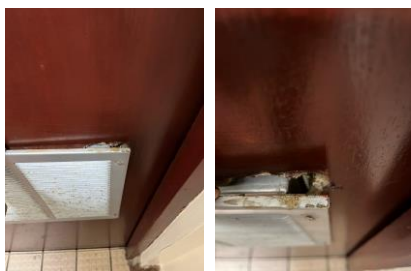
- 11) Ground floor Intumescent Ventilation grill installed to the refuse bin cupboard door is not securely fixed creating a gap between the vent and door.**

P2	1-3 Months Fire Rapid Response	
10/11	Ground floor intumescent grill on refuse cupboard door has damaged fitting. Inspect and secure grill.

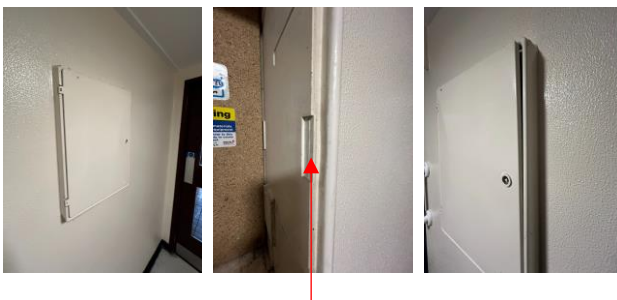
- 14) Flat 1 residential GRP electrical cupboard door will not secure due to a damage on the securing bead.**

Damaged securing bead

10/14	Flat 1 resident electrical GRP unit will not secure due to damaged locking edge. Replace unit.	 	P2	1-3 Months Electrical Team	
14/5	External electrical cupboard access could not be gained due to seized lock. Requires access and to fit new lock.	 	P2	1-3 Months Fire Rapid Response
