Fire Risk Assessment

2 – 24

Shepherds Fold,

Current Risk Rating = Tolerable

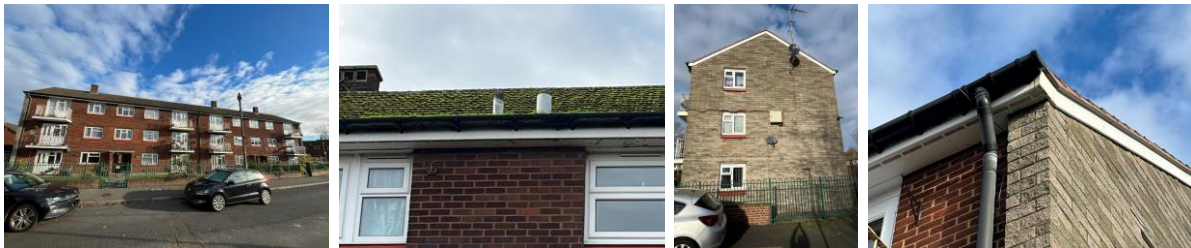
- 1) The external surface of the building is predominantly brick structure with uPVC soffits and fascia. The roof is pitched and fitted with Marley concrete interlocking roof tiles are fitted on the roof.

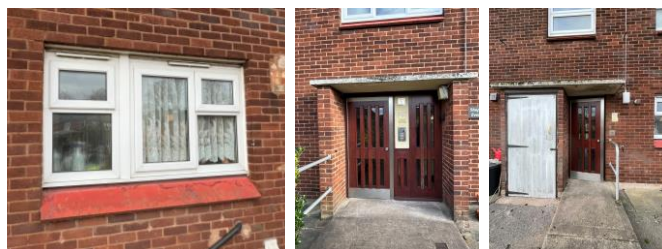
- 2) uPVC double-glazed units have been installed in each flat and on the communal stairway. The building features a canopied entrance, with a flat concrete canopy roof. A security/safety light is fitted within the porch area. The entrance and rear doors are primarily made of timber and glass, with a small section of spandrel panelling. Adjacent to the rear door is a brick-built cupboard housing the bin chute and waste bin; this cupboard is enclosed with a timber door.

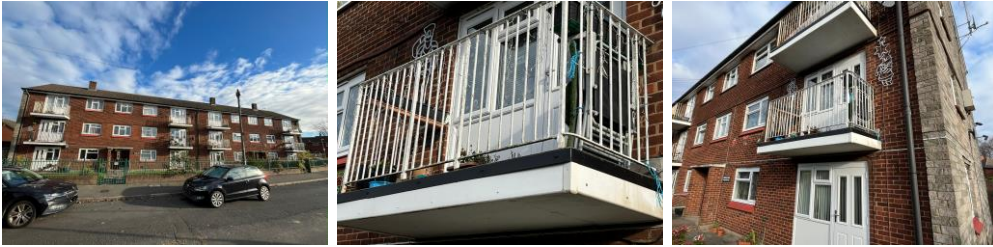
- 3) The flats on the first and second floors each have a small, front-facing balcony fitted with ironwork railings. The concrete floor of the balcony has a uPVC fascia fitted with some flats having the underneath covered in a fire board and others in uPVC. Recommend that the uPVC is removed with future refurbishment.

Some of these balconies have various items stored on them. Due to the low risk these will be ok to stay in place.

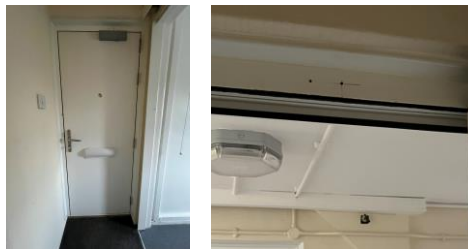
- a) **Flat 2: No self-closer fitted, install new self-closer.**

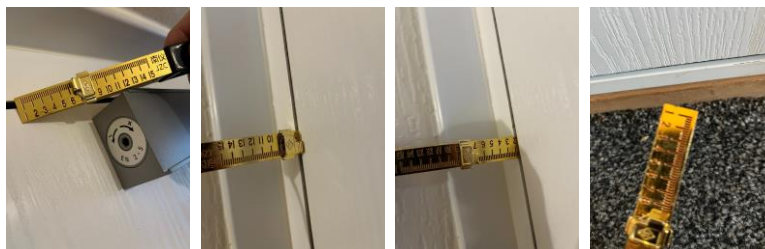
- b) **Flat 2: Gap's between door and frame. Refit door/frame and close gaps.**

- **Gap measures**
- **Hinge side: 4mm**
- **Top side: 6mm**
- **Bottom: 8mm**
- **Slam side: 7mm**

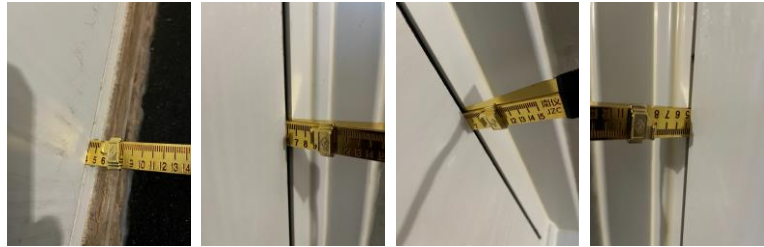
c) **Flat 4: Gap's between door and frame. Refit door/frame and close gaps.**

- **Gap measures**
- **Hinge side: 5mm**
- **Top side: 6mm**
- **Bottom: 4mm**
- **Slam side: 6mm**

P3	Within 3-6 months Fire Rapid Response jm18523940	Unable to close gaps
7/3c	Flat 4: Close gap between the door as frame. See section 7/3c for more details

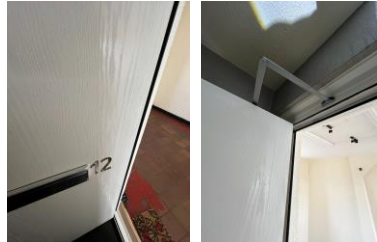
- h) **Flat 12: Adjust self-closer requires adjustment as door does not close fully without assistance.**

P3	Within 3-6 months Fire Rapid Response JM18726033	04/02/2026
7/3h	Flat 12: adjust self closer due to door not self closing.

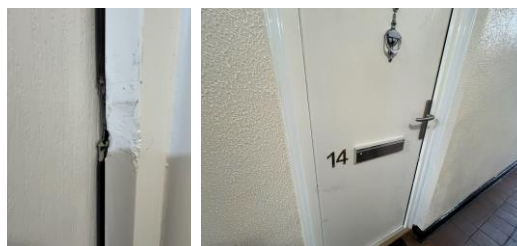
- i) **Flat 14: Did not get access to the flat. External section of the frame on the right-hand side halfway down is damaged. May need replacement.**

P2	Within 1-3 months Fire Rapid Response JM 18542841	15/01/2026
7/3i	Flat 14: Entrance door frame damaged. Also, signs of surface damage to the door. Assess and make fire safe. New door set required / ordered

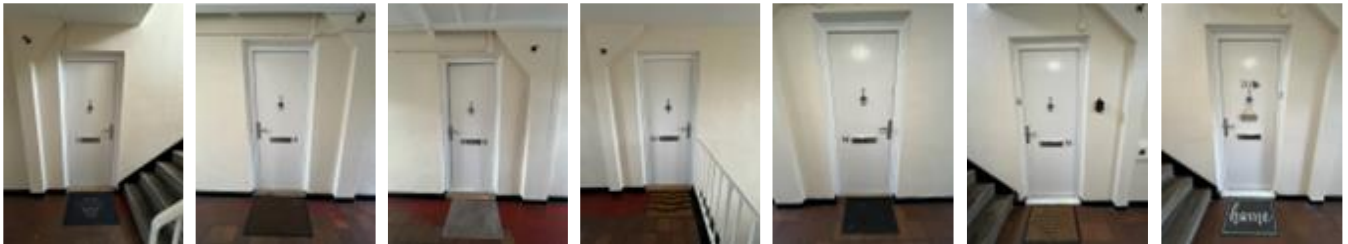
- 4) At a number of flat entrances door mats are present; the fire rating is not known on these door mats and are deemed to be low risk.

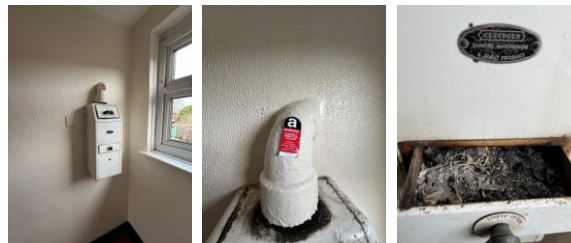
- 5) Upon the 1st floor landings there is small incinerator unit. In block 1-12 there is evidence that this unit is being used to burn items. The units within blocks 2-12 & 14-24 need to be removed or sealed up. *Email sent to Building and Fire Safety Team Manager and Assistant Building Surveyor 20/11/2025 who are looking to get the incinerators removed.*

P2	Within 1-3 months Fire Rapid Response JM:18724327	04/02/2026
7/5	Block 2-12 and 12-24: Incinerators situated on the 1 st floor of each block are to be removed. Email sent to Building and Fire Safety Team Manager and Assistant Building Surveyor 20/11/2025. Contract given to Bradleys

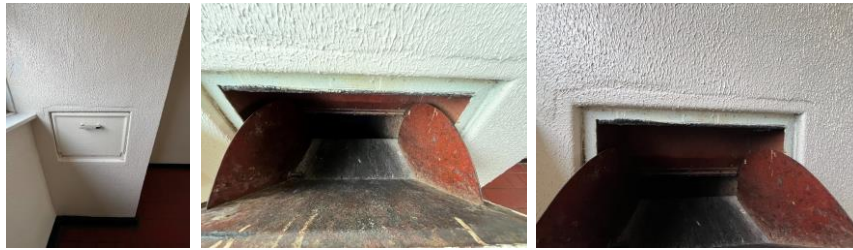
- 6) There are bin chutes situated on the 1st and 2nd floor of each block. These require upgrading due to not having suitable fire safety seals installed within them.

P3	Within 3-6 Bradleys	<i>Resolved</i>
7/6	Block 2-12 and 14-24: Upgrade bin chutes due to not being fitted with suitable fire seals.

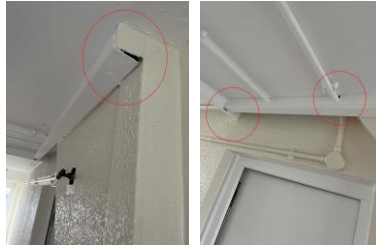
d) 1st Floor: Fire stopping required in 3 places to metal trunking above flat 8 – see pictures below for locations

7/7d	Block 2-12: Fire stopping to trunking required by flat 8. See photos for locations

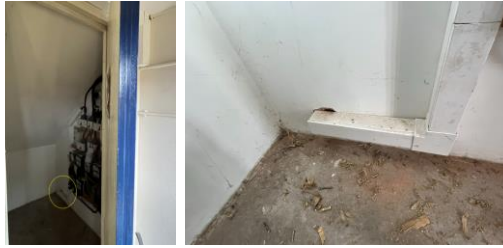
- a) Within block 2-12 the service cupboard located by the front door requires fire stopping. Location: Right hand side wall at the rear, where the plastic trunking is located.

P2	Within 1-3 months Fire Rapid Response JM 18492377	15/01/2026
10/6a	Block 2-12: Fire stop required, right hand side wall at the rear, by trunking.

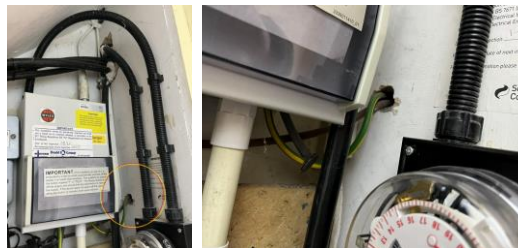
- c) Within block 2-12 the service cupboard requires fire stopping where the cables run through the wall. Location: Inside cupboard right hand side front wall above timer clock.

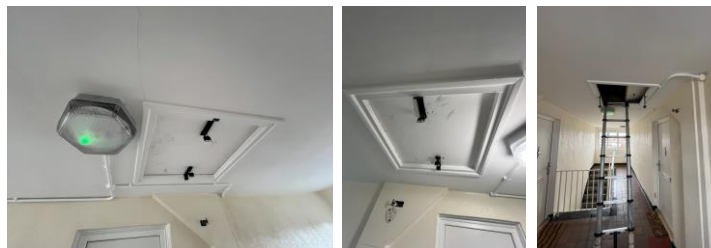
8) On the top floor there is a timber loft hatch access door. This access door is not fire rated and would recommend being upgraded to a fire rated loft access door within future refurbishment, due to the communal area being sterile it is low risk. The hatch door is to be kept padlocked at all times.

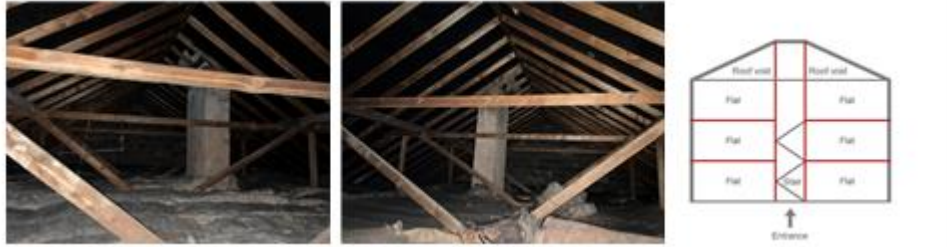
- b) Within the roof void of block 14-24 there is no compartment walls installed to separate the flats and communal areas. It is recommended that separation is installed within these areas.

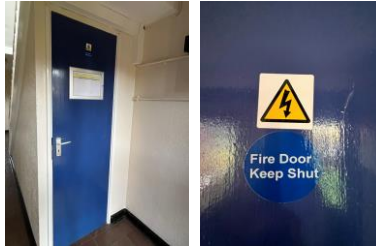
- 1) The service cupboards should display “Fire Door Keep locked” *Email sent to the caretaker to replace current signage 20/11/2025*

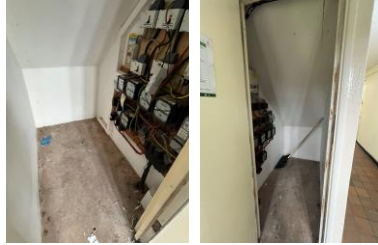
- 7) The blocks service cupboards are located on the ground floor and consist of notional FD30 fire rated door. All cupboards should be free from any combustibles and always kept locked. Signage to be displayed on these doors 'Fire Door Keep Locked'

- a) Relocate snow shovel from service cupboard in block 12-24.**
