# Fire Risk Assessment

**Shepherds Fold,  
Rowley Regis,  
B65 8BG**

**Date Completed: 05/12/2025**

**Current Risk Rating = Tolerable**

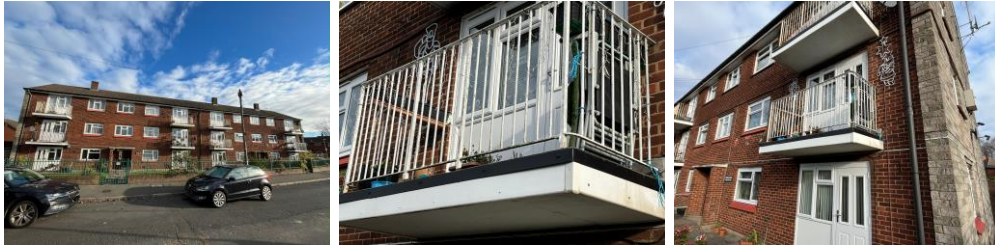
- 3) The flats on the first and second floors each have a small, front-facing balcony fitted with ironwork railings. The concrete floor of the balcony has a uPVC fascia fitted with some flats having the underneath covered in a fire board and others in uPVC. Recommend that the uPVC is removed with future refurbishment.

Some of these balconies have various items stored on them. Due to the low risk these will be ok to stay in place.

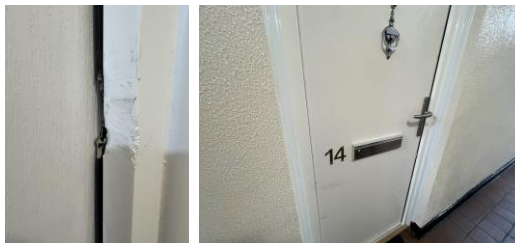
- i) **Flat 14: Did not get access to the flat. External section of the frame on the right-hand side halfway down is damaged. May need replacement.**

| 7/3i | Flat 14: Entrance door frame damaged. Also, signs of surface damage to the door. Assess and make fire safe. | | P2 | Within 1-3 months<br>Fire Rapid Response | |

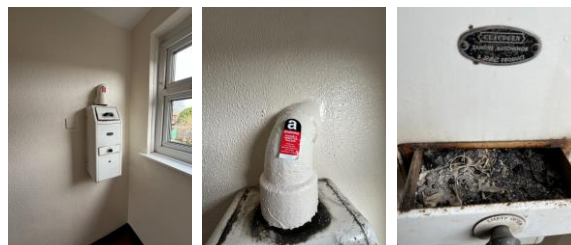
- 5) Upon the 1<sup>st</sup> floor landings there is small incinerator unit. In block 1-12 there is evidence that this unit is being used to burn items. The units within blocks 2-12 & 14-24 need to be removed or sealed up. *Email sent to Building and Fire Safety Team Manager and Assistant Building Surveyor 20/11/2025 who are looking to get the incinerators removed.*

| 7/5 | Block 2-12 and 12-24: Incinerators situated on the 1 <sup>st</sup> floor of each block are to be removed. Email sent to Building and Fire Safety Team Manager and Assistant Building Surveyor 20/11/2025. Contract given to Bradleys | | P3 | Within 3-6 months<br>Bradleys | <i>Resolved</i> |

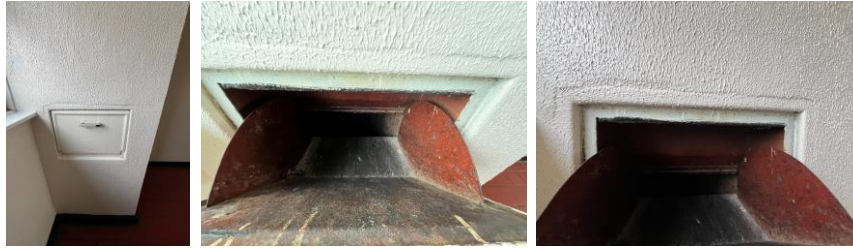
- 6) There are bin chutes situated on the 1<sup>st</sup> and 2<sup>nd</sup> floor of each block. These require upgrading due to not having suitable fire safety seals installed within them.

| 7/6 | Block 2-12 and 14-24: Upgrade bion chutes due to not being fitted with suitable fire seals. | | P3 | Within 3-6 months<br>Repairs | |

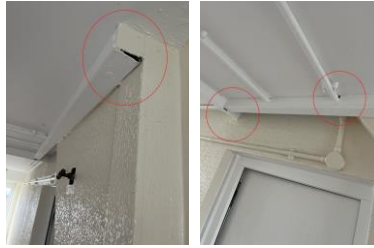
**d) 1<sup>st</sup> Floor: Fire stopping required in 3 places to metal trunking above flat 8 – see pictures below for locations**

| 7/7d | Block 2-12: Fire stopping to trunking required by flat 8. See photos for locations | | P2 | Within 1-3 months<br>Fire Rapid Response | |

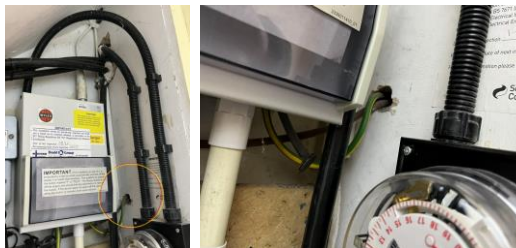
- c) Within block 2-12 the service cupboard requires fire stopping where the cables run through the wall. Location: Inside cupboard right hand side front wall above timer clock.

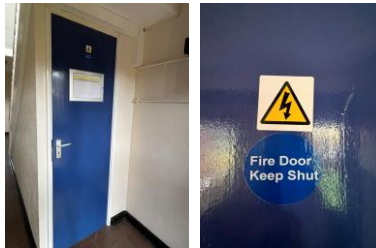
- 1) The service cupboards should display “Fire Door Keep locked” *Email sent to the caretaker to replace current signage 20/11/2025*

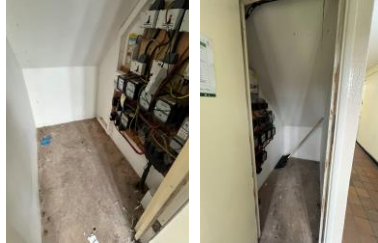
- 7) The blocks service cupboards are located on the ground floor and consist of notional FD30 fire rated door. All cupboards should be free from any combustibles and always kept locked. Signage to be displayed on these doors 'Fire Door Keep Locked'

- a) Relocate snow shovel from service cupboard in block 12-24.**
