Fire Risk Assessment

1-11

**Shepherds Fold,
Cradley Heath,
B65 8BG.**

Date Completed:01/12/2025

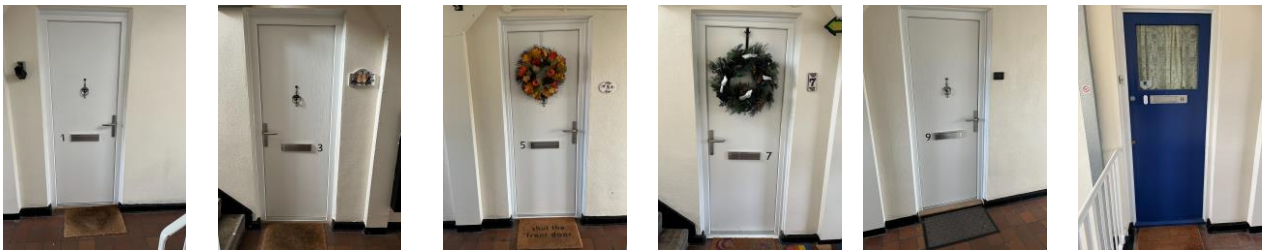
- 1) The majority of Individual flat doors are FD30s rated composite fire doors, with flat No 11 being a wooden door.

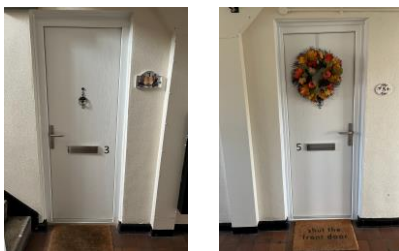
- 3) Flat 3 and no 5 Doors were inspected, and reliably fully self-closes on latch.

- 4) Flat 3 and 5 entrance doors had some excessive gaps when inspected, a full fire door inspection of all the doors in the block by the rapid fire team is recommended. See Action 7/4

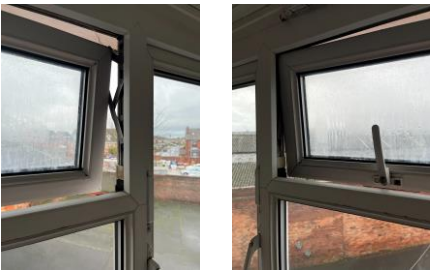
- 16) On the first floor at the top of the stairs the small centre window does not close correctly in to the frame, this requires adjustment. See Action 7/16.**

7/16	On the first floor at the top of the stairs the small centre window does not close correctly in to the frame, this requires adjustment.

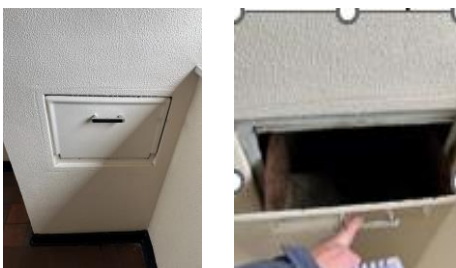
- 18) The bin refuse hoppers on the second and third floors do not have smoke seals fitted. Install smoke seals or upgrade with replacement hoppers. See action 7/18.**

P3	3-6 Months Repairs	
7/18	Install smoke seals or upgrade with replacement hoppers.

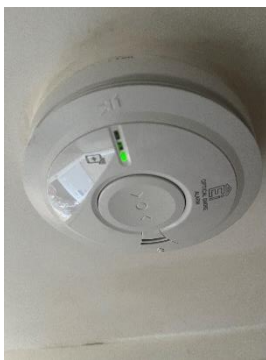
Flat 5 was accessed and was seen to be LD3 standard.
Flat 3 was accessed and was seen to be LD2 standard.

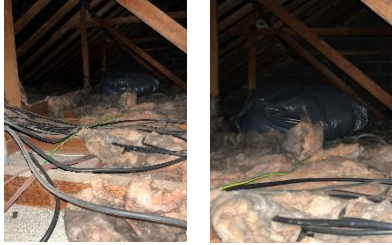
14/7	Electrical cables in loft space are not adequately supported throughout the span and require correctly supporting and tidying. Replace missing insulation where required.
