Fire Risk Assessment

1 -3 Warren Drive

Rowley Regis, B65 8PS

Date Completed: 5th December 2025

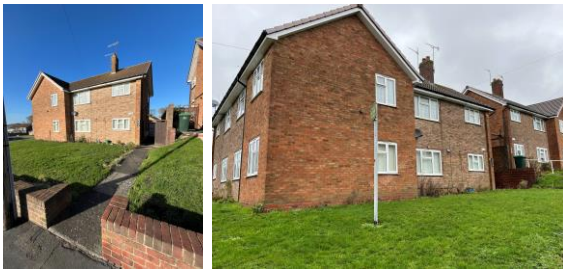
- 1) The exterior of the building is primarily traditional brick construction with a pitched roof design. The roof features concrete tiles and UPVC fascia boards along the roofline.

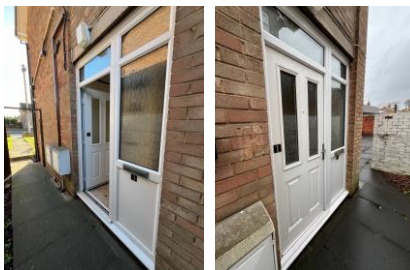
- 2) Front entrance door to the block is of UPVC construction with double glazing installed within the unit.

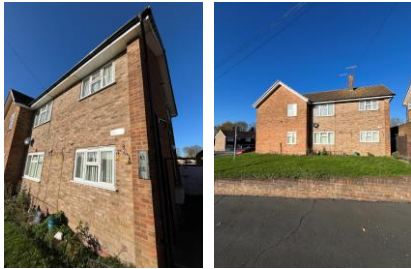
- 3) UPVC double-glazed window units have been installed in each flat and in the communal areas within the block.

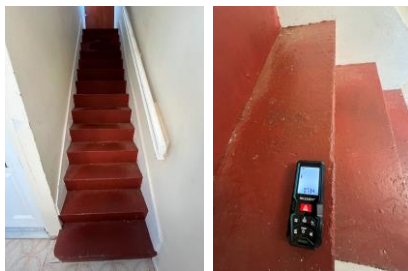
- 3) 1-3 Warren Drive contains a single concrete staircase, positioned at the entrance of the block, which provides an adequate means of escape for the 1st floor flat. The width of the staircase, measured from handrail to wall, is 734 mm respectively. This staircase is kept clear to ensure a safe means of escape.

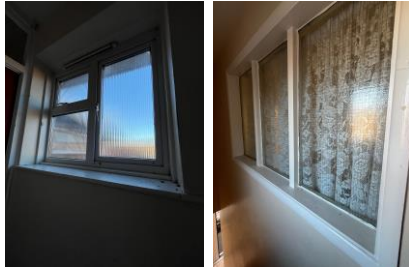
- 4) A UPVC window unit has been installed on the staircase landing which is openable without the use of key. This installation provides sufficient borrowed lighting and ventilation, while an incorporated Georgian wired glazing unit has been installed on the flat side to protect the means of escape and prevent the spread of fire and smoke. It should be noted that there is currently no automatic smoke ventilation system installed on the premises.

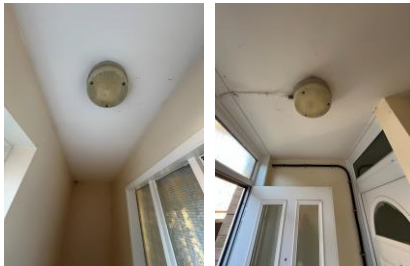
- 5) There is no emergency lighting in place at the block, however there is sufficient lighting installed over the staircase and over the small hallway by the final exit door.

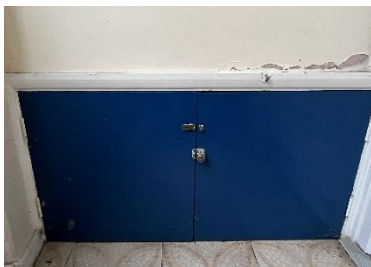
- 6) The ground floor entrance houses a service cupboard secured by a push-button lock; it is recommended that this mechanism be upgraded to a more secure, budget-type lock. *This has been noted in observations to be upgraded in any future refurbishment to the block.*

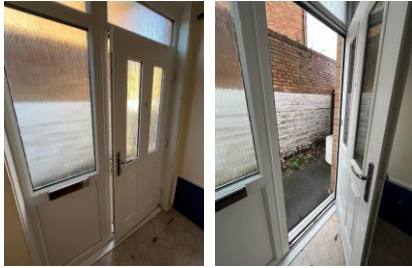
- 8) The final exit door is installed with a thumb turn lock, this aids easy and safe evacuation out of the building in an event of a fire.

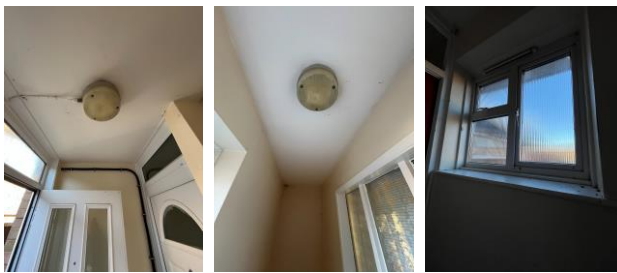
- 1) While dedicated emergency lighting has not been installed on the premises, the existing illumination is deemed adequate. This is due to the strategic placement of lighting units above the stairs and by the final exit, supplemented by sufficient borrowed lighting from the externally facing window on the staircase landing.

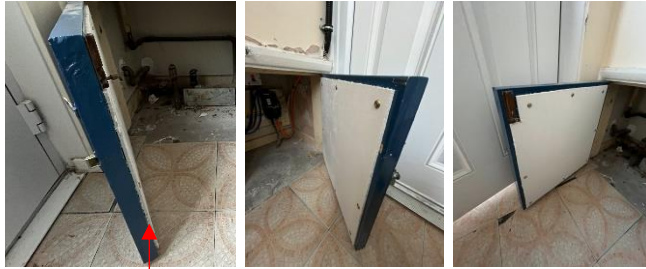
- 3) The rear of the service cupboard doors on the ground floor has been fitted with Promat SUPALUX boarding to establish a fire-resisting barrier. This installation is a form of passive fire protection intended to maintain the integrity of the fire compartmentation and delay the spread of fire and smoke.

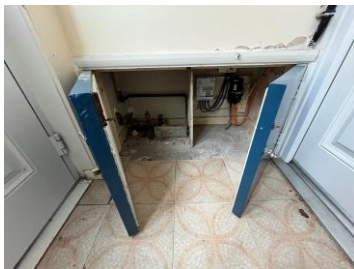
- 4) Electrical service cupboard is missing combined intumescent strips. *This has been noted in observations to upgrade service cupboard doors containing electrical installation to 44mm FD30s lockable doors with mandatory signage in any future refurbishment to the block*

Upgrade service cupboard doors containing electrical installation to 44mm FD30s lockable doors with mandatory signage.

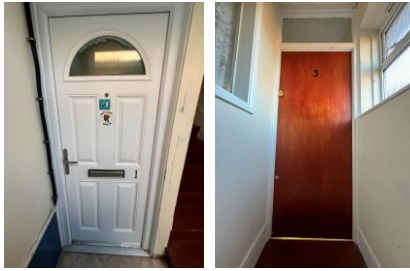
At present it is tolerable to have a notional FD30s timber door to flat 3 but would be recommended that on any future refurbishment of the block that this door be replaced with certified FD30s fire door.

- 5) Flat 1 has been fitted with a certified composite FD30S fire door assembly. In contrast, Flat 3 currently utilizes a notional timber door with an approximate FD30S fire rating. It is recommended that, during the next programmed refurbishment or maintenance cycle for the building, the door for Flat 3 be upgraded to a certified FD30S fire door to ensure full compliance with current safety standards and maintain consistent protection.

It is recommended that for future renovations of the block that the notional FD30s timber fire door at flat 3 to be replaced with FD30s certified fire rated doors.

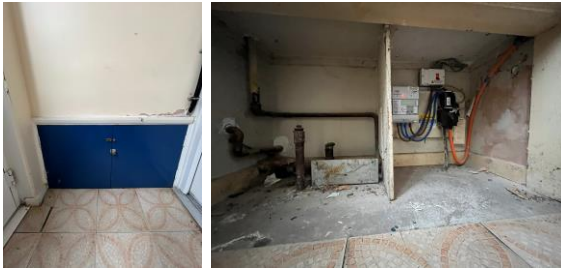
- 5) Resident electrical meter is in a service cupboard on the ground floor next to flat 1 entrance. This is kept free from any combustibles.
