# Fire Risk Assessment

## 2 - 4 Warren Drive

**Rowley Regis, B65 8PS**

**Date Completed: 5<sup>th</sup> December 2025**

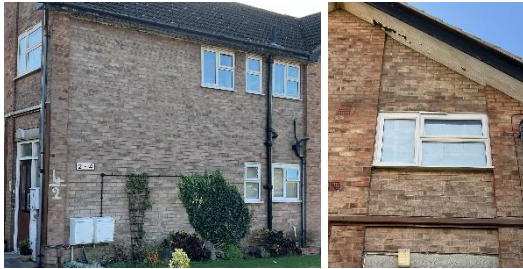
- 3) UPVC double-glazed window units have been installed in each flat and in the communal areas within the block.

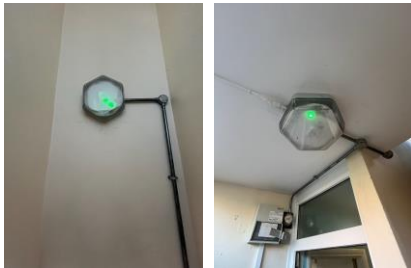
- 5) There is emergency lighting in place at the block, units are present in the ground floor hallways and over the staircase.

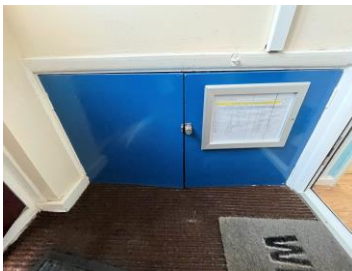
- 6) **The ground floor entrance houses a service cupboard secured by a push-button lock; it is recommended that this mechanism be upgraded to a more secure, budget-type lock.** *This has been noted in observations to be upgraded in any future refurbishment to the block.*

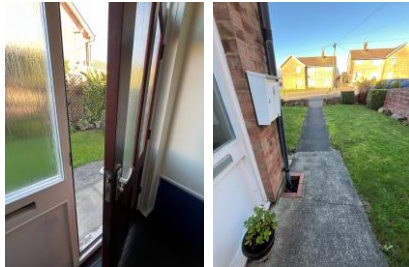
- 9) There is a sufficient final exit door which lead to a place of ultimate safety.

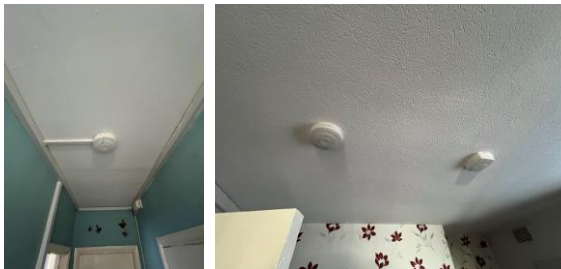
- 1) Early warning is limited to hard wire or battery smoke alarms within each of the resident's flats the equipment is subjected to a cyclical test.
- 2) Based on the sample of properties accessed during the fire risk assessment the smoke alarms within resident's flats are installed to an LD3 Standard.
- 3) There is no effective means for detecting an outbreak of fire to communal areas. The reason for this is:
  - I. Such systems may get vandalised.
  - II. False alarms would occur.
  - III. A Stay Put - Unless policy is in place
- 4) Access was obtained to resident's flats to check for detection.

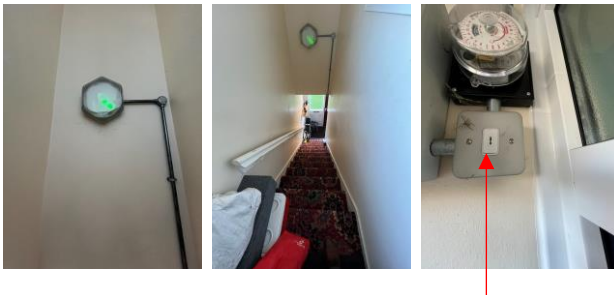
- 3) Emergency lighting is installed throughout the building, including communal areas such as hallway and stairways. The test switch is located next to the main distribution board in the entrance hallway.

Emergency lights and test switch

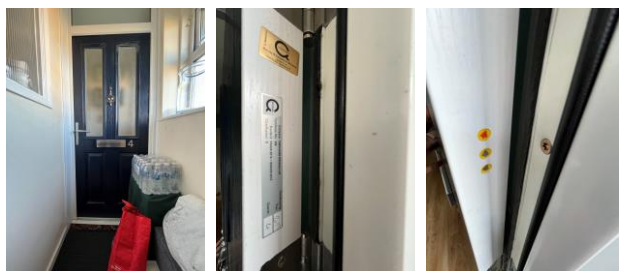
- 3) Flat 2 and 4 have been fitted with a composite FD30S fire doors assembly.

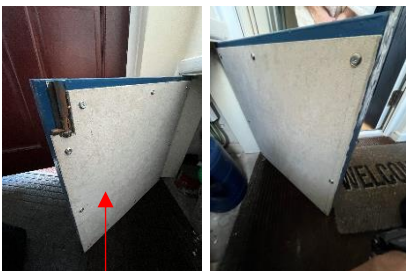
- 6) The rear of the service cupboard doors on the ground floor has been fitted with Promat SUPALUX boarding to establish a fire-resisting barrier. This installation is a form of passive fire protection intended to maintain the integrity of the fire compartmentation and delay the spread of fire and smoke.

SUPALUX boarding

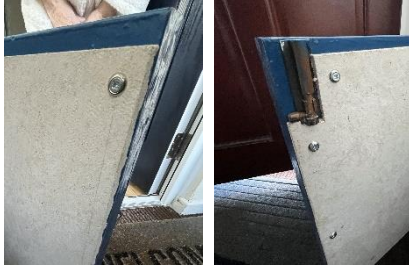
- 7) Electrical service cupboard is missing combined intumescent strips. *This has been noted in observations to upgrade service cupboard doors containing electrical installation to 44mm FD30s lockable doors with mandatory signage in any future refurbishment to the block.*

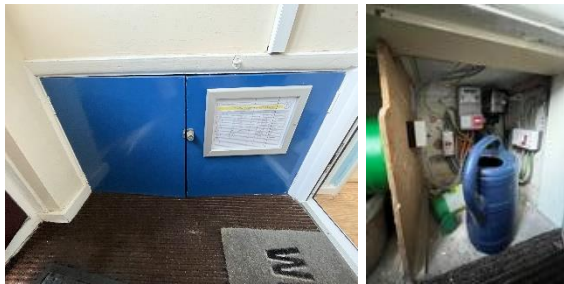
5) Resident electrical meter is in a service cupboard on the ground floor next to flat 2 entrance.

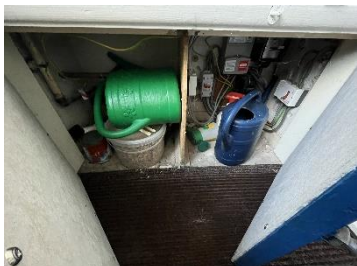
6) Electrical cupboard should be kept clear of any items of combustion, Items have been placed in the electrical cupboard which will need to be removed.

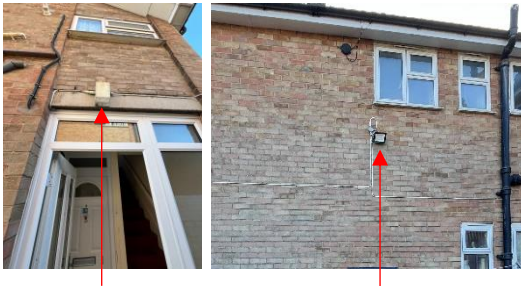
- 1) There is no current evidence of arson.
- 2) The perimeter of the premises is well illuminated with the installation of external lighting.

Front and rear external lighting.
