Fire Risk Assessment

5 -7 Warren Drive

Rowley Regis, B65 8PS

Date Completed: 8th December 2025

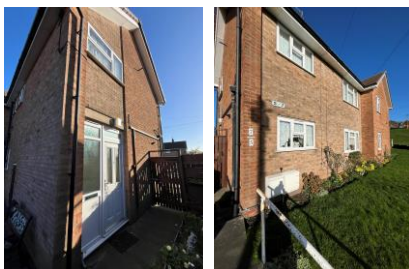
- 2) UPVC double-glazed door has been installed for the main entrance to the block with UPVC window units for each flat and in the communal areas within the block.

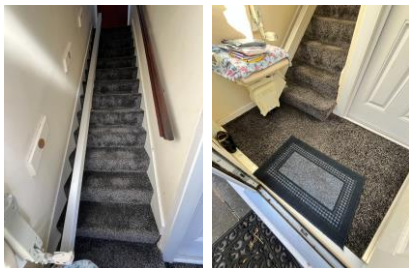
- 2) The section of the entrance hallway floor has carpet installed in the entrance hallway and stairs. The fire rating to the carpet is not known. It is recommended that this is to be removed on any future renovations to the block.

Communal hall and stairway have carpet installed. Fire resistance to the carpet is not known. Recommended to be removed on any future renovations to the block.

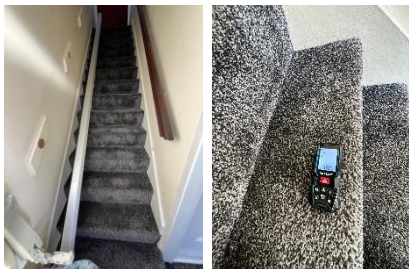
A stairlift has been installed on the staircase, reducing its width; however, this remains acceptable as the stairs serve only a single flat, and a handrail has been positioned on the opposite side to mitigate any associated risks. The stairs and hallway are currently carpeted, and this should be removed as part of any future refurbishment to ensure the escape route remains free from combustible materials.

- 3) 5 -7 Warren Drive contains a single concrete staircase, positioned at the entrance of the block, which provides an adequate means of escape. It was observed that a stairlift has been installed in the communal area of block 5-7, providing disability access between the ground and first floors towards flat 7. This installation has led to a slight reduction in the available width of the staircase for pedestrians traveling on foot, measured at 505mm, however, the risk level to any individuals in an emergency is considered low. This assessment is based on two key factors: the staircase primarily serves access to flat 7 exclusively, and the handrail has been successfully relocated to the opposite wall to mitigate potential hazards.

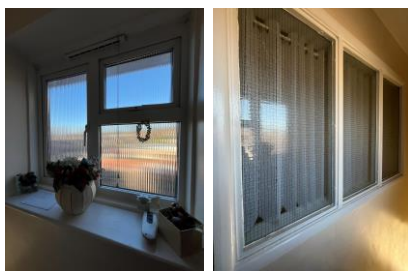
- 4) A UPVC window unit has been installed on the staircase landing which is openable without the use of key. This installation provides sufficient borrowed lighting and ventilation, while an incorporated Georgian wired glazing unit has been installed on the flat side to protect the means of escape and prevent the spread of fire and smoke. It should be noted that there is currently no automatic smoke ventilation system installed on the premises.

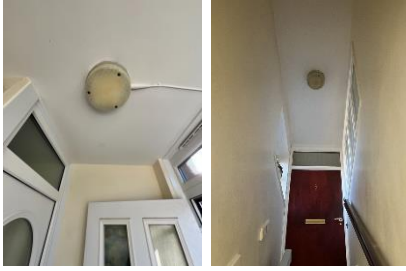
- 5) There is no emergency lighting in place at the block, however there is sufficient lighting installed over the staircase and over the small hallway by the final exit door.

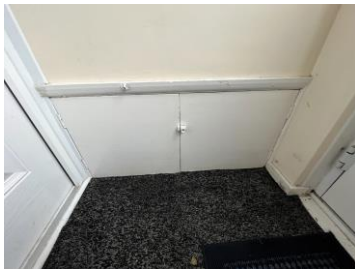
- 6) The ground floor entrance houses a service cupboard secured by a push-button lock. *It is recommended that this mechanism be upgraded to a more secure, budget-type lock in any future refurbishment to the block.*

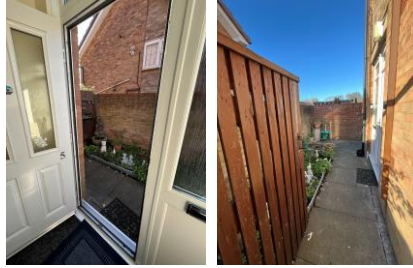
- 9) A safe and clear escape route is available from the block via a timber garden gate; the absence of a lock facilitates swift and safe evacuation for residents in an emergency.

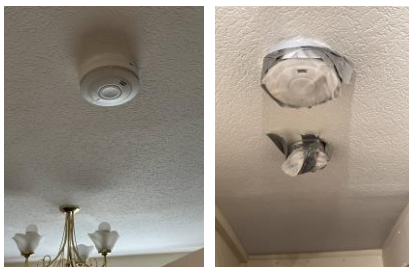
- 1) Early warning is limited to hard wire or battery smoke alarms within each of the resident's flats, this is installed to a minimum of LD3 as standard, the equipment is subjected to a cyclical test.
- 2) Based on the sample of properties accessed during the fire risk assessment the smoke alarms within resident's flats are installed to an LD3 Standard
- 3) There is no effective means for detecting an outbreak of fire to communal areas. The reason for this is:
 - I. Such systems may get vandalised.
 - II. False alarms would occur.
 - III. A Stay Put - Unless policy is in place
- 4) Access was obtained to resident's flats to check for detection.

Flat 5 – LD1, Hallway (*escape route*) Kitchen, Bedrooms & lounge
(*risk areas*)

SMBC's Job Manager system confirms detectors to LD1 standard were checked as part of the most recent annual gas service for flat 5. Flat 7 is a leaseholder property, so there is no information stored on the system for this flat.

Note: Hallway detectors were covered by contractors working on the flat on the day of conducting the FRA; this was only a temporary measure to avoid false activation.

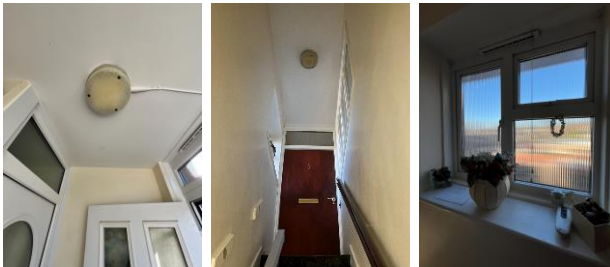
- 1) While dedicated emergency lighting has not been installed on the premises, the existing illumination is deemed adequate. This is due to the strategic placement of lighting units above the stairs and by the final exit, supplemented by sufficient borrowed lighting from the externally facing window on the staircase landing.

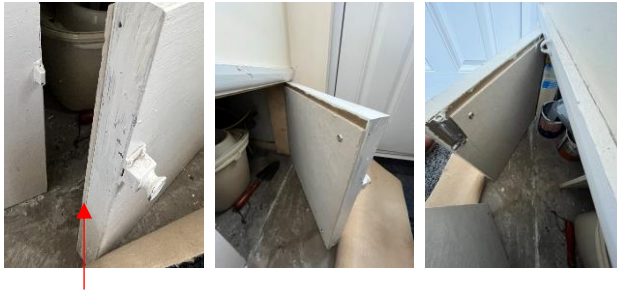
SUPALUX Boarding

- 3) The rear of the service cupboard doors on the ground floor has been fitted with Promat SUPALUX boarding to establish a fire-resisting barrier. This installation is a form of passive fire protection intended to maintain the integrity of the fire compartmentation and delay the spread of fire and smoke.

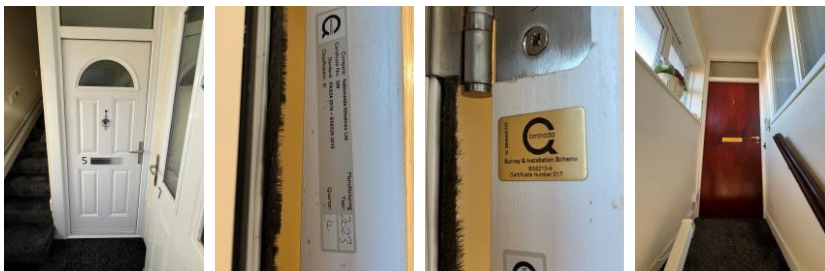
At present it is tolerable to have a notional FD30s timber door to flat 7 but would be recommended that on any future refurbishment of the block that this door be replaced with certified FD30s fire door.

- 4) Flat 5 has been fitted with a certified composite FD30s fire door assembly. In contrast, Flat 7 which is a leaseholder property currently utilizes a notional timber door with an approximate FD30s fire rating. It is recommended that, during the next programmed refurbishment or maintenance cycle for the building, the door for Flat 7 be upgraded to a certified FD30s fire door to ensure full compliance with current safety standards and maintain consistent protection.

It is recommended that for future renovations of the block that the notional FD30s timber fire door at flat 7 to be replaced with FD30s certified fire rated door.

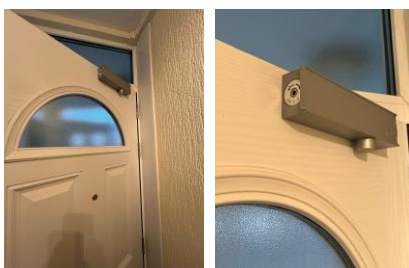
- 5) Access was gained to flat 5 to sample self closing devices and condition of fire and smoke seals.
- 6) Flat 5 self closing device arm has been disconnected from the frame.**

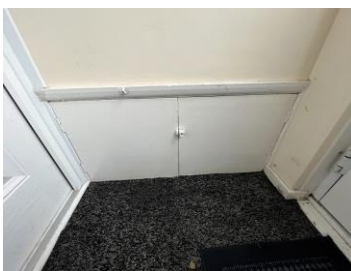
- 4) **Service cupboard in entrance hallway requires “Fire Door Keep Locked” signage**

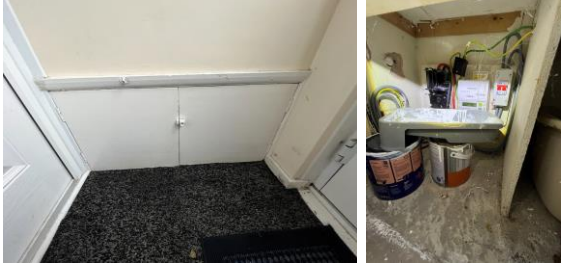
- 5) Resident electrical meter is in a service cupboard on the ground floor next to flat 5 entrance, this was found to have tins of paint stored within it. These will need to be removed.**

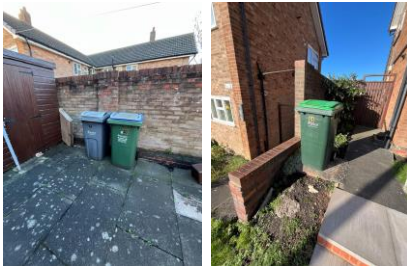
- 1) Sandwell Cleaning services are not employed at this block.
- 2) Refuse bin is stored in a dedicated area next to a brick wall and away from the envelope of the building, this is at the rear of the block within the courtyard. Garden waste bin was located on the front of the block.

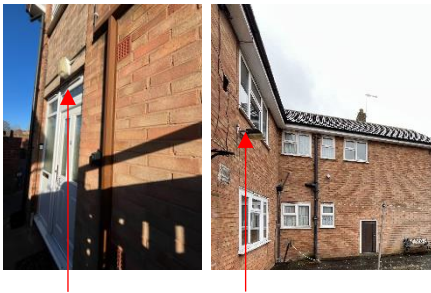
Front & rear external lighting.

- 1) There is no current evidence of arson.
- 2) The perimeter of the premises is well illuminated with the installation of external lighting.

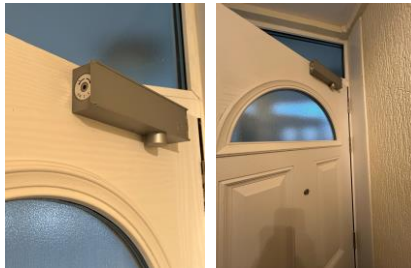
Question/ Ref No	Required Action	Supporting photograph	Priority	Timescale and Person Responsible	Date Completed
10/6	Flat 5 self-closing device arm has been disconnected from the frame, will require reinstallation.

P2	1 -3 Months Fire Rapid Response
