Fire Risk Assessment

Alfred Gunn House

**Thompson Road,
Oldbury, B68 8RW**

Date Completed: 4th December 2025

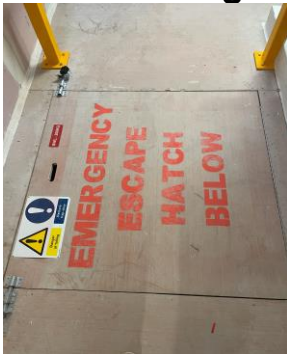
- 1) Escape hatches have been created in both lift motor rooms due to the excessive single travel distance of sixty metres to the entrance door to the plant room. **Floor joists supporting both escape hatches within lift motor rooms to be trimmed to allow for ease of lifting.**

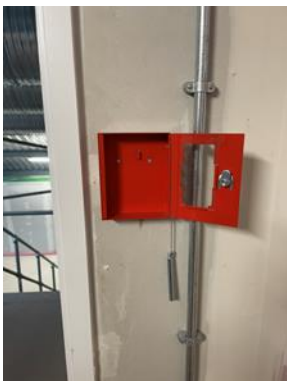
- 2) Due to the lack of escape ironmongery to the plant room doors. Red break glass boxes have been installed however the keys have been removed. Keys to be replaced and situation to be monitored. Relates to entrance door to plant room and entrance door to lift motor room directly in front of metal stair.

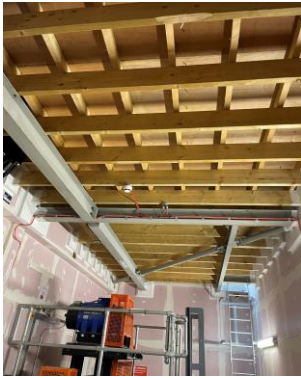
- 3) **Break glass box required in lift motor room (furthest from metal stair) to house keys for escape hatch.**
- 4) The timber flat roof covering the lift motor room and timber floor covering to the plant room should be considered, as part of a future works programme, for having the combustibility rating of these elements improved by the application of an intumescent paint by a specialist contractor. See observations section 19.

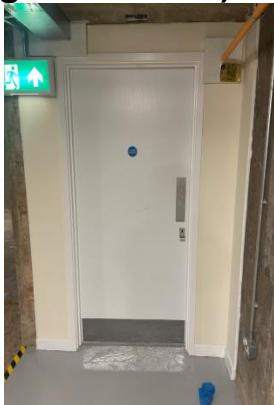
- 23) Dead lock to be removed/sealed to inner lobby door (lower ground floor) discharging into staircase B.

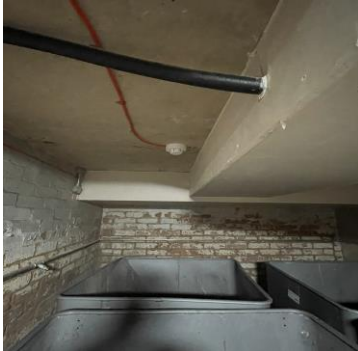
- 5) A deluge system is provided to the refuse chute bin store. An approved contractor maintains the system. The frequency for the maintenance checks is twice per year (April and October) of each calendar year. The newly installed fire stopping (boarded construction creating a down stand) has resulted in the smoke detection, which operates the deluge system, being within 300mm of the down stand. **Smoke detection to be re positioned (relates to both bin rooms).**

P2	Fire Rapid Response 1-3 Months	
8/5	Smoke detection within both bin rooms to be repositioned as within 300mm of down stand.

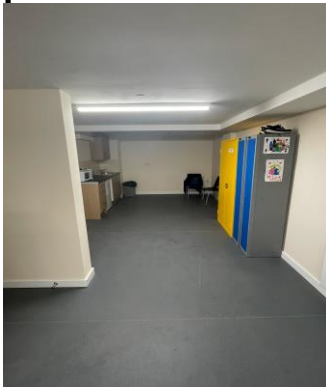
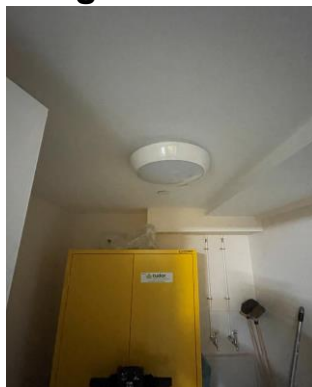
- 6) The lower ground floor has a caretaker's room with smoke detection provision. **This should be extended into the sluice room to provide audible warning to the WC area.**

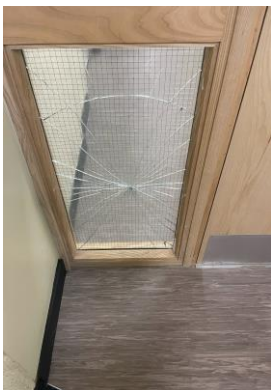
- 7) **Cracked glazing noted to door set adjacent to flat 14 in block C. Glazing to be replaced.**

10/7	Cracked Glazing to be replaced. Block C adjacent flat 14

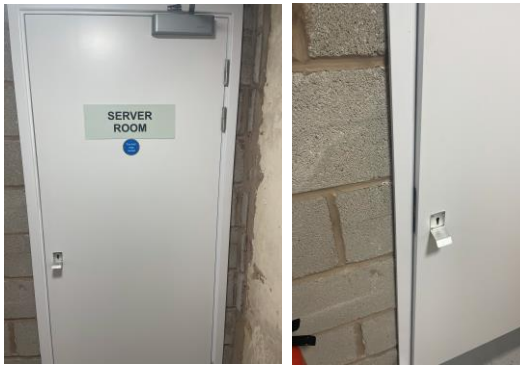
- 11) All service cupboards are locked with suited 54 mortice locks.
- 12) **Fire doors to the server room and the room behind the electrical intake room require adjustment as not closing into the frame.**

P3	Repairs 3-6 months	
10/12	Fire doors (2) to the server room and the room behind the electrical intake room require adjustment as not closing into the frame.

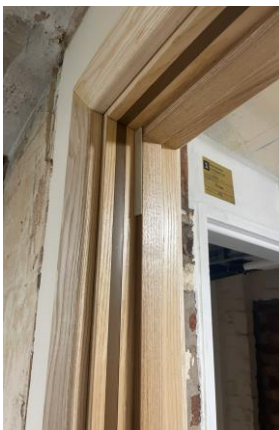
- 13) **Smoke seals are required to lift lobbies at Lower Ground Floor Level.**

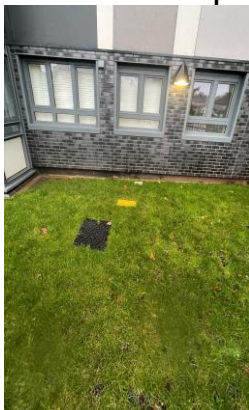
- 7) Front hydrant requires better identification. WMFS Water Officer has confirmed by email that they will install a suitable hydrant identification plate.
