Fire Risk Assessment

1 - 23

Monk Close,
Tipton,
DY4 7TP

Date Completed: 13/10/2025

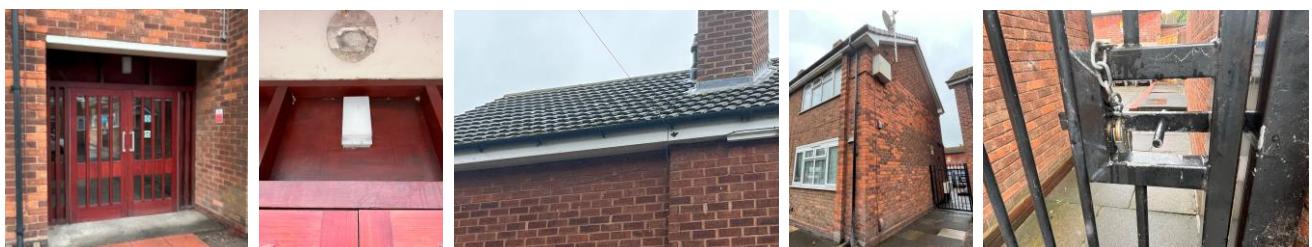
At the front of the premises, the main entrance features double wooden doors with glazed panels. Above the door, there is a security light. This door is not fitted with any locks and is accessible 24/7. Additionally, access to the premises is available via two side gates, which are secured with padlocks to prevent unauthorised entry.

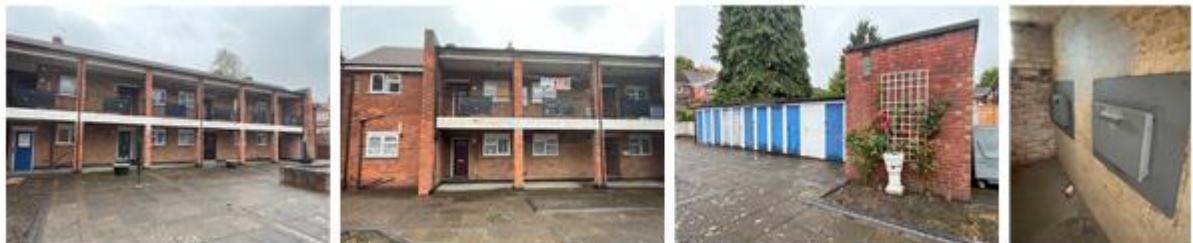
The main entrance leads into a large courtyard; on the ground floor there are 6 flats and an electrically service cupboard that open directly on to the courtyard. Also, within the courtyard is situated a purpose-built detached brick building that comprises of residential storage cupboards and a bin room with chutes.

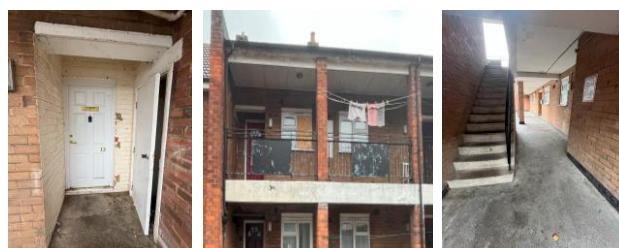
The flats on the first-floor lead out onto an open walkway. The walkway is concrete structure with ironwork railings. Next to the flat doors is a non-fire rated door that accesses a storage cupboard. Standard lighting is installed on the walls along this walkway to illuminate the area, no emergency lighting is fitted and not required under 3.41 of Approved Document B Volume 1. The stairway leads straight down to the front entrance, that comes out on Monk Close.

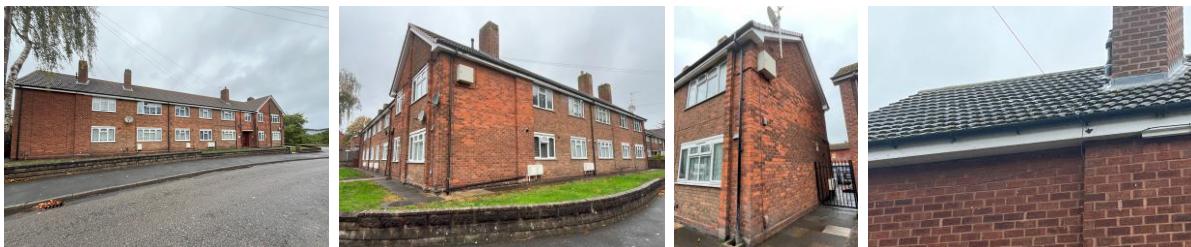
- 1) The external surface of the building is predominantly brick structure with uPVC soffits and fascia. The roof is pitched and fitted with Marley concrete interlocking roof tiles are fitted on the roof.

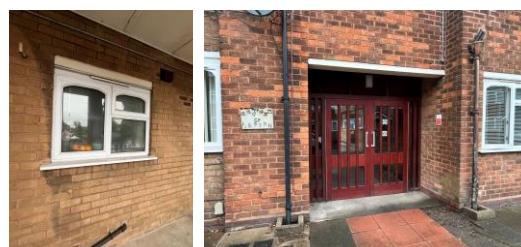
- 2) uPVC double glazed units have been installed to each flat. The main entrance is a timber and glass panelled door and frame, which is set back slightly from the building line. There is a light installed above the door to add safety/security. This door is not locked and accessible 24/7

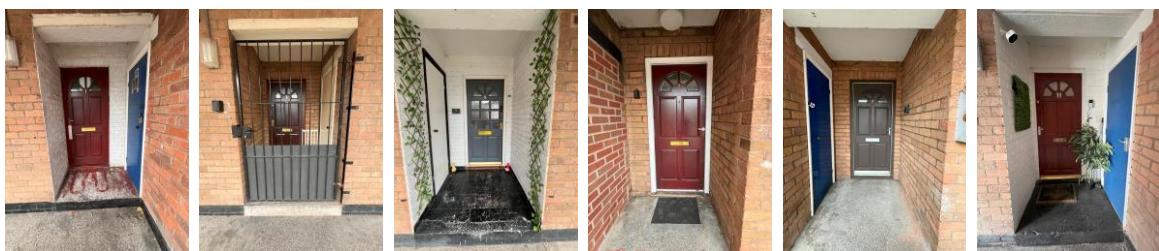
Ground floor 1-11

- 1) Each flat should be fitted with a minimum of an LD3 system to allow early warning from fire. See Section 8
- 2) 1st floor flats should be fitted with a minimum of a notional FD30 rated door. No access was gained at the time of the fire risk assessment, so cannot conclude if all doors meet the current standards and that any fire safety door furniture is fitted or been tampered with. Ground floor flats lead out into a courtyard so do not have to be fitted with FD30s rated doors.

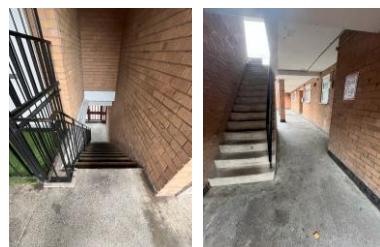
10) There is a concrete single stairway leading from the first floor to the final exit. Due to this area being left in darkness during dusk, **fit a light on the stairway route to assist.**

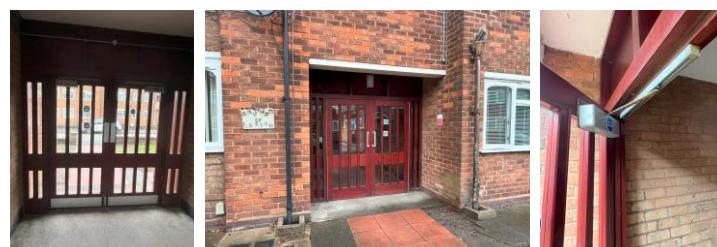
11) Final exit doors do not have any locking mechanisms fitted, so are opened by pushing them. They lead directly out on to Monk Close. The doors and frame are timber construction with glass panels and are fitted with self-closers. Above the roadside of the door a light is fitted to assist with safety/security.

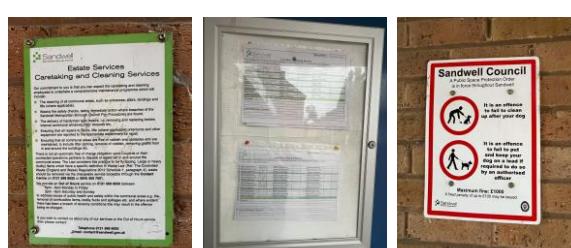
12) Communal areas are kept free of flammable items. The communal areas are checked on a regular basis by Caretaking / Cleaning teams 365 days per year and all items of rubbish are immediately removed. There is also an out of hour's service that allows combustible items of furniture / rubbish to be removed.

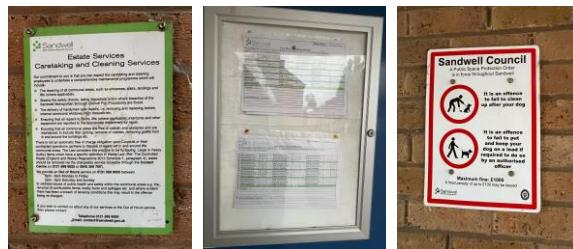
- 1) There is a regular Cleaning Service to the premises carried out by caretakers to minimise risk of waste accumulation.

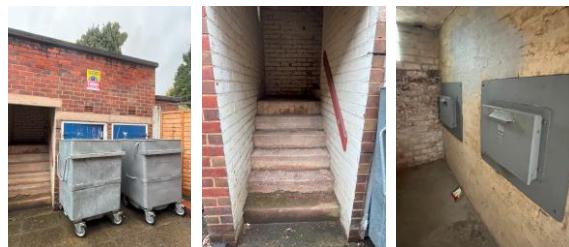
- 2) The refuse bins are located to the rear of the main building, next to a purpose-built bin room. The bins are kept outside due to being too big for the room.

The bin room also has a chute system but is not used due to the bins being located outside.

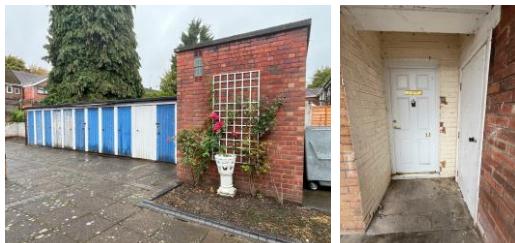
- 1) Residents instructed not to bring L.P.G cylinders into block.
- 2) The tenancy conditions, Section 7 – Condition 5.6 stipulates “If you live in a flat or maisonette, you, people living with you and any visitors to your property must not keep or use paraffin oil, petrol, bottled gas appliances or any other explosive, FLAMMABLE or dangerous material in the property. This restriction also applies to any storage facility situated in or attached to the block, which has been provided for your use.”
- 3) Residents should not store flammable liquids or gas cylinders on site.
- 4) No Flammable liquids stored on site by Caretakers / Cleaners.
- 5) Residents have individual storage cupboard internally and externally which they keep secured by means of own keys.
