Fire Risk Assessment

2-4

**Springfield Lane,
Rowley Regis,
B65 8PS**

Date Completed: 12/01/2026

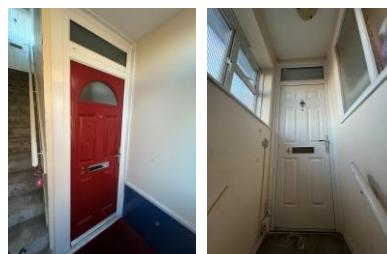
- 1) Each property is fitted with a minimum of an LD3 detection system within the flat. See Section 8
- 2) All corridors are of adequate width (at least 1050mm) and will be maintained clear to that width as a minimum.
- 3) Furthest distance to travel is from flat 4 to the final exit, this distance is approx. 14ft (4267mm)
- 4) None of the corridors that form part of the means of escape are dead ends.
- 5) Two flats within the block, both doors are FD30 composite doors

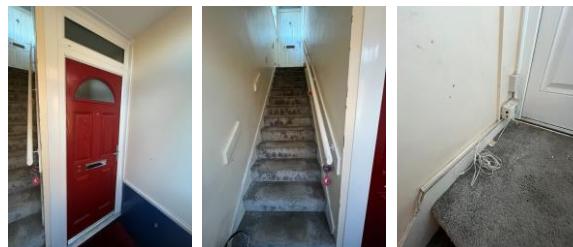
7) Outside 2 flat entrance a door mat is present, outside flat 4 and on the stairs, carpet is fitted; the fire rating is not known of the door mat or carpet and are deemed to be low risk as in good condition.

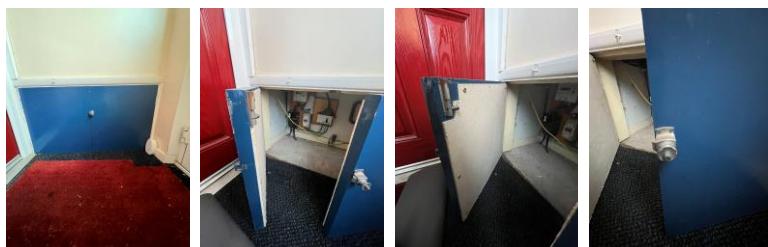
12) The service cupboard which is accessed with a thumb catch and is not lockable is located outside Flat 2, within the communal area, is recommended for upgrade during future refurbishment works. See Section 10. “Fire Door – Keep Shut” signage should be affixed to the current door.
Refer to Section 12 for the associated action.

- 1) The service cupboard outside flat 2 requires “Fire Door Keep shut” signage being fit. This to be changed after the cupboard has been upgraded with a lock to ‘Fire Door Keep Locked’

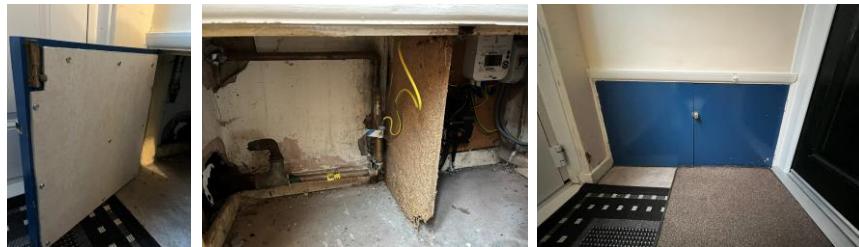
6) The service cupboard located outside Flat 2, within the communal area, is recommended for full upgrade during future refurbishment works. This should include the installation of a new fire-resistant door and frame, complete with an appropriate lock, intumescent seals and smoke brushes. The existing door currently has Supalux board fitted to its internal face. No signage present on the service cupboard door. Refer to Section 12 for the associated action.

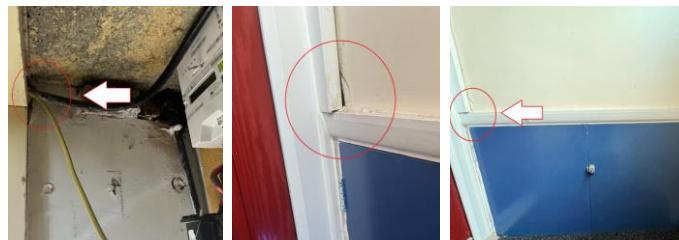
a) **Fire stopping required within the service cupboard that is situated outside flat 2.**

Location of fire stopping - As you look from outside: Inside, top front left of the cupboard where the cable comes through into the plastic cable trunking that's within the communal area.

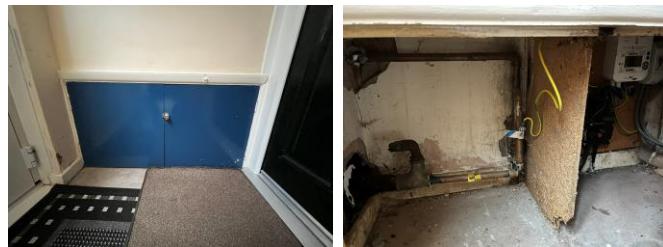
7) The blocks service cupboards are located on the ground floor. Service cupboard should be free from any combustibles. See section 10/6

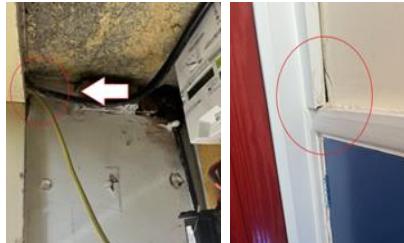
Question/ Ref No	Required Action	Supporting photograph	Priority	Timescale and Person Responsible	Date Completed
10/6a	<p>Fire stopping required within the service cupboard situated outside flat 2.</p> <p>Location of fire stopping - where the cable comes through into the plastic cable trunking that's within the communal area.</p>

P2	<p>Within 1-3 months</p> <p>Fire Rapid Response</p>
