Fire Risk Assessment

18-20

**Springfield Lane,
Rowley Regis,
B65 8PS**

Date Completed: 06/01/2026

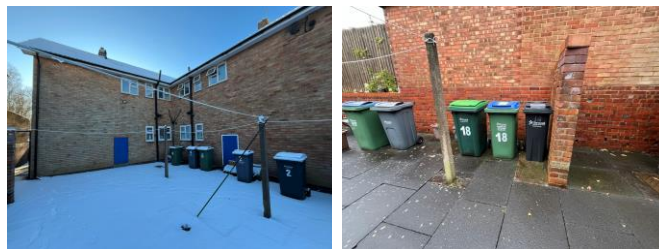
Bins are situated at the rear of the premises within the courtyard. A number of these bins are kept close to the premises and will recommend they are relocated away from the building, and a purpose-built bin area is installed with future refurbishments.

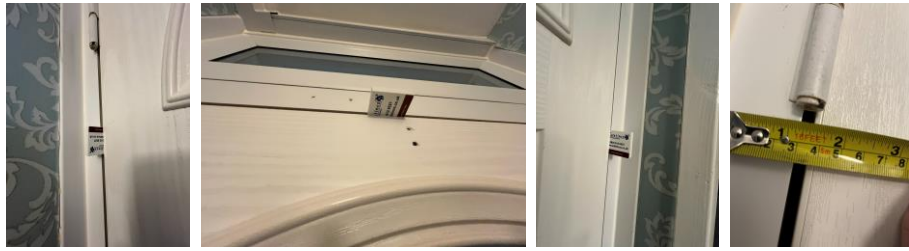
- b) Flat 18: Gap between the closed door and frame is approx. 6mm. Inspect and reduce the gap where possible.**

7/6b	Flat 18: Rehang door to close current gap of 6mm between frame and door

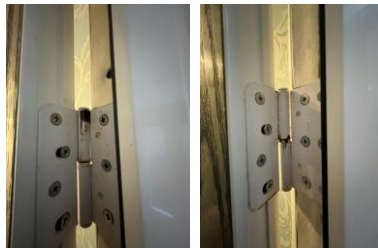
- c) Flat 18: Door hinges showing signs of damage. Oil leaking, replace hinges.**

P3	Within 3-6 months Fire Rapid Response	
7/6c	Flat 18: Hinges showing signs of damage, oil leaking. Inspect and change if required.

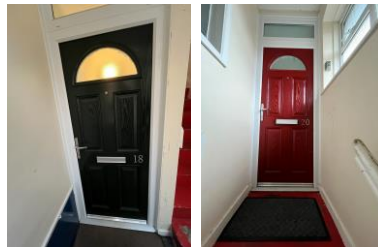
- 7) At the flat entrances door mats are present; the fire rating is not known on these door mats and are deemed to be low risk.**

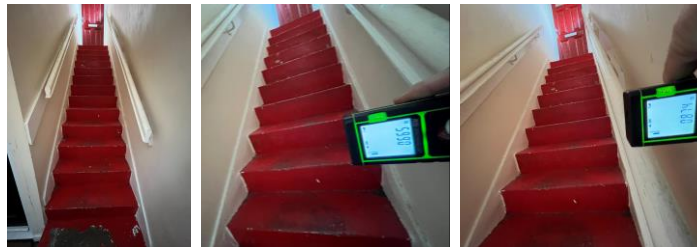
- 9) Within this block the first floor is accessed via a single staircase that provides a means of escape for flat 20 and has a width of a minimum of 665mm between the handrails, and 874mm wall to wall.

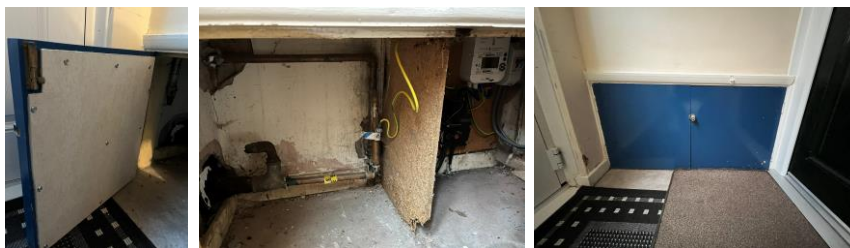
- 12) The service cupboard which is accessed with a thumb catch and is not lockable is located outside Flat 18, within the communal area, is recommended for upgrade during future refurbishment works. See Section 10. "Fire Door – Keep Shut" signage should be affixed to the current door. Refer to Section 12 for the associated action.

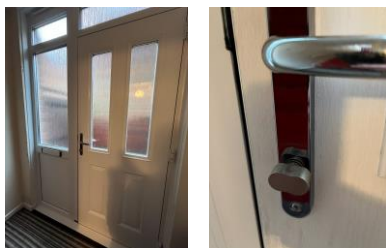
- 13) The final exit door is fitted with a thumb turn lock for ease of egress from within the property.

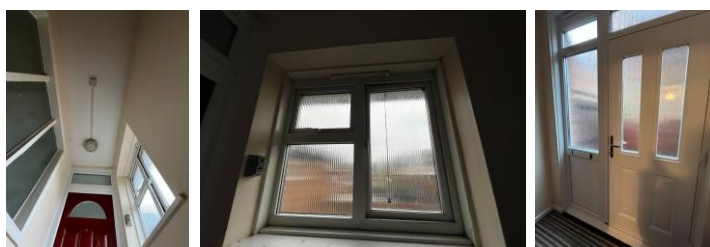
- 15) No emergency lighting is provided to communal landings and stairs. Adequate lighting comes from standard lighting also from the door and window areas.

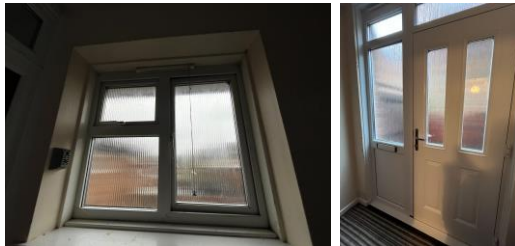
- 1) These premises are not fitted with emergency lighting
- 2) There is standard lighting within the communal area also landing window and final exit door to assist in lighting the communal areas from outside

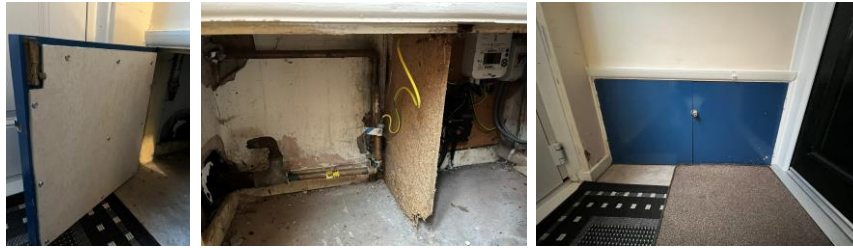
- 6) The service cupboard located outside Flat 18, within the communal area, is recommended for full upgrade during future refurbishment works. This should include the installation of a new fire-resistant door and frame, complete with an appropriate lock, intumescent seals and smoke brushes. The existing door currently has Supalux board fitted to its internal face. No signage present on the service cupboard door. Refer to Section 12 for the associated action.

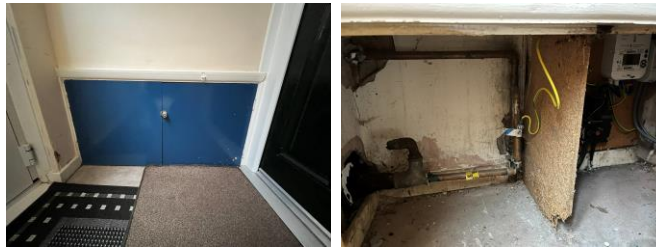
- 7) The blocks service cupboards are located on the ground floor. Service cupboard should be free from any combustibles. See section 10/6

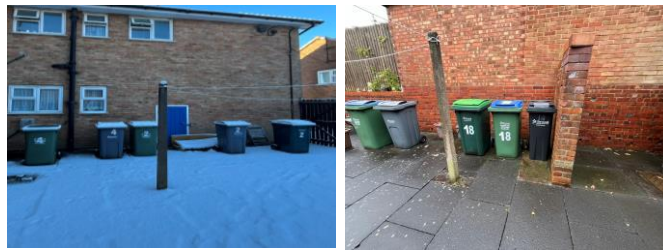
- 1) There is a regular Cleaning Service to the premises.
- 2) **The refuse bins for 18-20 Springfield Lane are being stored under the windows of the block in the rear courtyard. These are to be moved away from the premises, maybe reposition these with the bins from the adjoining property 2-4 Royal Oak Road, as both properties share the same rear courtyard.**

P3	Within 3-6 months Fire Rapid Response	
15/2	Relocate bins away from the building. Resite them to the same area where 2-4 Royal Oak Road bins are stored.

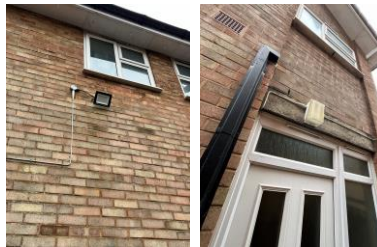
- 1) Regular checks are undertaken by Caretakers / Cleaning Team(s) 365 days per year which helps reduce the risk of arson.
- 2) Access to the premises is by means of a key that only residents have.
- 3) Perimeter is covered by external lighting

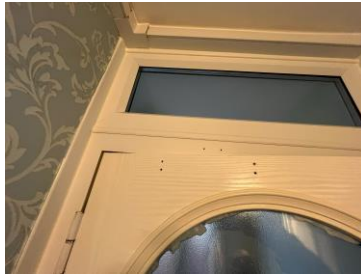
- a) Flat 18: No self-closer fitted at the time of Fire risk assessment, install new self-closer. Rapids resolved issue on the 23/12/2025

Question/ Ref No	Required Action	Supporting photograph	Priority	Timescale and Person Responsible	Date Completed
7/6a	Flat 18: Refit and adjust self closer. Resident removed due to arthritis

P2	Within 1-3 months Fire Rapid Response	<i>Resolved 23/12/2025</i>
