Fire Risk Assessment

2-8

**Bluestone Walk
Rowley Regis,
B65 9DG.**

Date Completed: 07/01/2026

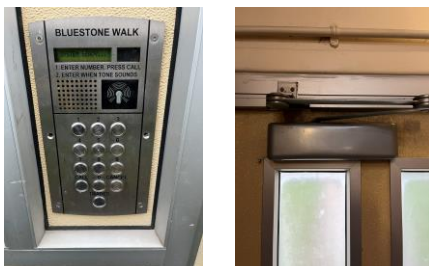
- 15) The only communal doors are the final exit doors.
- 16) The final exit door at the front of the building has a door entry system installed with a self closing device. These systems are designed to fail safe i.e., door unlocked in the event of a power failure. This prevents residents being locked in or out of the building.

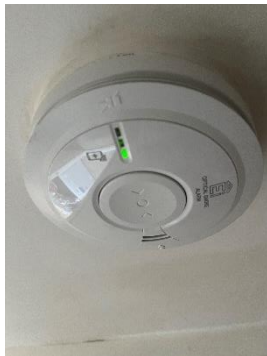
Flat 8 was accessed and was seen to be LD2 standard.
