Fire Risk Assessment

57 -59 Cromwell Close

Rowley Regis, B65 8NT

Date Completed: 6th January 2026

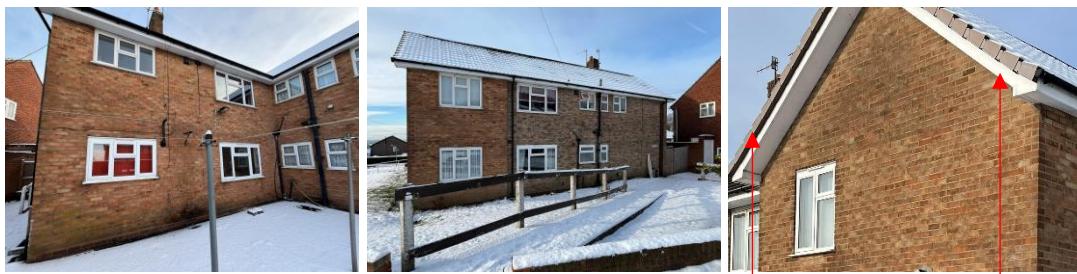
- 1) The exterior of the building is primarily traditional brick construction with a pitched roof design. The roof features concrete tiles and UPVC fascia boards below the roofline and underside with dry end verge caps above.

Dry verge end caps and UPVC fascia

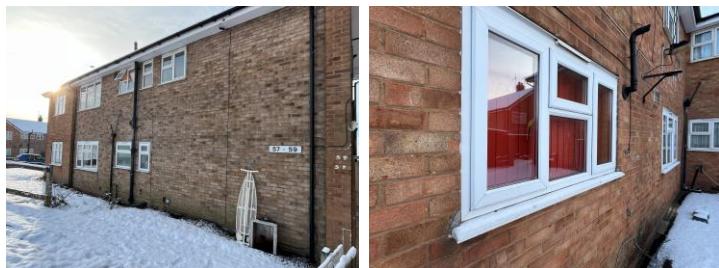
3) UPVC double-glazed window units have been installed in each flat on the front and the rear and in the communal areas within the block.

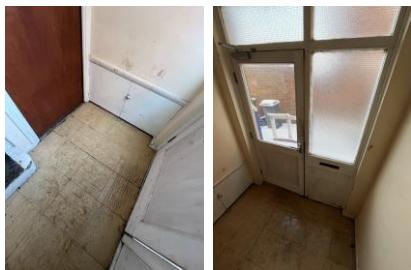
- 1) Each flat is equipped with, as a minimum LD3 fire detection to facilitate means of escape and provide sufficient response time.
- 2) A small section of the entrance hallway floor is finished with vinyl tiles. This area is maintained free of obstructions and combustible materials, thereby supporting a safe and unobstructed means of escape in the event of a fire.

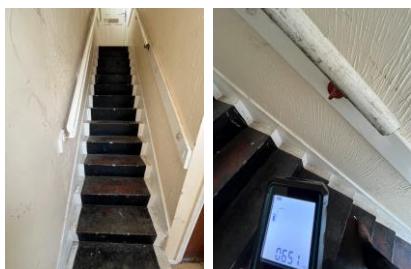
- 3) 57-59 Cromwell Close contains a single concrete staircase, positioned at the entrance of the block, which provides an adequate means of escape. The width of the staircases, measured from handrail to handrail, is 651mm respectively. This staircase is kept clear to ensure a safe means of escape.

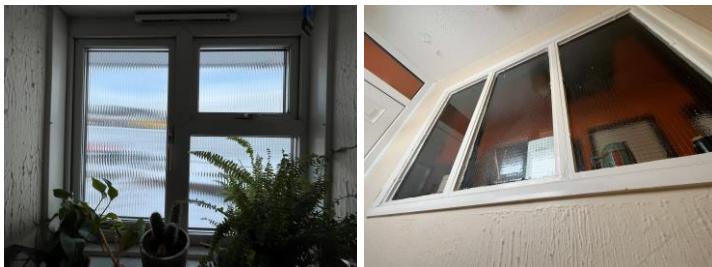
4) A UPVC window unit has been installed on the staircase landing which is openable without the use of key. This installation provides sufficient borrowed lighting and ventilation, while an incorporated Georgian wired glazing unit has been installed on the flat side to protect the means of escape and prevent the spread of fire and smoke. It should be noted that there is currently no automatic smoke ventilation system installed on the premises.

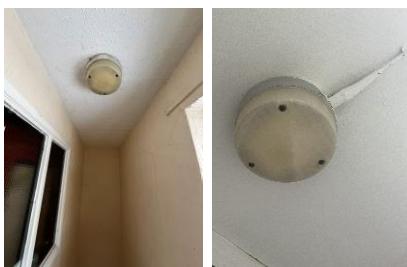
5) There is no emergency lighting in place at the block, however there is sufficient lighting installed over the staircase and over the small hallway by the final exit door.

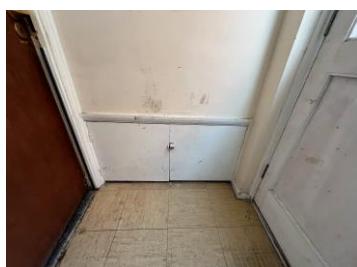
6) The ground floor entrance houses a service cupboard secured by a push-button lock; *it is recommended that this mechanism be upgraded to a more secure, budget-type lock.*

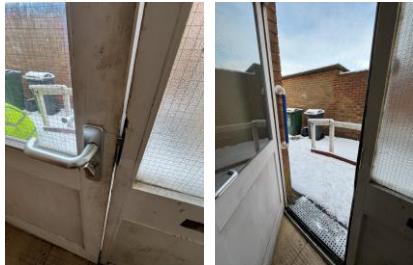
8) The final exit door is installed with a thumb turn lock, this aids easy and safe evacuation out of the building in an event of a fire.

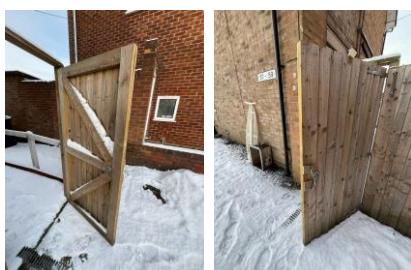
10) Ultimate safety is ensured through access via a timber gate. The gate is intentionally left without a locking mechanism, allowing for immediate, unobstructed egress.

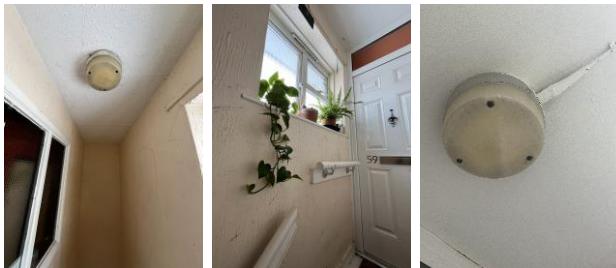
- 1) While dedicated emergency lighting has not been installed on the premises, the existing illumination is deemed adequate. This is due to the strategic placement of lighting units above the stairs and by the final exit, supplemented by sufficient borrowed lighting from the externally facing window on the staircase landing.

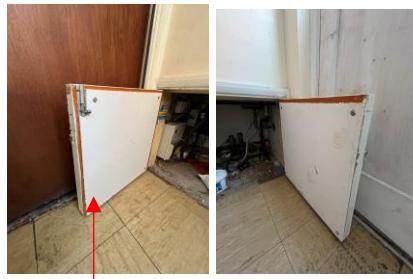
- 3) The rear of the service cupboard doors on the ground floor has been fitted with Promat SUPALUX boarding to establish a fire-resisting barrier. This installation is a form of passive fire protection intended to maintain the integrity of the fire compartmentation and delay the spread of fire and smoke.

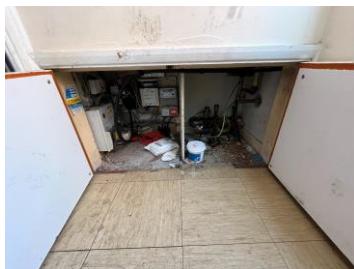
4) Electrical service cupboard is missing combined intumescent strips.

This has been noted in observations to upgrade service cupboard doors containing electrical installation to 44mm FD30s lockable doors with mandatory signage in any future refurbishment to the block

Upgrade service cupboard doors containing electrical installation to 44mm FD30s lockable doors with mandatory signage

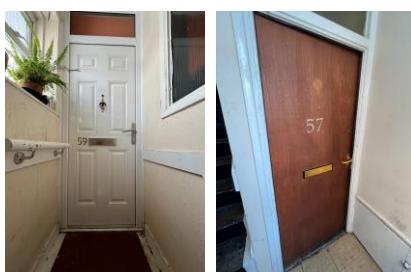
At present it is tolerable to have a notional FD30s timber door to flat 57 but would be recommended that on any future refurbishment of the block that this door be replaced with certified FD30s fire door.

5) Flat 59 has been fitted with a composite FD30S fire door assembly. In contrast, Flat 57 currently utilizes a notional timber door with an approximate FD30S fire rating. It is recommended that, during the next programmed refurbishment or maintenance cycle for the building, the door for Flat 57 be upgraded to a certified FD30S fire door to ensure full compliance with current safety standards and maintain consistent protection.

It is recommended that for future renovations of the block that the notional FD30s timber fire door at flat 57 to be replaced with FD30s certified fire rated door.

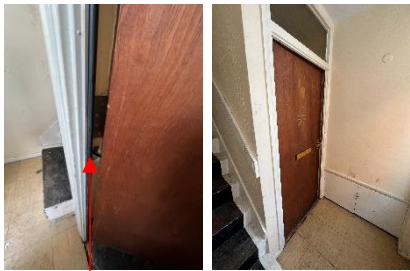
Concealed self closing chain.

7) Flat 57 is fitted with a Perko concealed self-closing chain installed within the door frameset. During testing to verify the effective operation of the self-closing mechanism, the door failed to fully close and did not seat correctly within the frame. The defective Perko chain will need to be removed, and the door installed with an overhead self-closing device.

Question/ Ref No	Required Action	Supporting photograph	Priority	Timescale and Person Responsible	Date Completed
10/7	Flat 57 remove defective Perko concealed self-closing chain, replace with overhead self-closing device

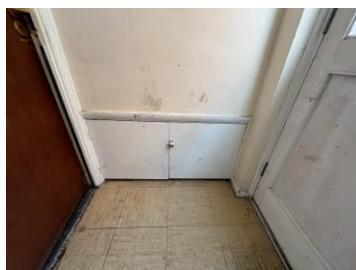
- 4) Service cupboard in entrance hallway will require "Fire Door Keep Locked" signage once the compartment is upgraded with fire rated doors.

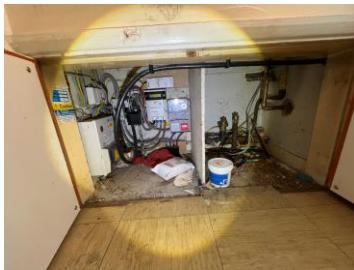
- 5) Residents electrical meter is in a service cupboard on the ground floor next to flat 57 entrance. This was cleared of any combustibles by the resident on the day of the Fire Risk Assessment.

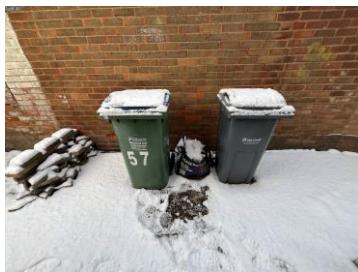
- 1) Sandwell Cleaning services are not employed at this block
- 2) Refuse bin is stored in a dedicated area next to a brick wall and away from the envelope of the building, this is at the rear of the block within the courtyard.

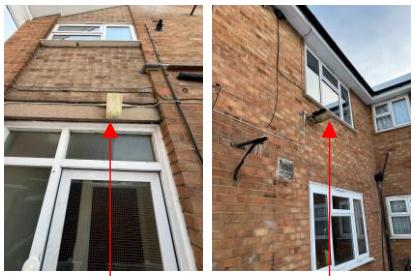
Front and rear external lighting.

- 1) There is no current evidence of arson.
- 2) The perimeter of the premises is well illuminated with the installation of external lighting.
