# Fire Risk Assessment

**50-52 Royal Oak Road**

**Rowley Regis, B65 8NX**

**Date Completed: 13th January 2026**

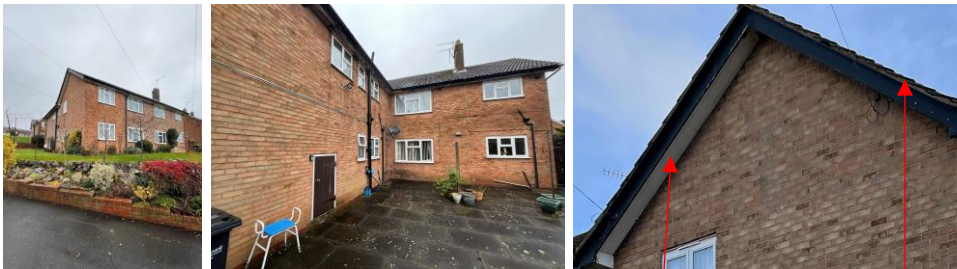
- 1) The exterior of the building is primarily traditional brick construction with a pitched roof design. The roof features concrete tiles and laminated fascia boards along the roofline and underside

Laminated boards on the underside & fascia

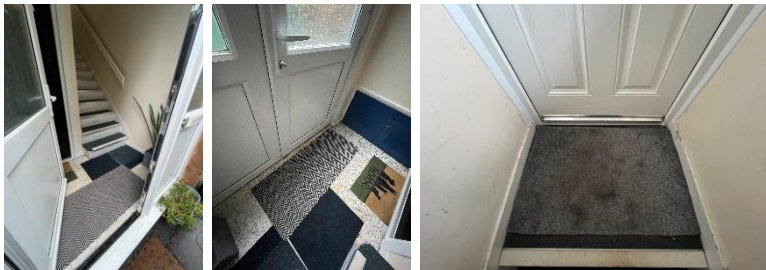
- 1) Each flat is equipped with, as a minimum LD3 fire detection to facilitate means of escape and provide sufficient response time.
- 2) The small section of the entrance hallway floor is installed with vinyl lino, however there are floor mats of various sizing placed over. The sizing and condition of the mats are acceptable. This area is kept clear of any obstruction and combustibles promote maintain safe exit in an event of fire.

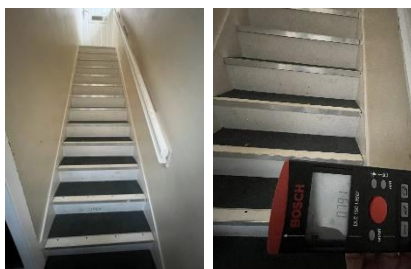
- 3) 50-52 Royal Oak Road contains a single concrete staircase, positioned at the entrance of the block, which provides an adequate means of escape. The width of the staircases, measured from handrail to wall, is 791 mm respectively. This staircase is kept clear to ensure a safe means of escape.

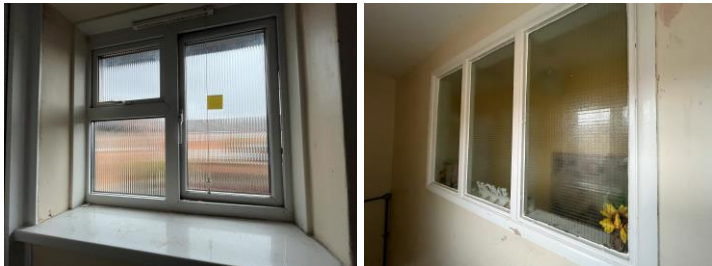
- 5) A UPVC window unit has been installed on the staircase landing which is openable without the use of key. This installation provides sufficient borrowed lighting and ventilation, while an incorporated Georgian wired glazing unit has been installed on the flat side to protect the means of escape and prevent the spread of fire and smoke. It should be noted that there is currently no automatic smoke ventilation system installed on the premises.

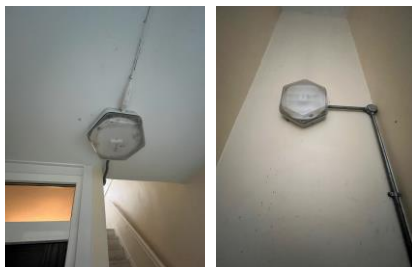
- 6) There is no emergency lighting in place at the block, however there is sufficient lighting installed over the staircase and over the small hallway by the final exit door.

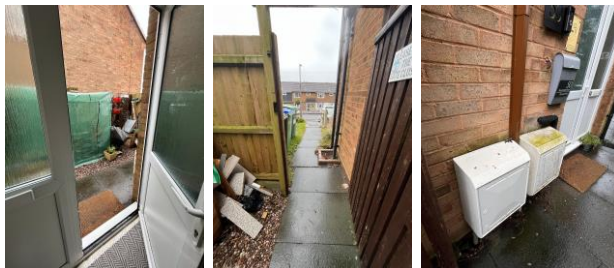
- 9) There are two service cupboards installed on the external wall along the egress path. These cupboards house the residents' gas meters, but do not obstruct the clear and safe evacuation route from the building via the single ground-floor exit.

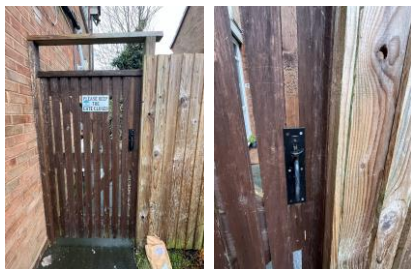
- 10) Ultimate safety is ensured through access via a timber gate. The gate is intentionally left without a locking mechanism, allowing for immediate, unobstructed egress.

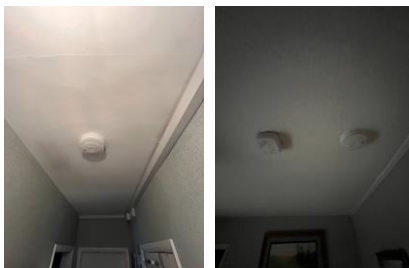
- 1) Early warning is limited to hard wire or battery smoke alarms within each of the resident's flats, this is installed to a minimum of LD3 as standard, the equipment is subjected to a cyclical test.
- 2) There is no effective means for detecting an outbreak of fire to communal areas. The reason for this is:
  - I. Such systems may get vandalised.
  - II. False alarms would occur.
  - III. A Stay Put - Unless policy is in place
- 4) Access was obtained to flat 50 to check for confirmation of detection.

Flat 50 - Detection in hallway, bedroom, lounge and kitchen LD1  
Flat 52 – No access gained.

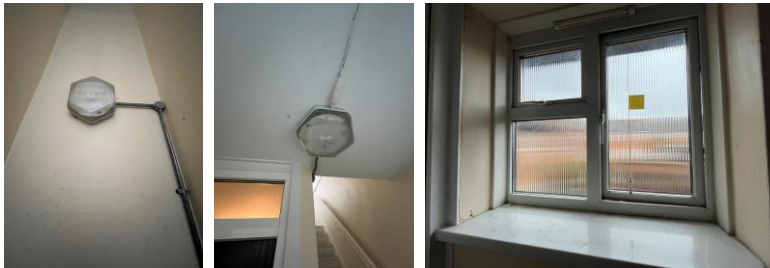
- 1) While dedicated emergency lighting has not been installed on the premises, the existing illumination is deemed adequate. This is due to the strategic placement of lighting units above the stairs and by the final exit, supplemented by sufficient borrowed lighting from the externally facing window on the staircase landing.

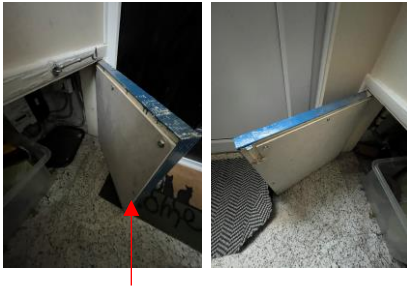
- 3) The rear of the service cupboard doors on the ground floor has been fitted with Promat SUPALUX boarding to establish a fire-resisting barrier. This installation is a form of passive fire protection intended to maintain the integrity of the fire compartmentation and delay the spread of fire and smoke.
-

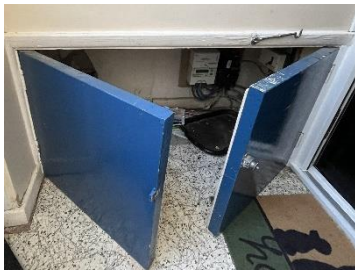
- 4) Electrical service cupboard is equipped with notional doors, *This has been noted in observations to upgrade service cupboard doors containing electrical installation to 44mm FD30s lockable doors with mandatory signage in any future refurbishment to the block.*

Upgrade service cupboard doors containing electrical installation to 44mm FD30s lockable doors with mandatory signage

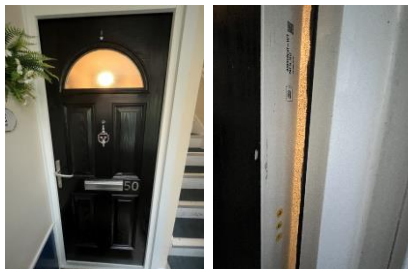
- 5) Flat 50 has been fitted with a certified composite FD30S fire door assembly. Could not gain access to inspect flat entrance door to flat 52.

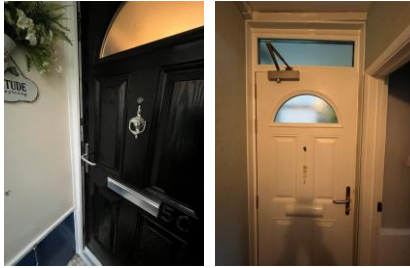
- 6) Access was gained to flat 50 to sample self closing device and condition of fire and smoke seals on flat entrance doors. Self closing device did not fully self close into the frame when tested.**

| Question/<br>Ref No | Required Action | Supporting photograph | Priority | Timescale<br>and Person<br>Responsible | Date<br>Completed |
|---|---|---|---|---|---|
| 10/6 | Flat 50, adjust self-closing device to allow full closure into the frame. | | P2 | 1 -3 Months<br>Fire Rapid<br>Response | |

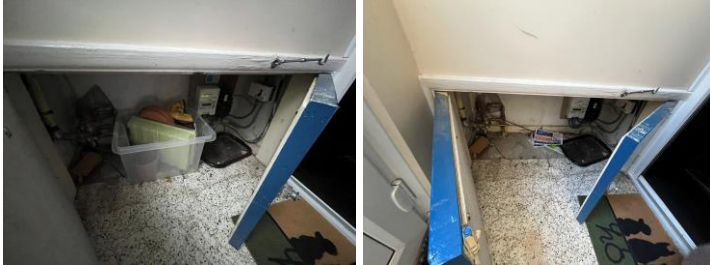
Items removed by tenant on the day

- 5) The residents' electrical meter is located within a service cupboard on the ground floor, adjacent to the entrance to Flat 50. This cupboard should be kept clear of any combustible items. Any such items present were removed on the day of the Fire Risk Assessment (FRA).

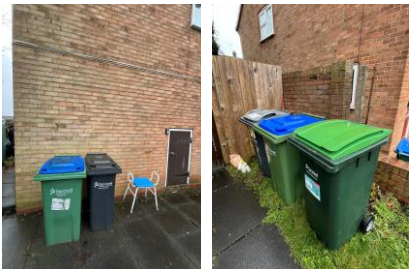
- 1) Sandwell Cleaning services are not employed at this block
- 2) Refuse bins are located at both the front and rear of the building. The bins at the front are positioned away from the building envelope and therefore pose no risk. The refuse bins at the rear are located adjacent to the brick wall forming part of the building envelope; however, their positioning does not present any risk.

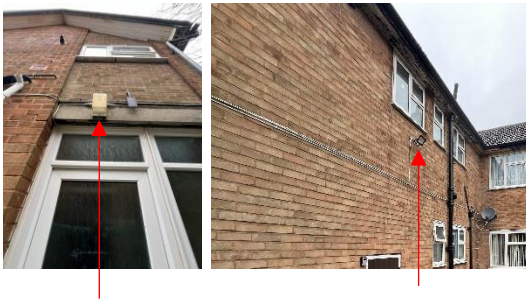
Front and rear external lighting.

- 1) There is no current evidence of arson.
- 2) The perimeter of the premises is well illuminated with the installation of external lighting.
