Fire Risk Assessment

54 - 56 Royal Oak Road

Rowley Regis, B65 8DU

Date Completed: 13th January 2026

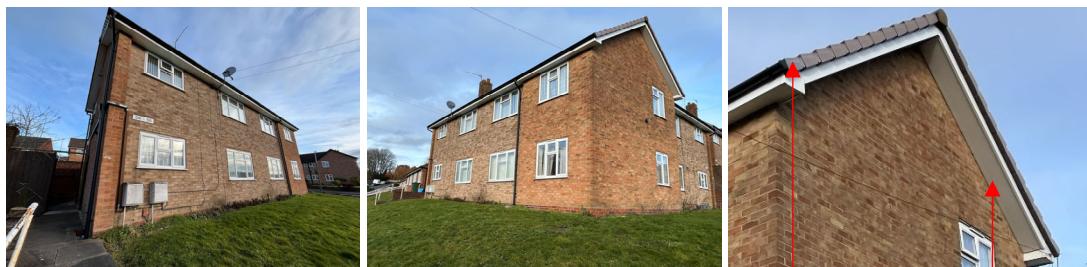
- 1) The exterior of the building is primarily traditional brick construction with a pitched roof design. The roof features concrete tiles and UPVC fascia boards below the roofline and underside with dry end verge caps above.

Dry verge end caps and UPVC facia

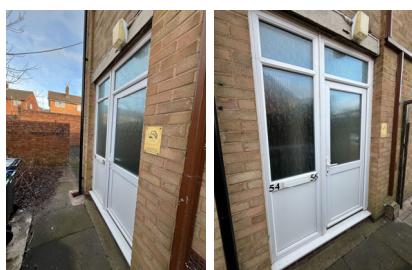
- 2) Front entrance door to the block is of UPVC construction with double glazing installed within the unit.

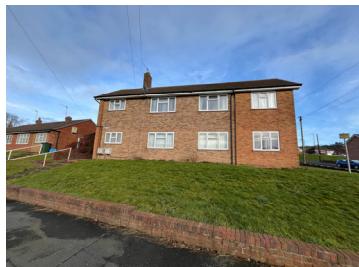
3) UPVC double-glazed window units have been installed in each flat and in the communal areas within the block.

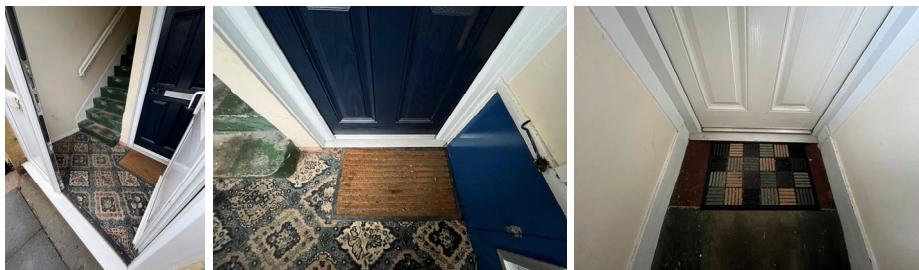
- 1) Each flat is equipped with, as a minimum LD3 fire detection to facilitate means of escape and provide sufficient response time.
- 2) A small section of the entrance hallway floor is finished with carpet with floor mats over the top. The mats are of acceptable size and condition. This area is maintained free of obstructions and combustible materials, thereby supporting a safe and unobstructed means of escape in the event of a fire.

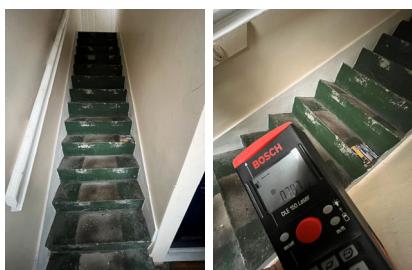
- 3) 54-56 Royal Oak Road contains a single concrete staircase, positioned at the entrance of the block, which provides an adequate means of escape. The width of the staircases, measured from handrail to wall, is 787 mm respectively. This staircase is kept clear to ensure a safe means of escape.

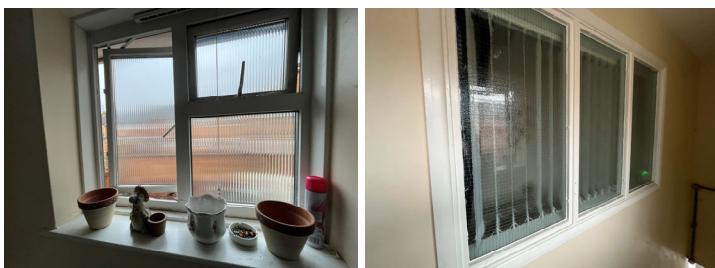
4)A UPVC window unit has been installed on the staircase landing which is openable without the use of key. This installation provides sufficient borrowed lighting and ventilation, while an incorporated Georgian wired glazing unit has been installed on the flat side to protect the means of escape and prevent the spread of fire and smoke. It should be noted that there is currently no automatic smoke ventilation system installed on the premises.

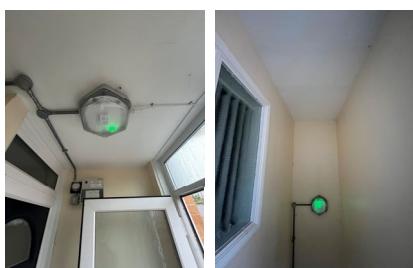
5)There is emergency lighting in place at the block, units are present in the entrance hallway and over the staircase

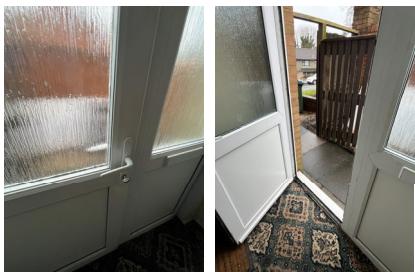
7)The final exit door is installed with a thumb turn lock, this aids easy and safe evacuation out of the building in an event of a fire.

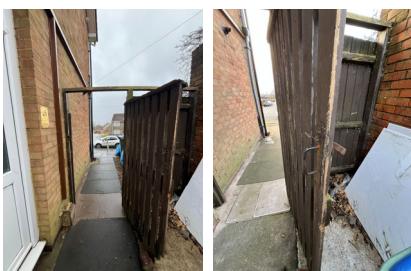
8) Ultimate safety is ensured through access via a timber gate. The gate is intentionally left without a locking mechanism, allowing for immediate, unobstructed egress.

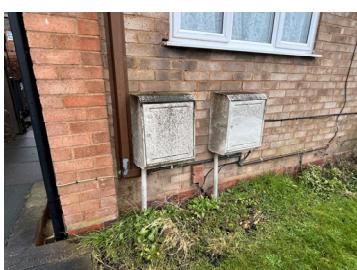
9) There are two service cupboards installed on the external wall on the front elevation of the block, these do not obstruct the clear and safe evacuation route from the building via the single ground-floor exit.

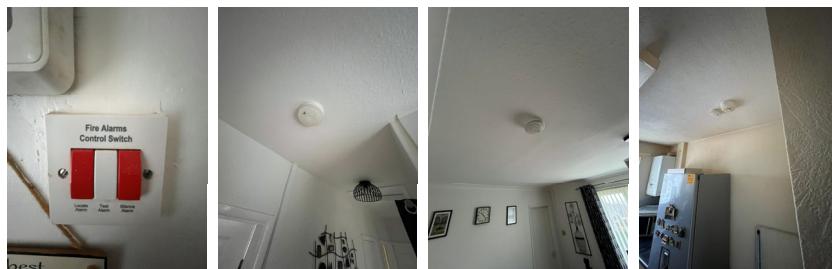
- 1) Early warning is limited to hard wire or battery smoke alarms within each of the resident's flats, this is installed to a minimum of LD3 as standard, the equipment is subjected to a cyclical test.
- 2) There is no effective means for detecting an outbreak of fire to communal areas. The reason for this is:
 - I. Such systems may get vandalised.
 - II. False alarms would occur.
 - III. A Stay Put - Unless policy is in place
- 4) Access was obtained to resident's flats to check for confirmation of detection.

Flat 54 detection in hallway, lounge – LD2

Flat 56 detection in hallway, lounge, kitchen – LD2

- 5) SMBC's Job Manager system confirms detectors to LD3 standard as minimum were checked as part of the most recent annual gas service for flat 54 & 56

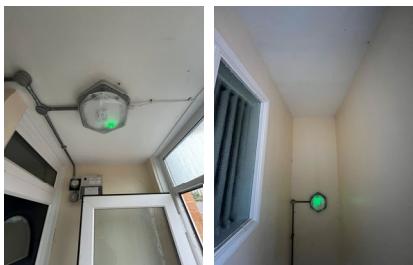
Emergency lights test switch

4) There are 2 self-contained units installed on within the block, these are evident over the ground floor entrance and over the staircase. The emergency light test switch is located next to a distribution board which is installed in the entrance hallway next to flat 54.

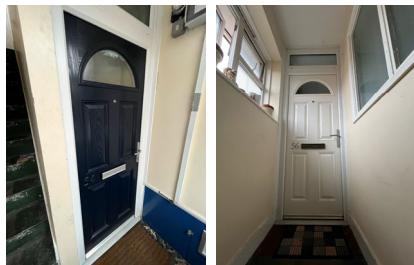
5) Flats 54 & 56 have been fitted with a composite FD30S fire door assembly.

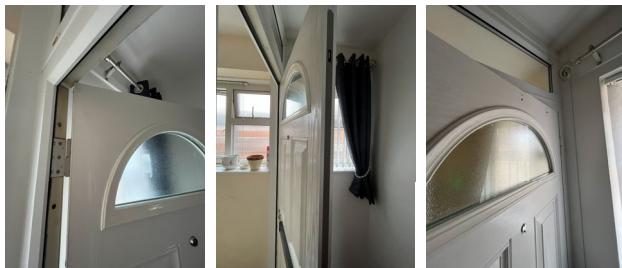
7) Flat 56 has removed the self closing device, this will need to be reinstalled to meet compliance.

Question/ Ref No	Required Action	Supporting photograph	Priority	Timescale and Person Responsible	Date Completed
10/7	Re-install self-closing device to flat 56

P2	1 - 3 Months Fire Rapid Response

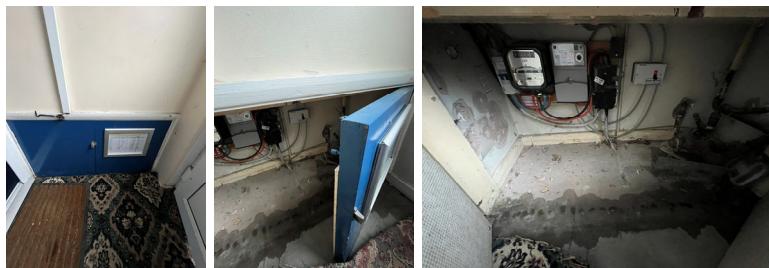
5) The residents' electrical meter is located within a service cupboard on the ground floor, adjacent to the entrance to Flat 54. This cupboard should be kept clear of any combustible items

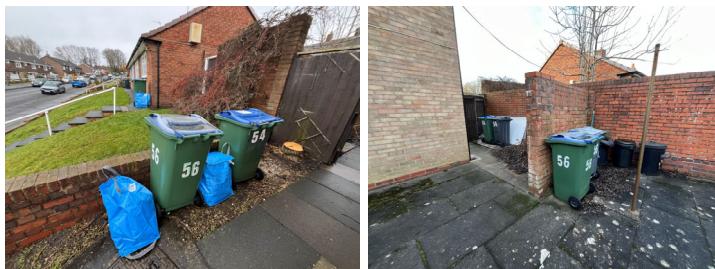
- 1) Sandwell Cleaning services are not employed at this block
- 2) Refuse bins are located at both the front and rear of the building. The bins at the front are positioned away from the building envelope and therefore pose no risk. The refuse bins at the rear are located adjacent to the brick wall forming no part of the building envelope, their positioning does not present any risk.

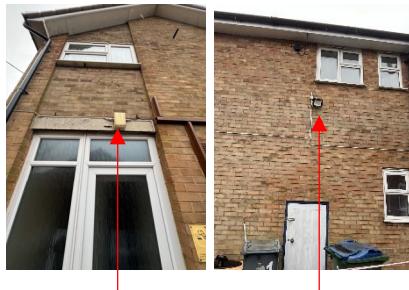
- 1) There is no current evidence of arson.
- 2) The perimeter of the premises is well illuminated with the installation of external lighting. Rear lighting is installed on to block 1 -3 Warren drive which shares the same courtyard as 54 -56 Royal Oak Drive.

Front and rear external lighting.

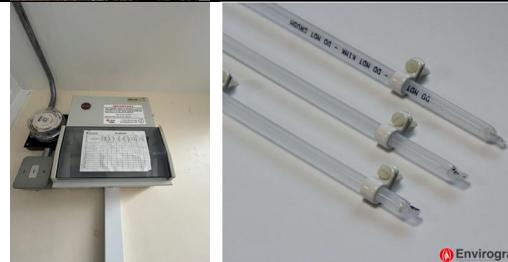
7) An electrical distribution board is currently installed within the entrance hallway above Flat 54. Enviroburst and similar type products may mitigate any associated risk with electrical installations that are not enclosed in fire resisted cupboards; therefore, it is recommended that the installation of these products is explored further, this has been recorded in section 19(Observations)

An electrical distribution board is currently installed within the entrance hallway above Flat 54. It is recommended that a Enviroburst fire suppression system be fitted to lower any potential risk.
