# Fire Risk Assessment

## Meadow Avenue (Aspen House)

**Charlemont Farm, West Bromwich,  
B71 3EF.**

**Date Completed: 02/02/2026**

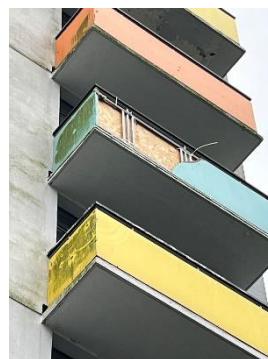
- 2) A sixth-floor balcony HPL panel has been damaged and temporarily repaired with a timber sterling board panel. A new panel has been purchased and will be fitted as soon as reasonably practicable.

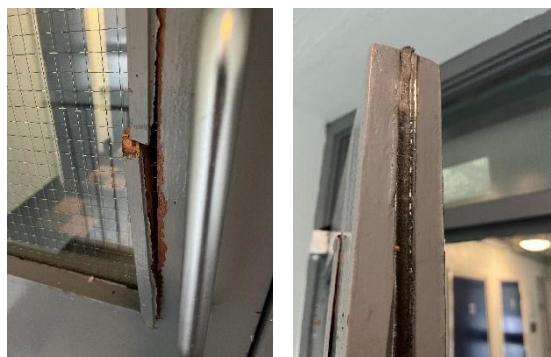
**9) The 8<sup>th</sup> floor rear stairwell fire door has damaged glass beading and a damaged latch-side smoke seal requiring rectification. See action 7/9.**

Question/ Ref No	Required Action	Supporting photograph	Priority	Timescale and Person Responsible	Date Completed
7/9	The 8 <sup>th</sup> floor rear stairwell fire door has damaged glass beading and a damaged latch-side smoke seal, requiring rectification.

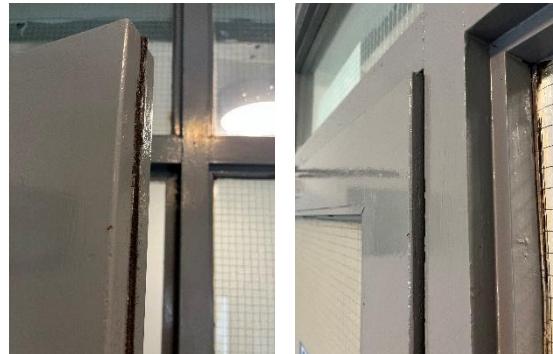
10) The 8<sup>th</sup> floor front stairwell fire door has a damaged latch-side smoke seal and the door leaf is bowed. These defects require rectification. See action 7/10.

7/10	The 8 <sup>th</sup> floor front stairwell fire door has a damaged latch-side smoke seal and the door leaf is bowed. These defects require rectification.

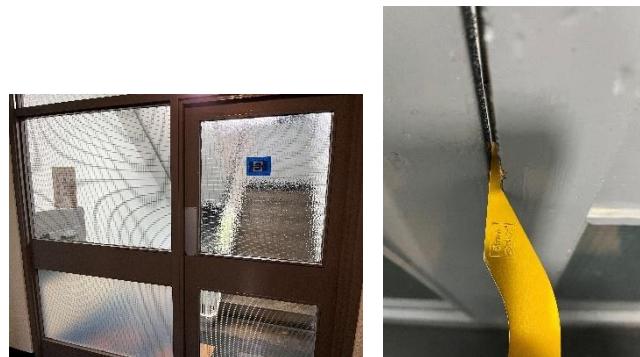
11) The 5<sup>th</sup> floor rear stairwell fire door has a 6mm latch-side gap, requiring adjustment. See action 7/11.

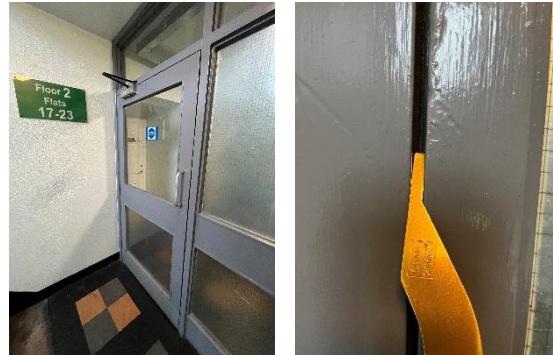
12) The 2<sup>nd</sup> floor front stairwell fire door has a 6mm latch-side gap, requiring adjustment. See action 7/12.

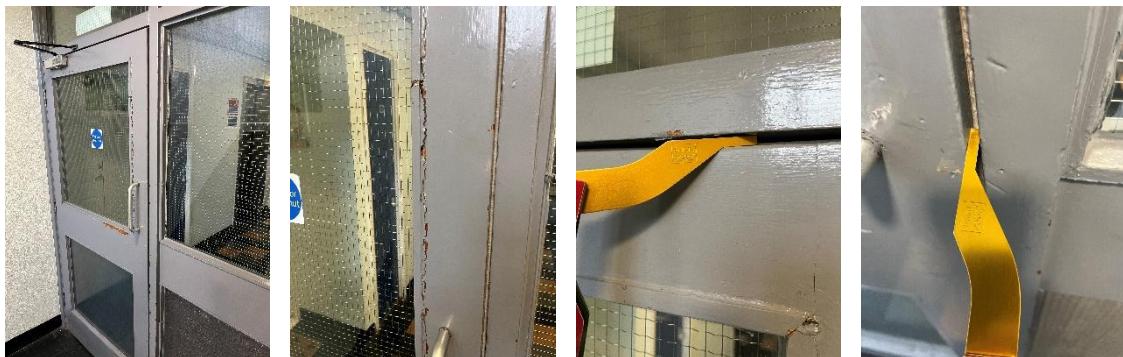
13) The 1st floor front stairwell fire door has damaged glass beading and a 6mm head and latch-side gap requiring rectification. See action 7/12.

7/13	<p>The 1st floor front stairwell fire door has damaged glass beading and excessive head and latch-side gaps (6mm). These defects require rectification.</p>

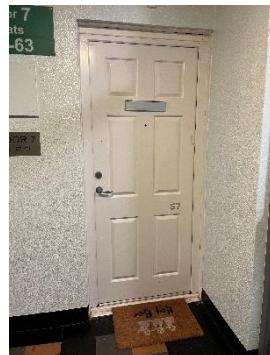
20) Individual floor mats were noted outside some flats. Fire rating of the mats is unknown but deemed to be of low risk.
