# Fire Risk Assessment

## Meadow Avenue (Beech).

**Charlemont Farm, West Bromwich,  
B71 3EJ.**

**Date Completed: 03/02/2026**

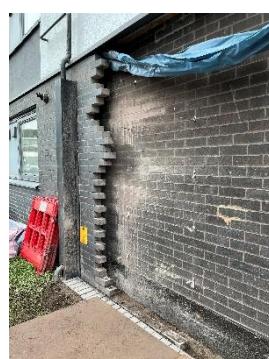
- 1) The external wall at Beech House has 3 separate areas of cladding. The external wall system was upgraded in 2017/18 and comprises of:
  - Brickwork from ground to 1ST floor. Fire classification A1.
  - At the time of the assessment repairs were ongoing to rectify damaged caused by a vehicle impact to the ground floor exterior wall.

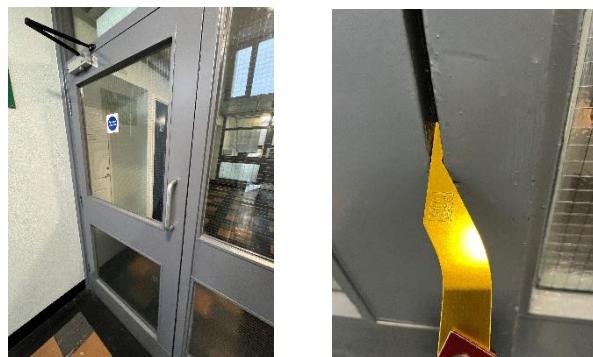
9) **The 6<sup>th</sup> floor front stairwell fire door has a 6mm latch-side gap, requiring adjustment. See action 7/9.**

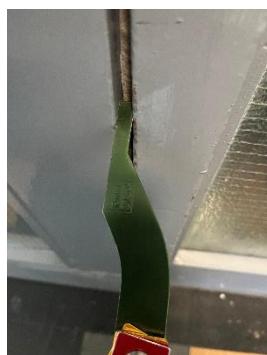
12) The 3<sup>rd</sup> floor front stairwell fire door has an 8mm latch-side gap, requiring adjustment. See action 7/12.

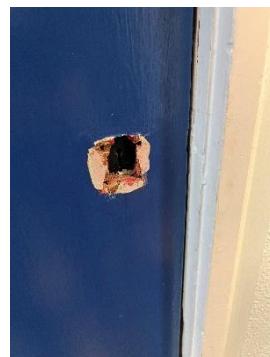
7) The escutcheon plate on the service cupboard door leaf near flat 127 on the 6<sup>th</sup> floor is missing, a replacement is required. See action 10/7.

P2	Fire Rapid Response 1 – 3 months.	
10/7	The escutcheon plate on the service cupboard door leaf near flat 127 on the 6 <sup>th</sup> floor is missing, a replacement is required.

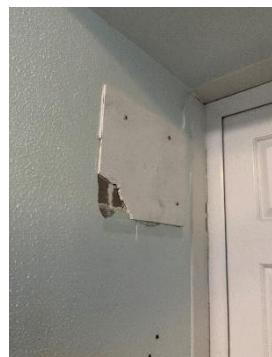
14) **The access panel for flat 177 is damaged, repair is required.**  
**See action 10/14**

P2	Fire Rapid Response 1 – 3 months.	
10/14	The tap access panel for Flat 177 is damaged. Repair required.

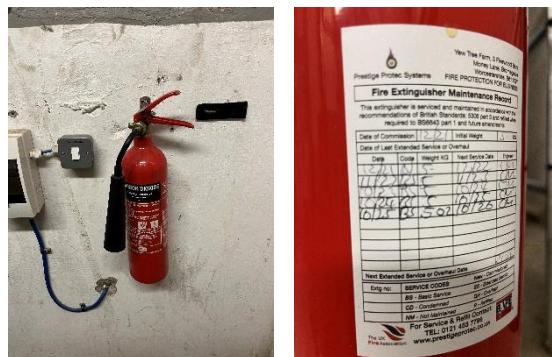
4) A portable fire CO2 fire extinguisher is provided in the lift motor room. A contract is in place for maintenance of the extinguisher. The frequency for the maintenance checks is once (October) each calendar year. There is no extinguisher information sign. A CO2 extinguisher information sign is required to be fitted. See action 11/4.
